# **DISTRICT INFRASTRUCTURE ASSESSMENT REPORT**

## **BOGGY CREEK IMPROVEMENT DISTRICT**

**APRIL 30, 2026**

**BOGGY CREEK IMPROVEMENT DISTRICT  
ORLANDO, FLORIDA**

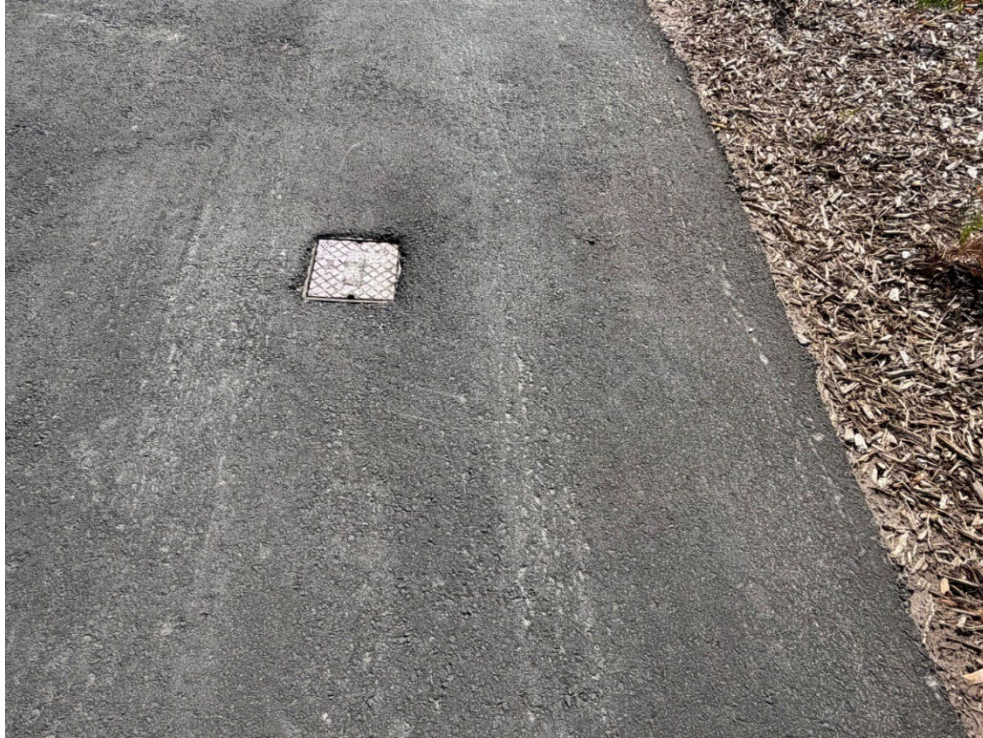
**Photo 5.1 – Damaged Asphalt  
(New Photo – 2026 Assessment)**

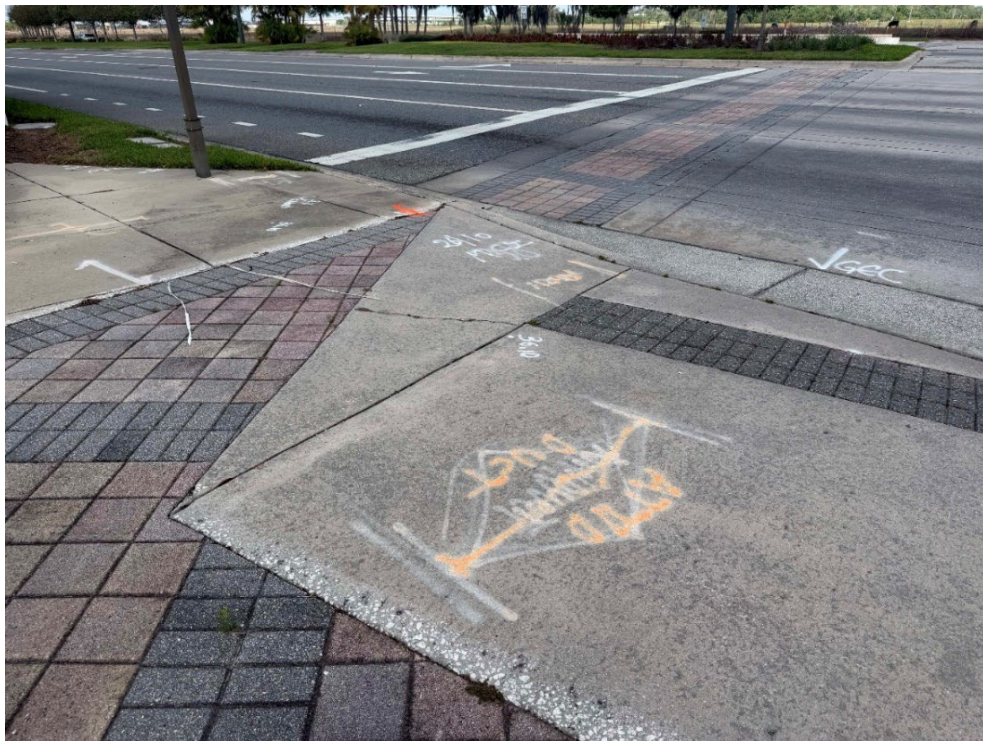
**Photo 10 – Surficial Concrete Cracks in Handicap Ramp (No Observed Changes)  
(Refer to Prior Photo 13- 2025 Assessment)**

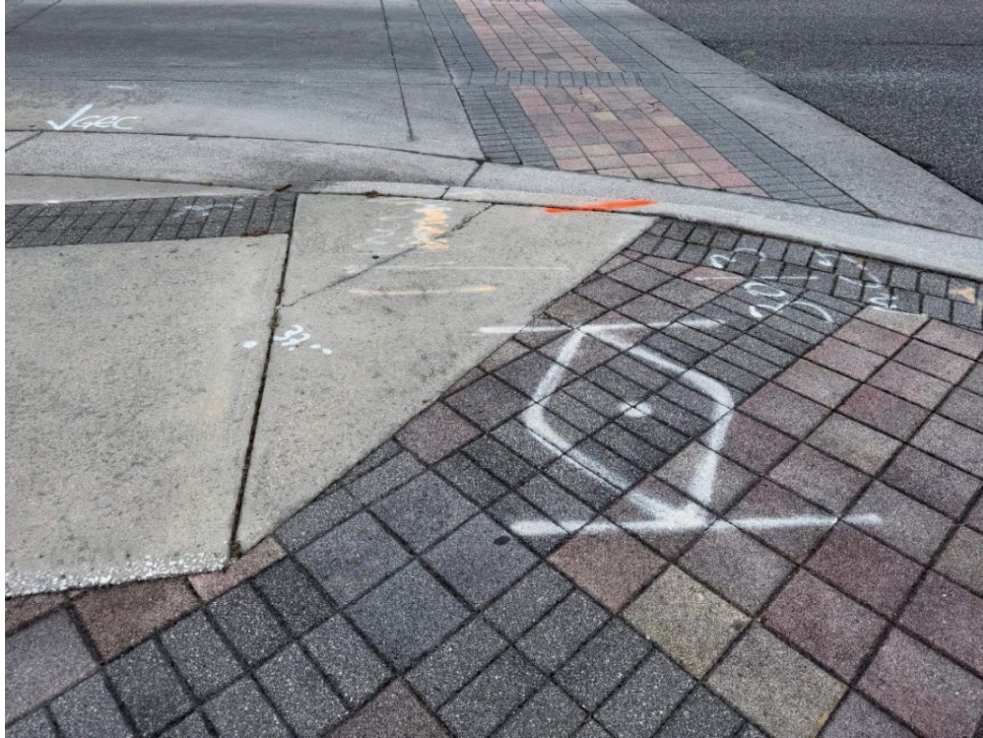
**Photo 11 – Surficial Concrete Cracks in Handicap Ramp (No Observed Changes)  
(Refer to Prior Photo 14- 2025 Assessment)**

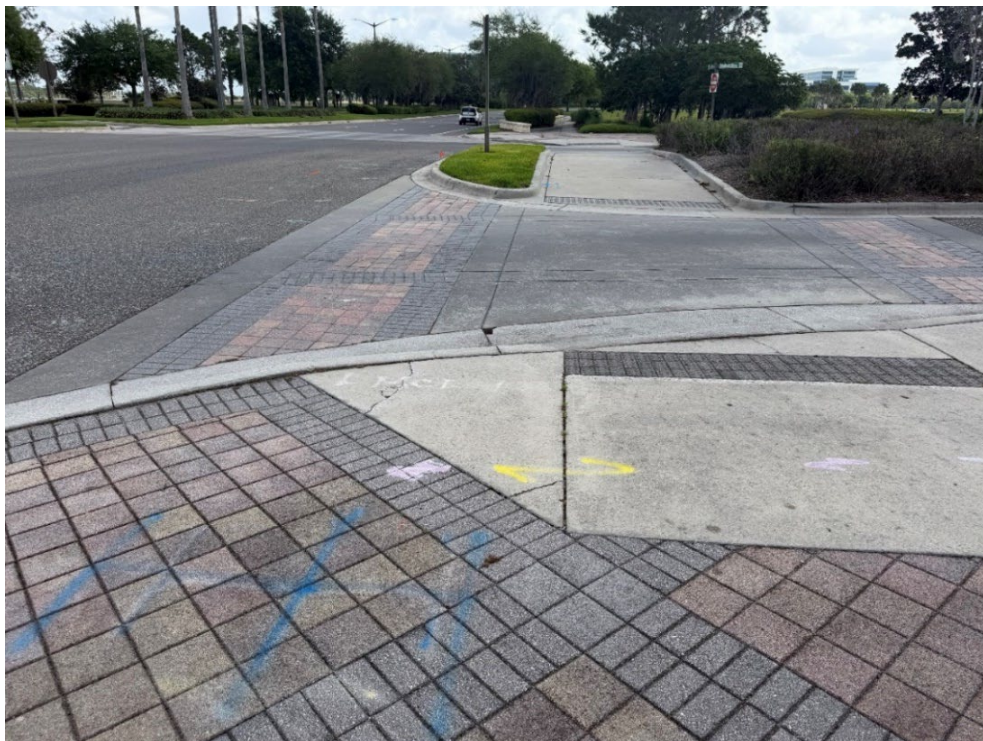
**Photo 12 – Surficial Concrete Cracks in Handicap Ramp (No Observed Changes)  
(Refer to Prior Photo 15- 2025 Assessment)**

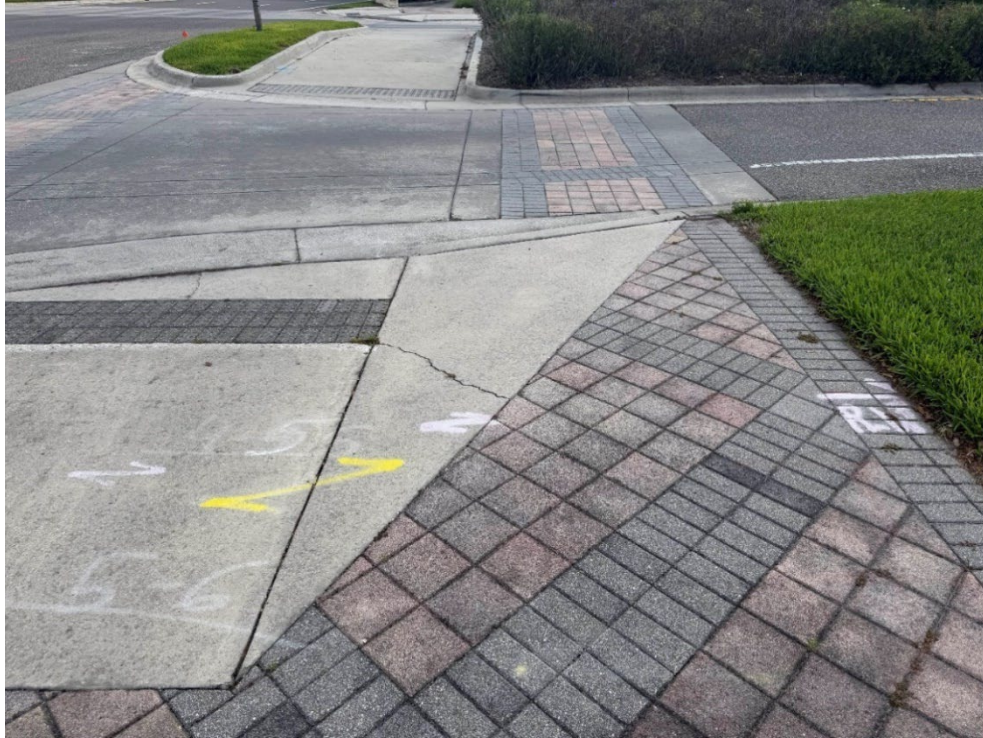
**Photo 13 – Surficial Concrete Cracks in Handicap Ramp (No Observed Changes)  
(Refer to Prior Photo 16- 2025 Assessment)**

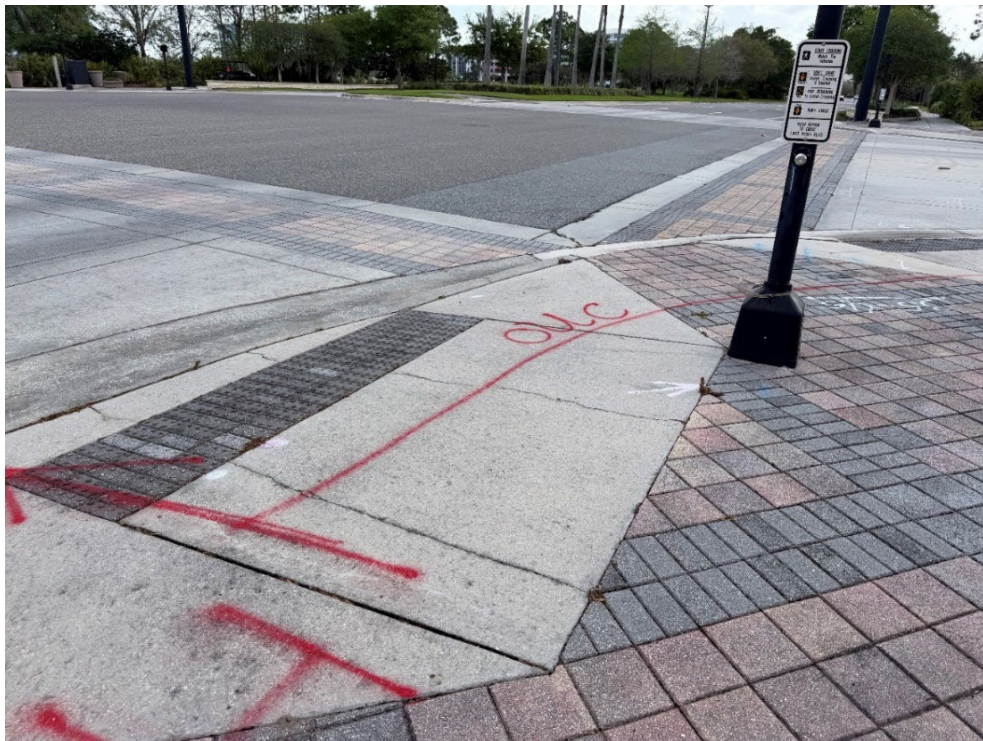
**Photo 14 – Surficial Concrete Cracks in Handicap Ramp (No Observed Changes)  
(Refer to Prior Photo 17 - 2025 Assessment)**

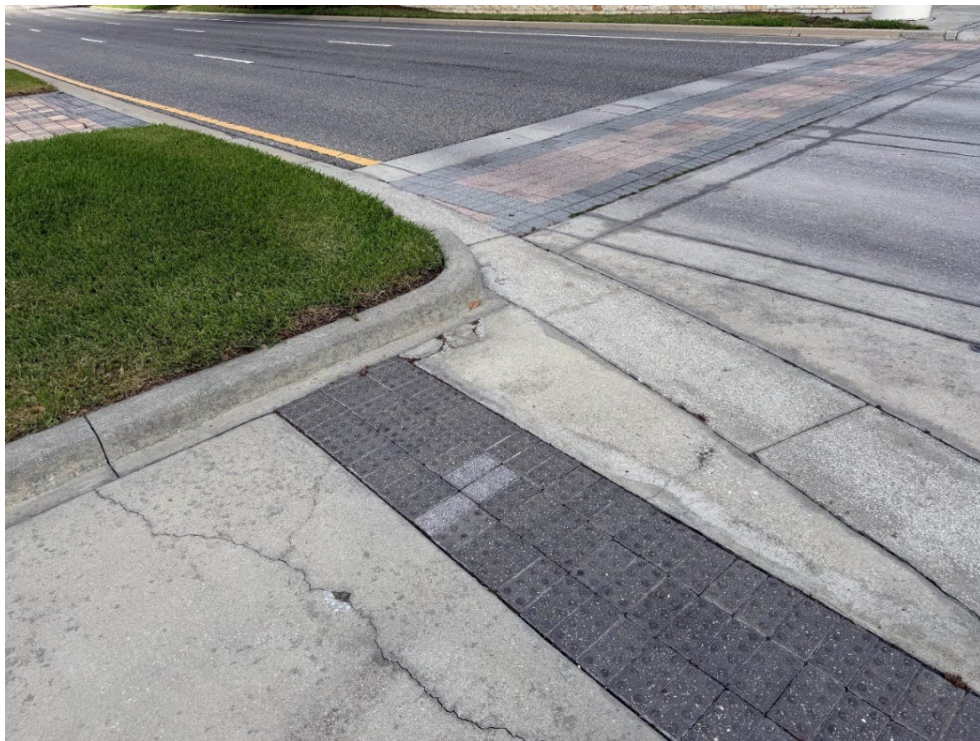
**Photo 16 – Surficial Concrete Cracks in Handicap Ramp (No Observed Changes)  
(Refer to Prior Photo 20- 2025 Assessment)**

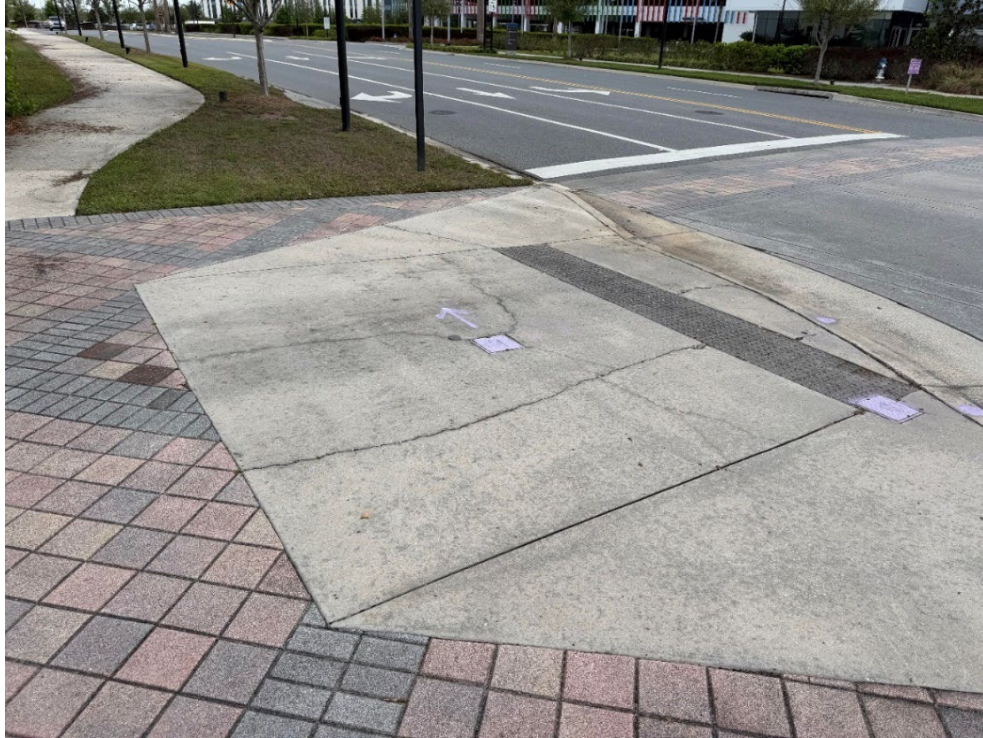
**Photo 17 – Surficial Concrete Cracks in Handicap Ramp (No Observed Changes)  
(Refer to Prior Photo 21- 2025 Assessment)**

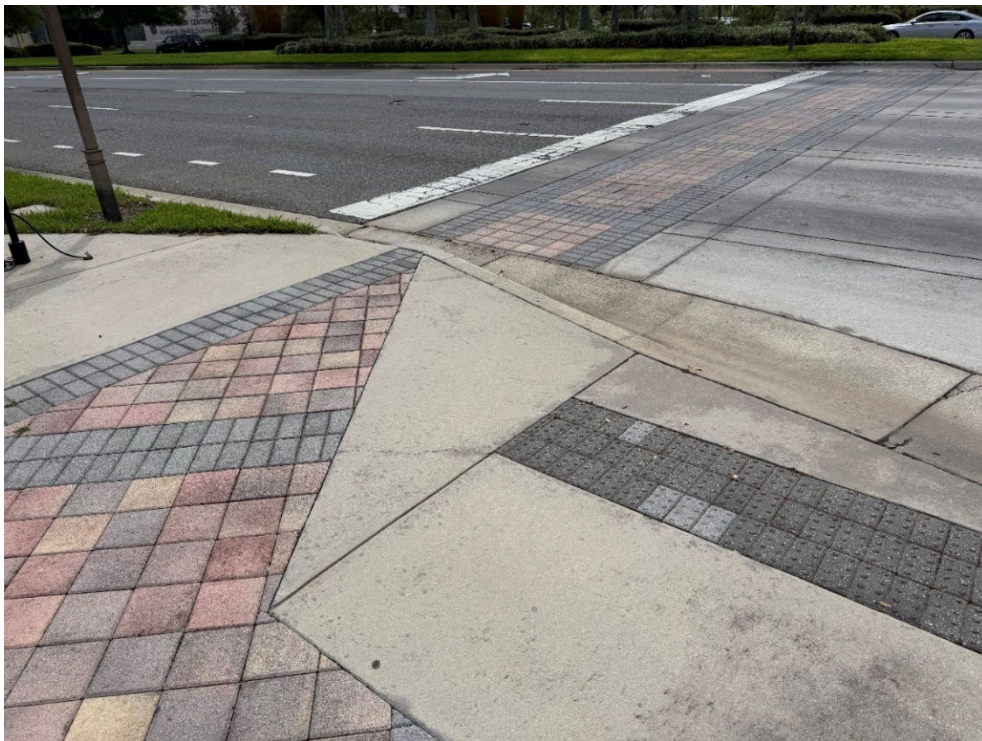
**Photo 24 – Surficial Concrete Cracks in Handicap Ramp (No Observed Changes)  
(Refer to Prior Photo 31- 2025 Assessment)**

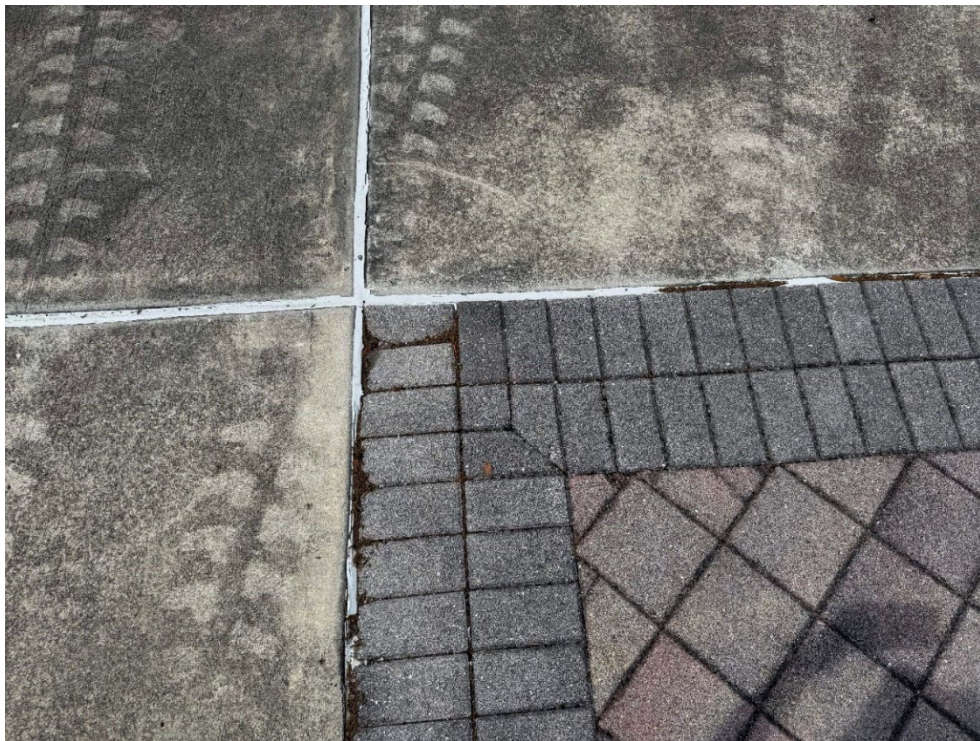
**Photo 26 – Surficial Concrete Cracks in Handicap Ramp (No Observed Changes)  
(Refer to Prior Photo 33- 2025 Assessment)**

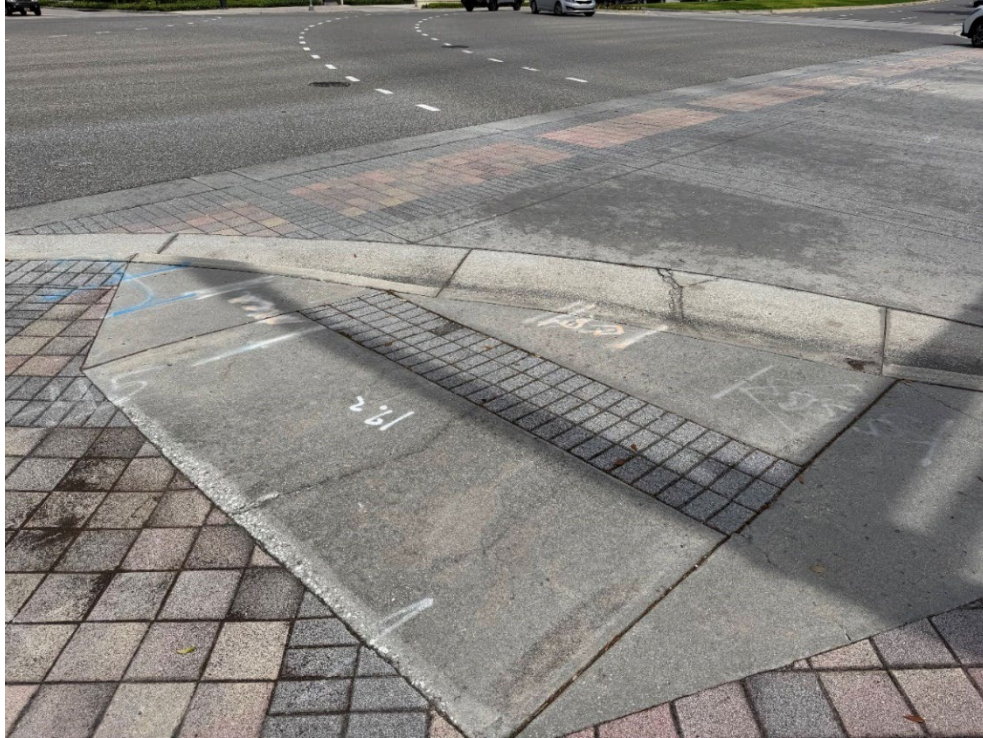
**Photo 27 – Paver Base Failure (No Observed Changes)  
(Refer to Prior Photo 34- 2025 Assessment)**

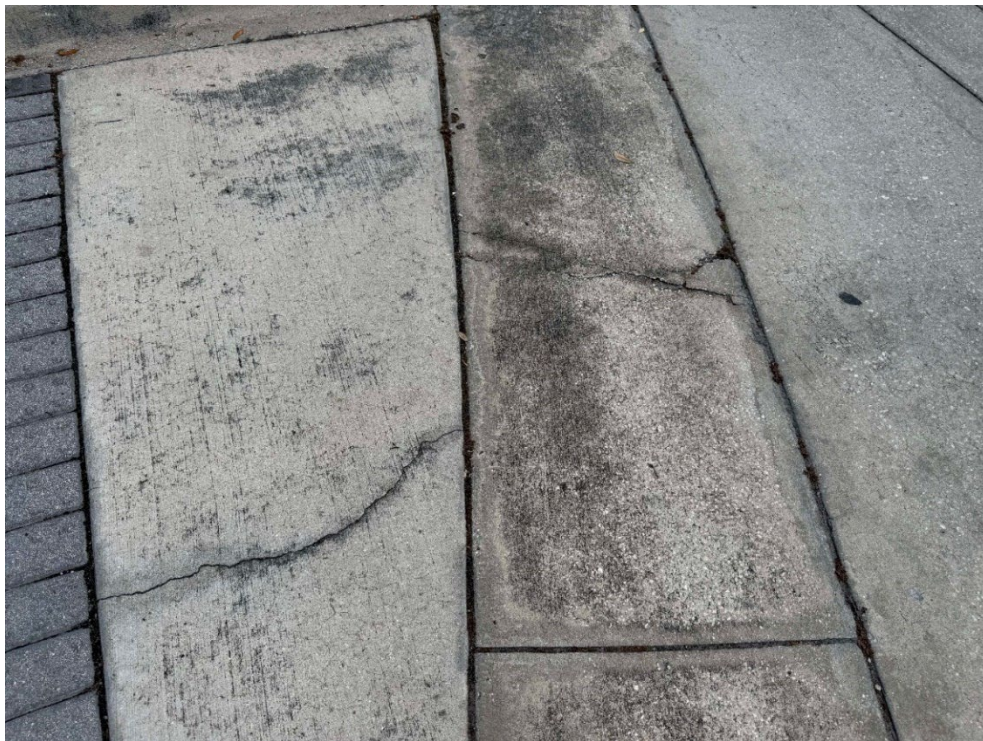
**Photo 30 – Surficial Concrete Cracks in Median Strip (No Observed Changes)  
(Refer to Prior Photo 37- 2025 Assessment)**

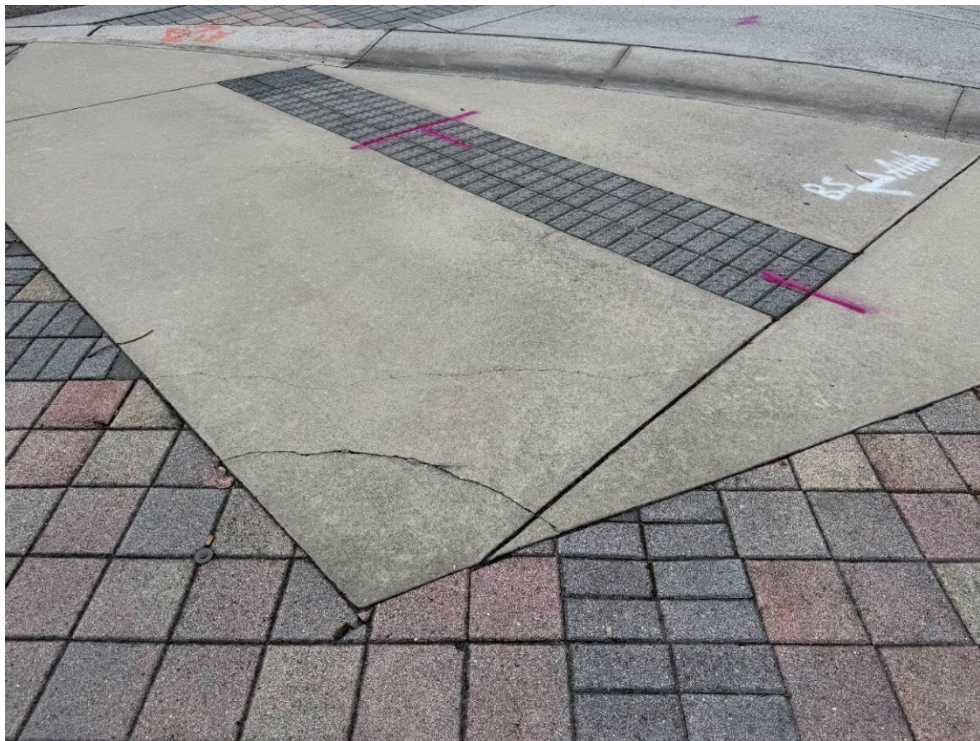
**Photo 32 – Surficial Concrete Cracks in Median Strip (No Observed Changes)  
(Refer to Prior Photo 39- 2025 Assessment)**

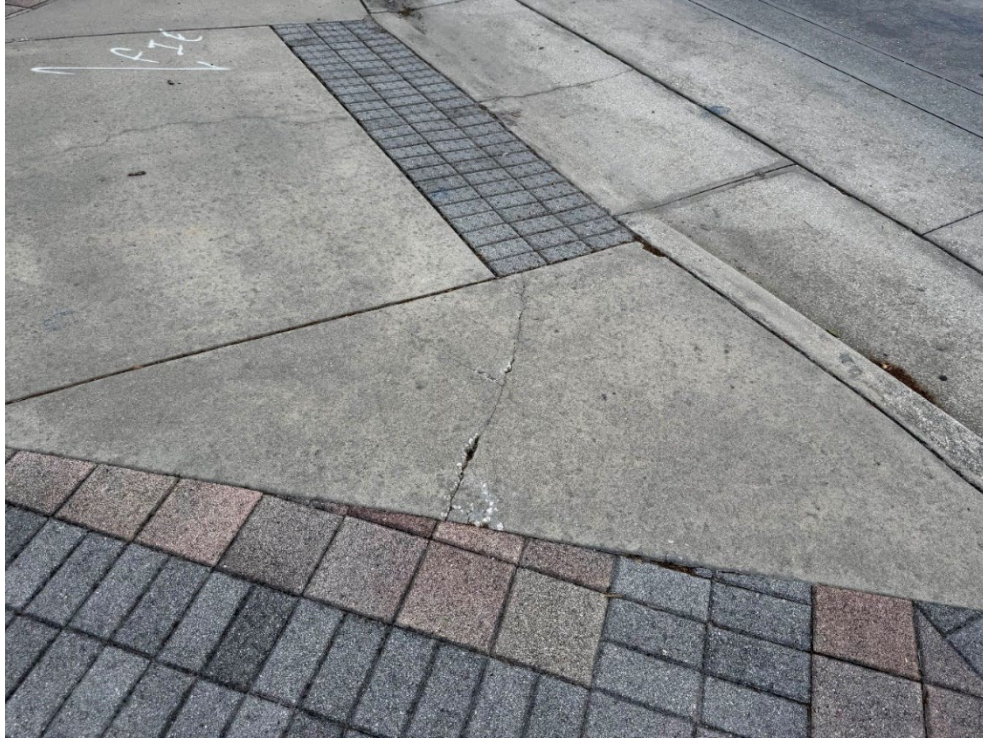
**Photo 33 – Surficial Concrete Cracks in Handicap Ramp (No Observed Changes)  
(Refer to Prior Photo 40- 2025 Assessment)**

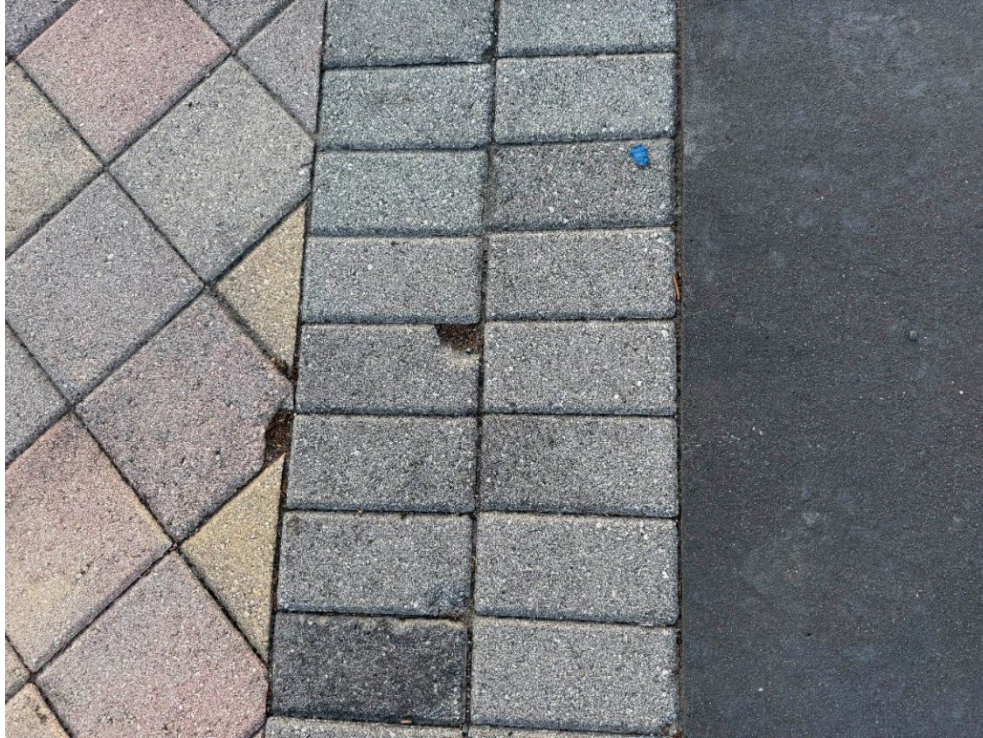
**Photo 37 – Multiple Chipped Pavers (No Observed Changes)  
(Refer to Prior Photo 44- 2025 Assessment)**

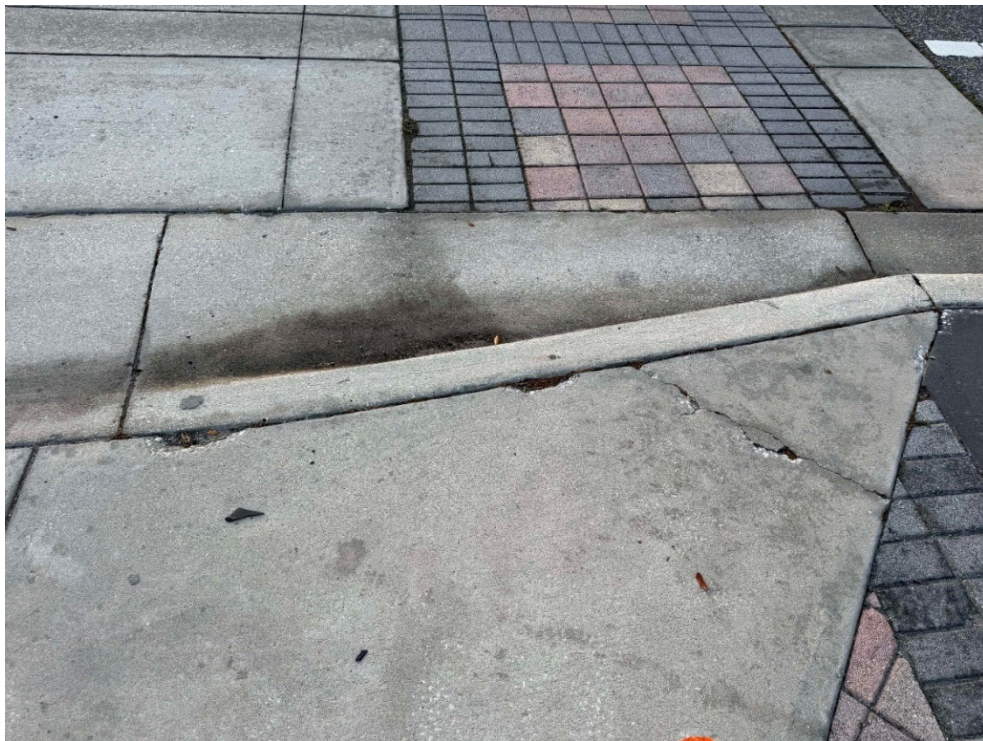
**Photo 38 – Multiple Chipped Pavers (No Observed Changes)  
(Refer to Prior Photo 45- 2025 Assessment)**

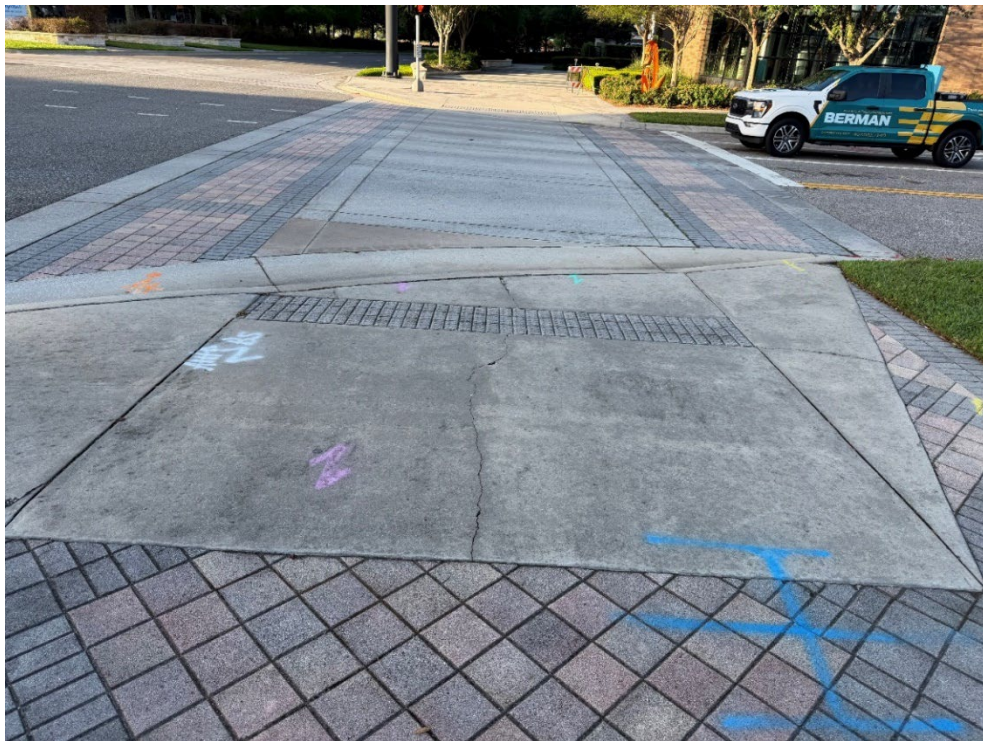
**Photo 39 – Multiple Broken Pavers (No Observed Changes)  
(Refer to Prior Photo 47- 2025 Assessment)**

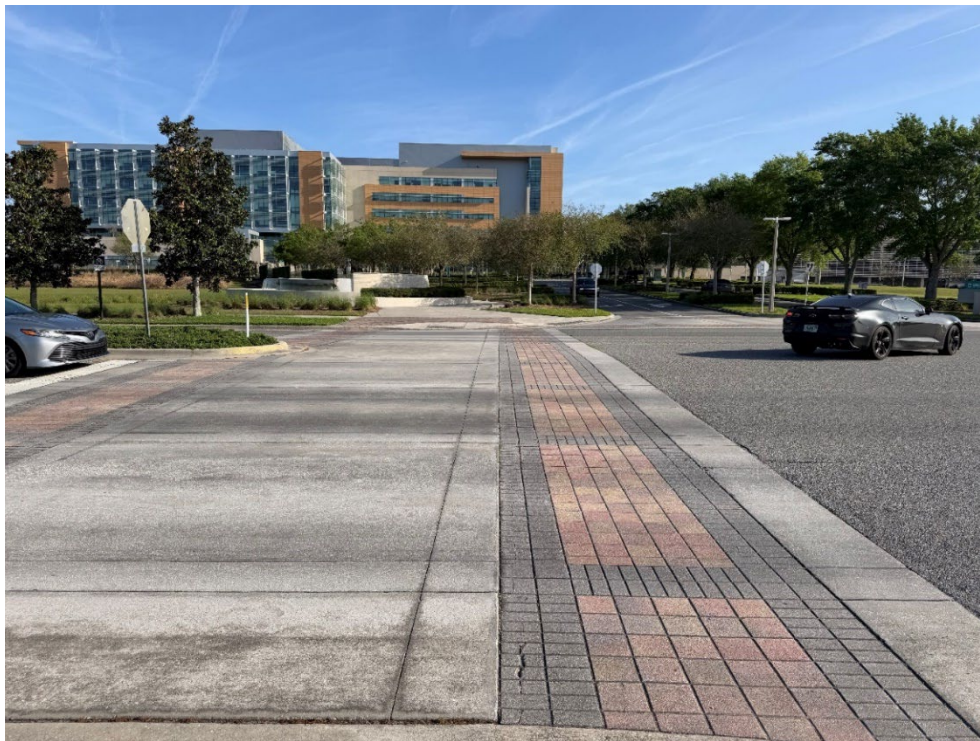
**Photo 47 – Paver Base Failure in North Median Looking North (No Observed Changes)  
(Refer to Prior Photo 57- 2025 Assessment)**

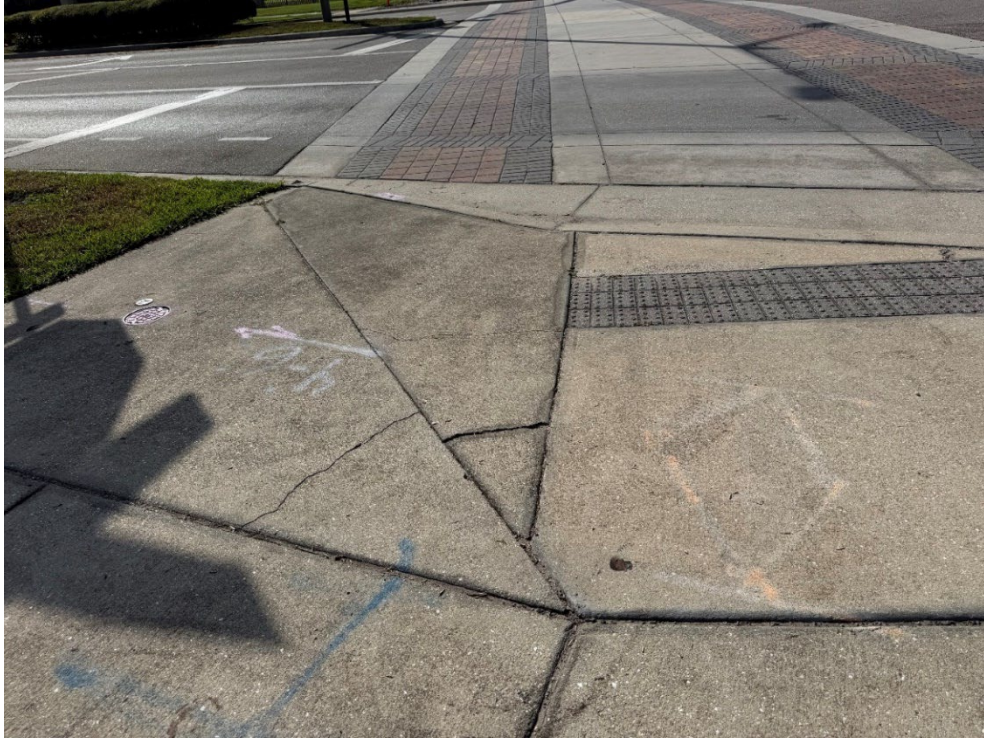
**Photo 53.1 – Surficial Concrete Cracks in Handicap Ramp  
(New Photo – 2026 Assessment)**

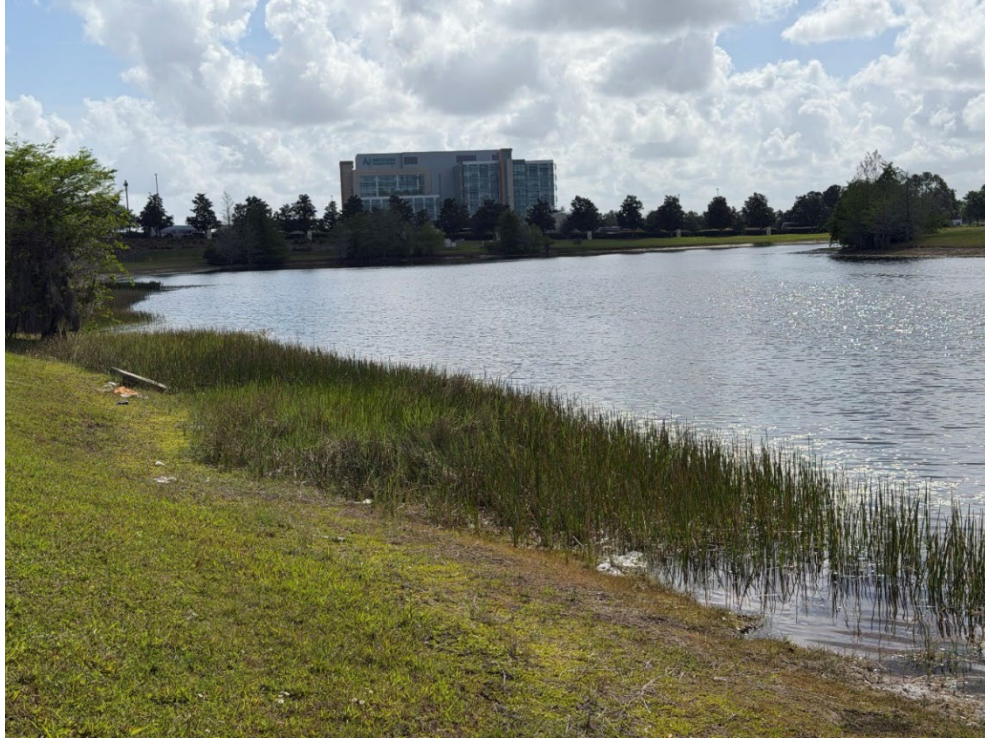
**Photo 57 – Pond Berm Facing East in Good Condition (No Observed Changes)  
(Refer to Prior Photo 75- 2025 Assessment)**

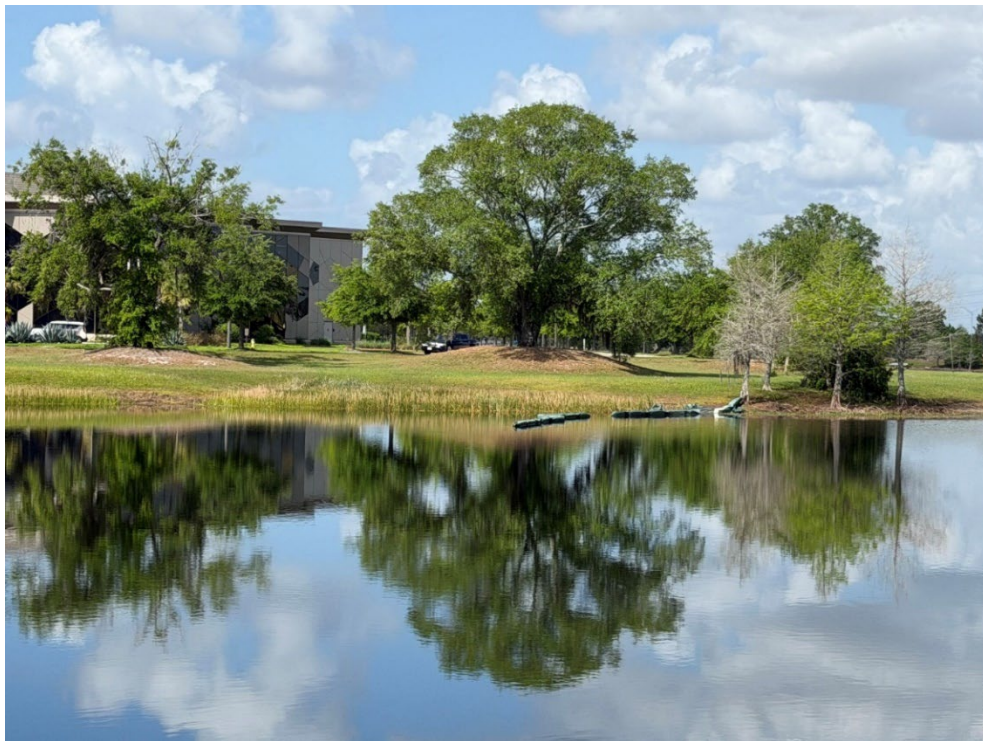
**Photo 58 – Vegetation in Pond (No Observed Changes)  
(Refer to Prior Photo 76- 2025 Assessment)**

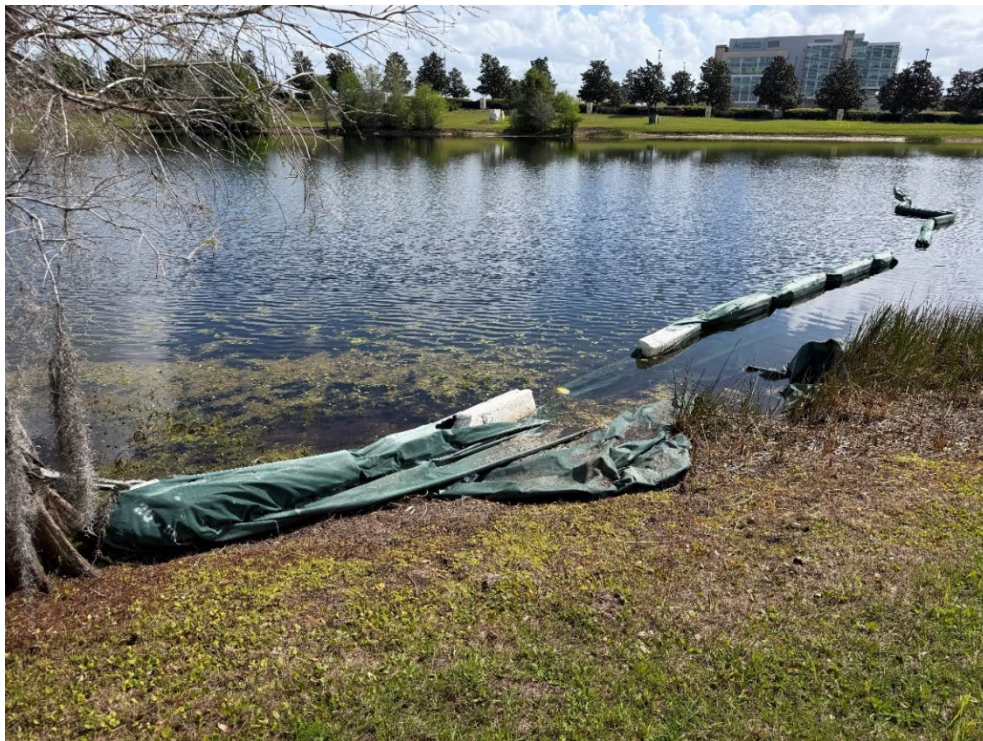
**Photo 59 – Vegetation in Pond – View from East End (No Observed Changes)  
(Refer to Prior Photo 78- 2025 Assessment)**

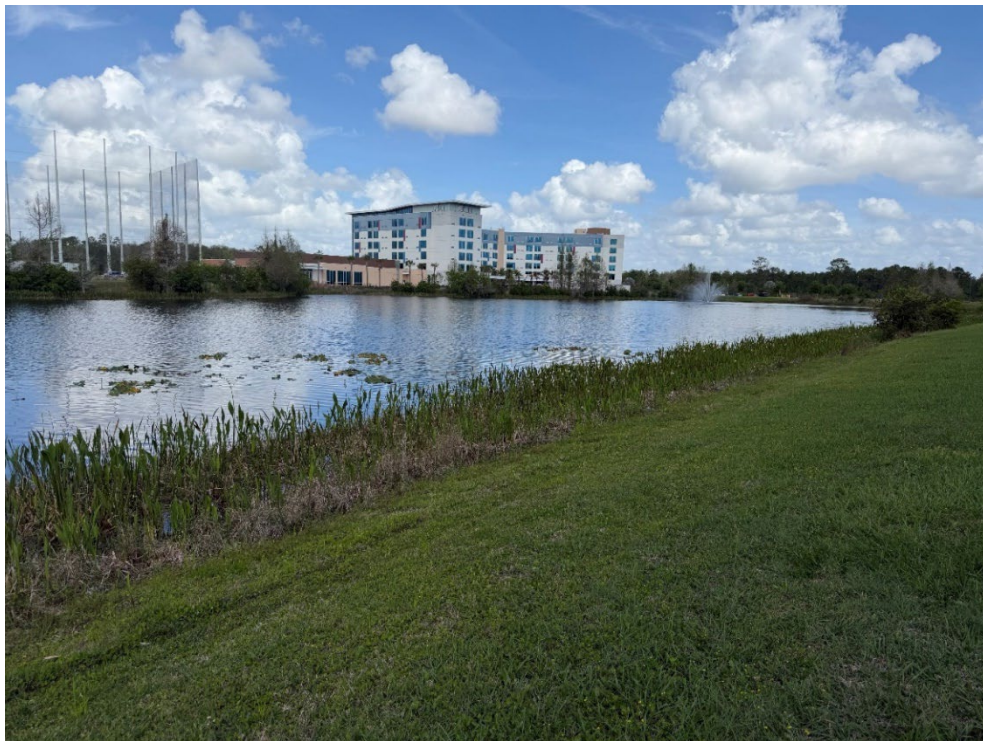
**Photo 61 –NE Corner Berm (No Observed Changes)  
(Refer to Prior Photo 81- 2025 Assessment)**

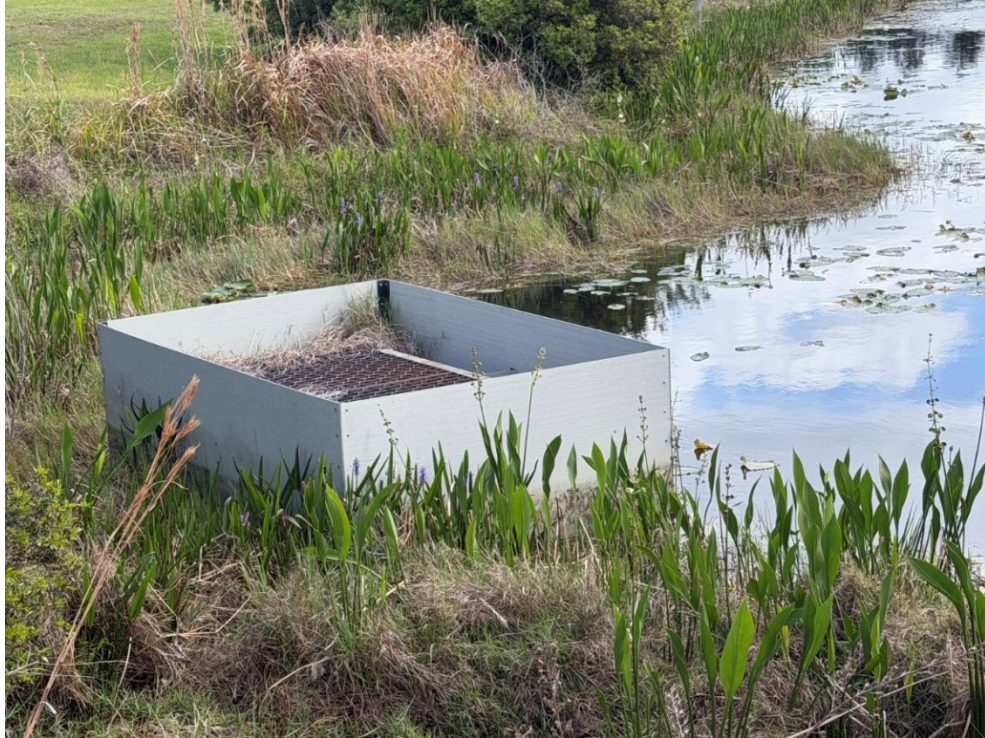
**Photo 61.1 – Vegetation in Pond and Pond Berm in Good Condition  
(New Photo – 2026 Assessment)**

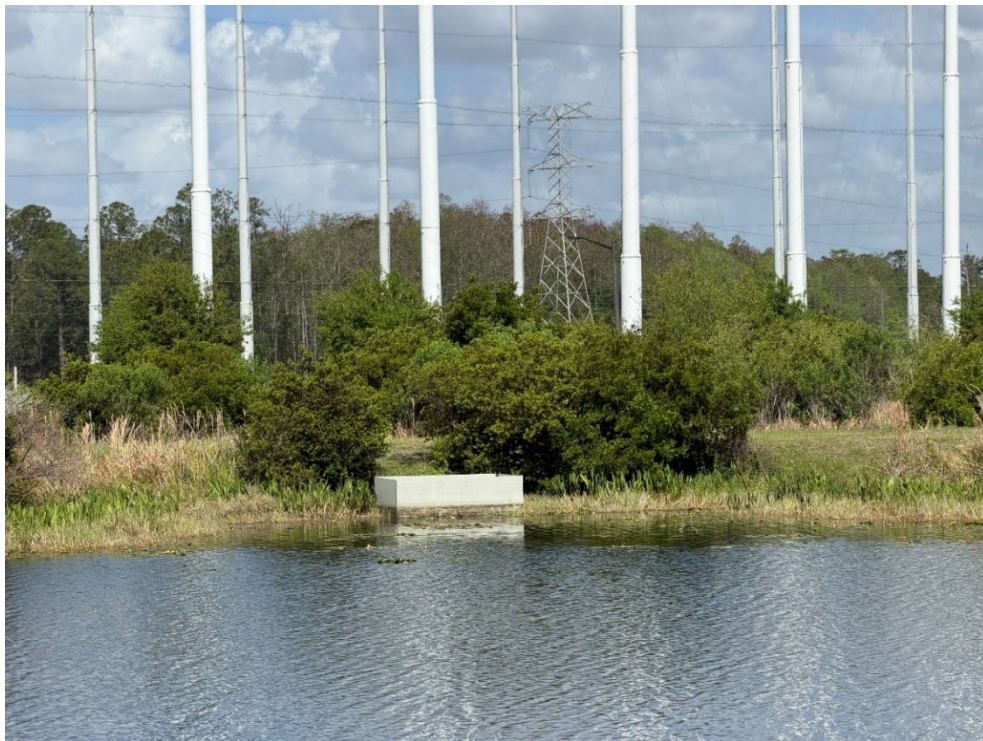
**Photo 61.4 – Outfall Structure Containing Vegetation  
(New Photo – 2026 Assessment)**

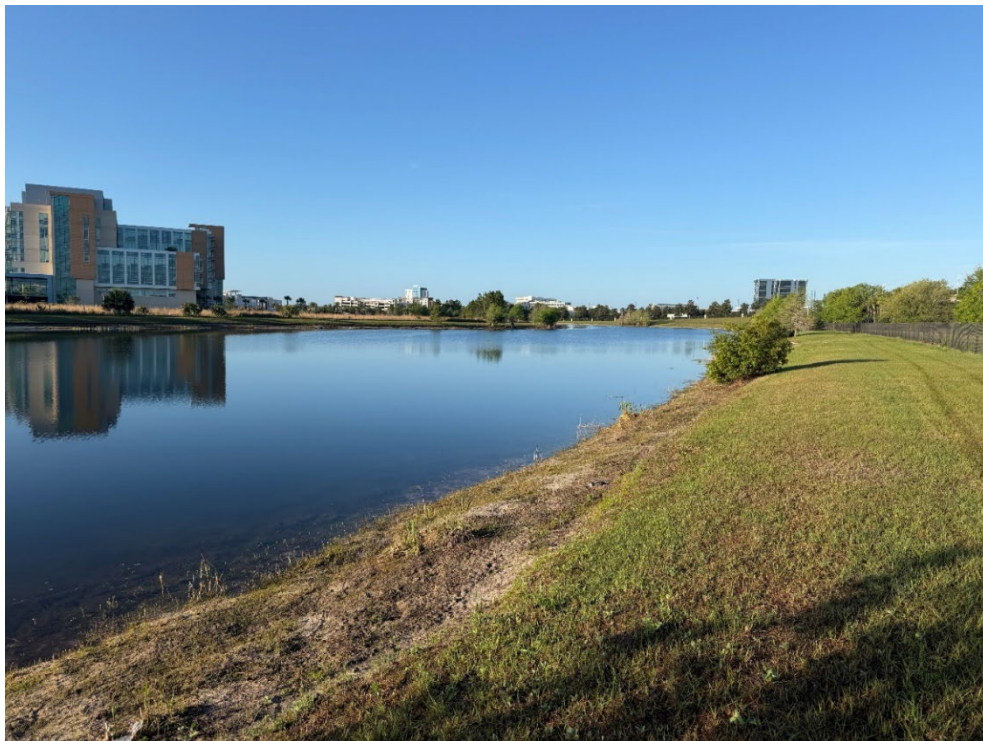
**Photo 65 – West Side of Pond in Good Condition (No Observed Changes)  
(Refer to Prior Photo 85 - 2025 Assessment)**

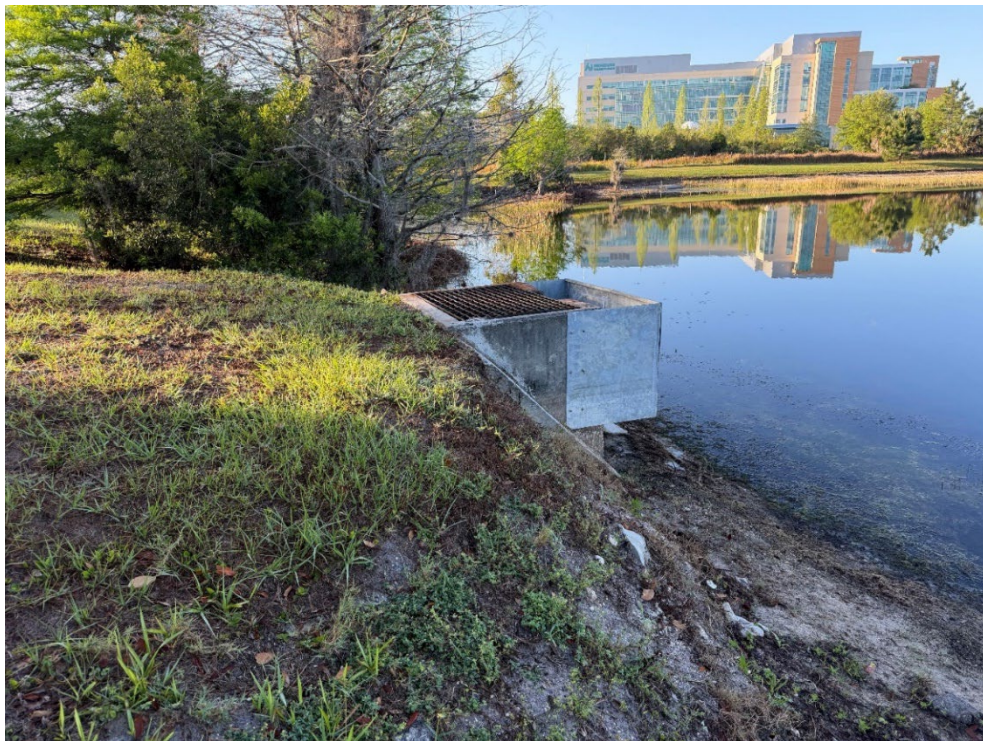
**Photo 67 – Weir on NE Corner in Good Condition  
(No Observed Changes) (Refer to Prior Photo 87 - 2025 Assessment)**

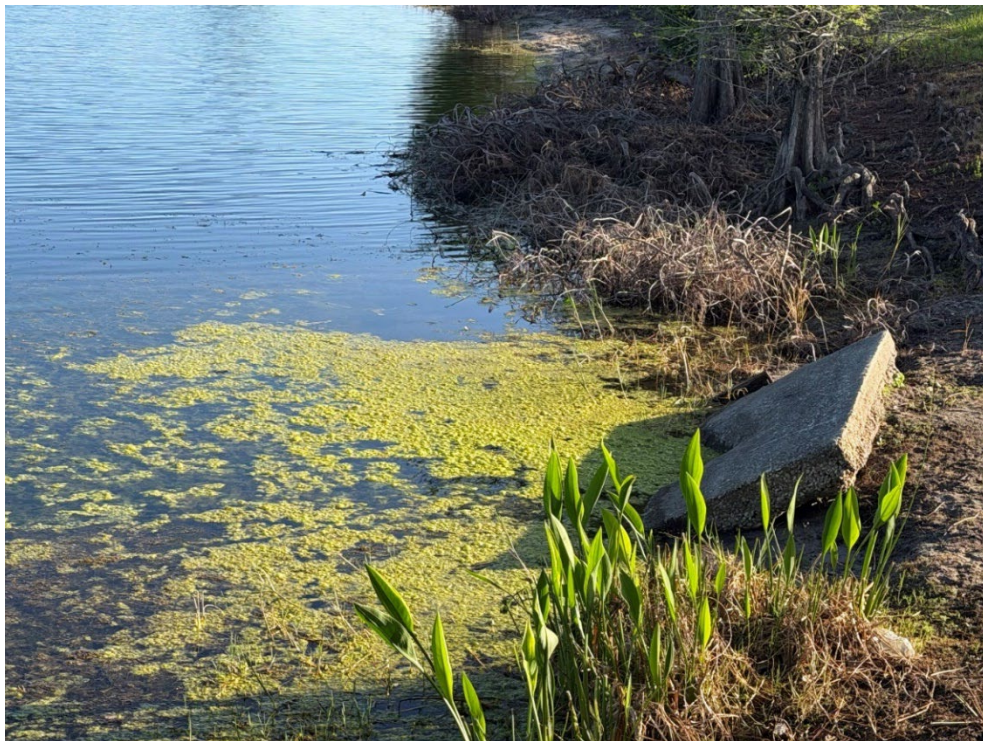
**Photo 70.1 – Stormwater Inflow in Good Condition  
(New Photo – 2026 Assessment)**

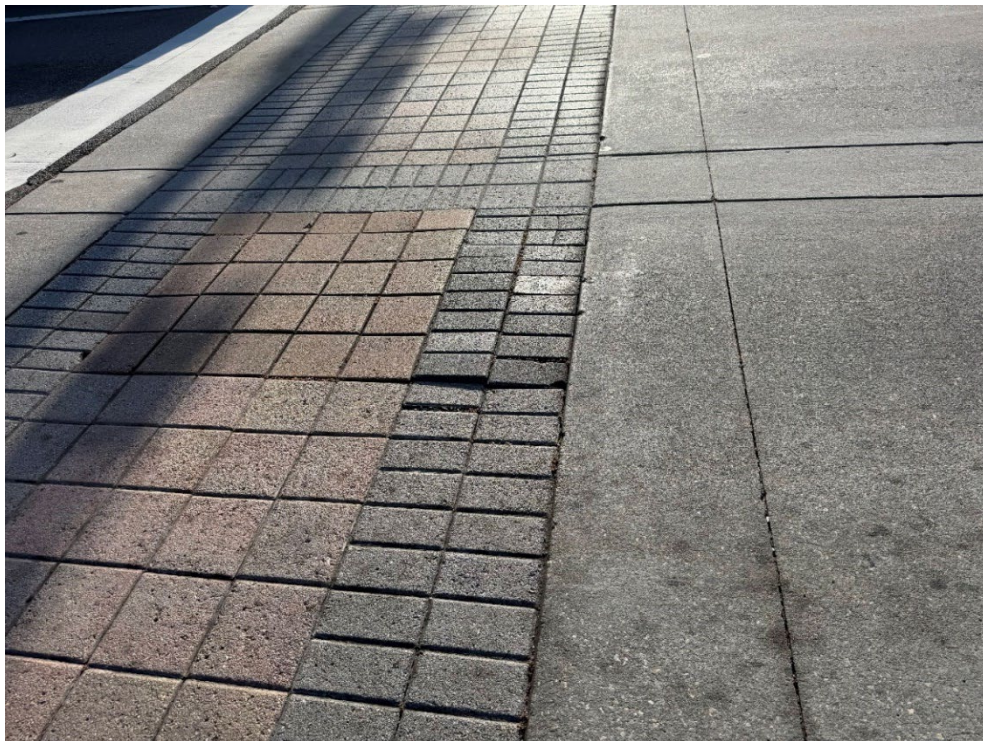
**Photo 71 – Cracked Pavers, Minor Settling (No Observed Changes)  
(Refer to Prior Photo 91- 2025 Assessment)**

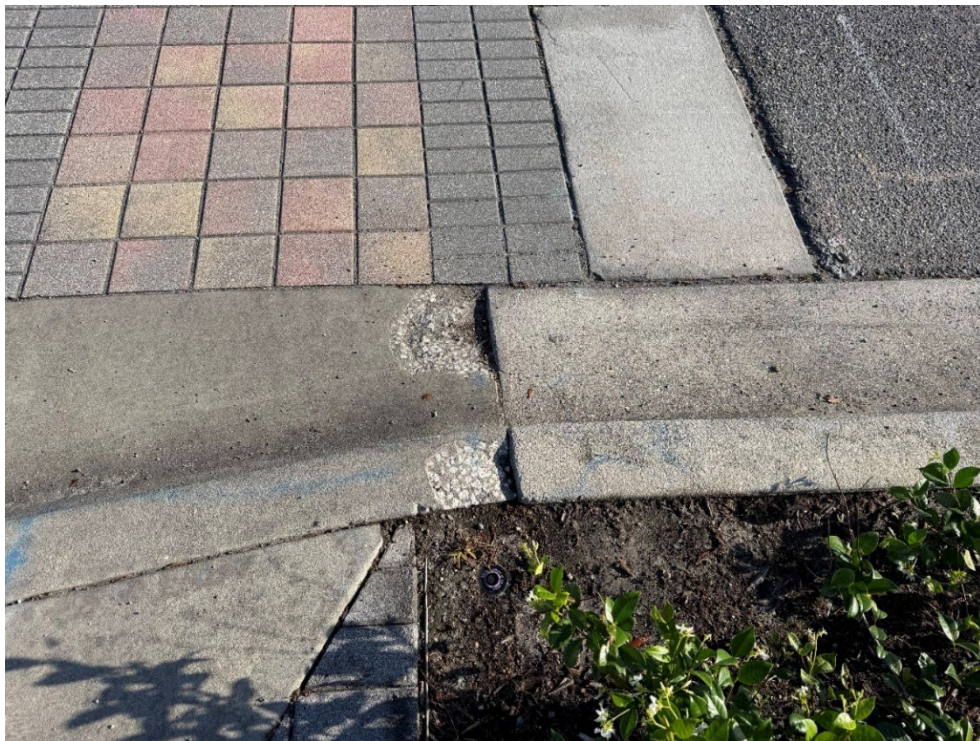
**Photo 72.1 – Cracked Concrete, Minor Settling  
(New Photo – 2026 Assessment)**
