# **DISTRICT INFRASTRUCTURE ASSESSMENT REPORT**

## **BOGGY CREEK IMPROVEMENT DISTRICT**

**APRIL 30, 2026**

**BOGGY CREEK IMPROVEMENT DISTRICT  
ORLANDO, FLORIDA**

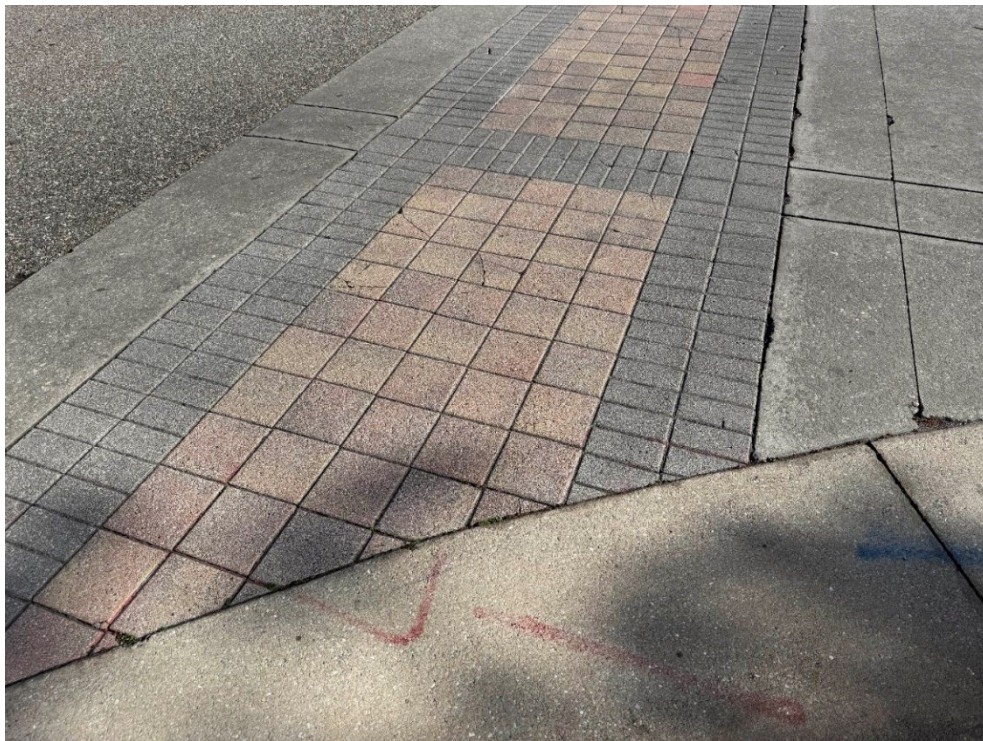
**Photo 73 – Cracked Pavers, Minor Settling (No Observed Changes)  
(Refer to Prior Photo 95 - 2025 Assessment)**

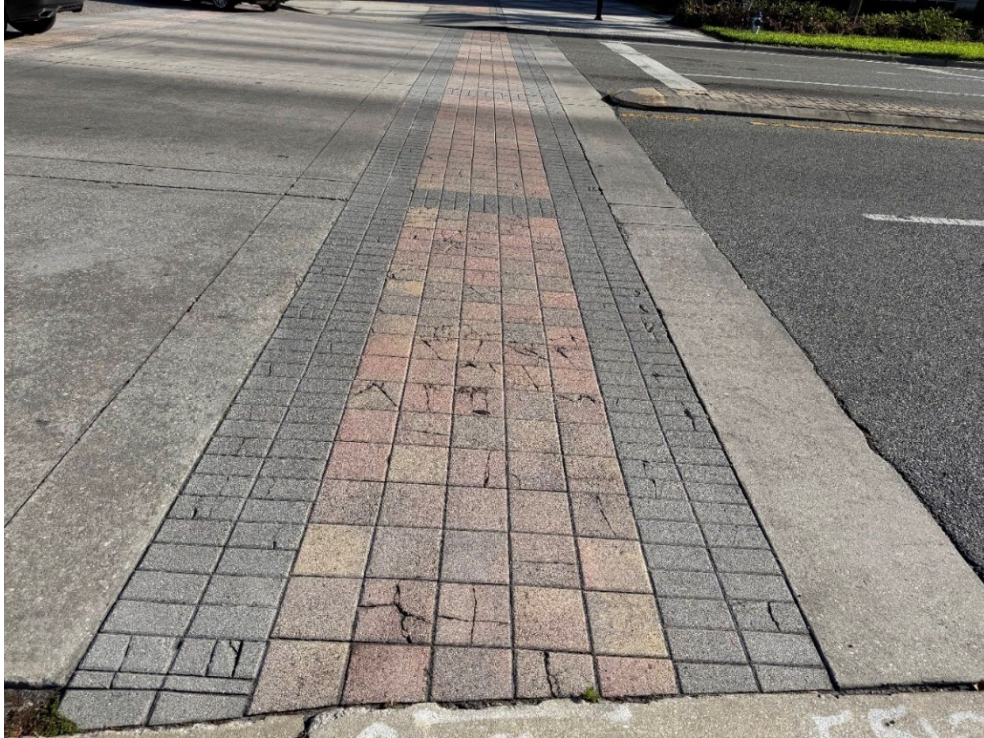
**Photo 74 – Cracked Pavers (No Observed Changes)  
(Refer to Prior Photo 96- 2025 Assessment)**

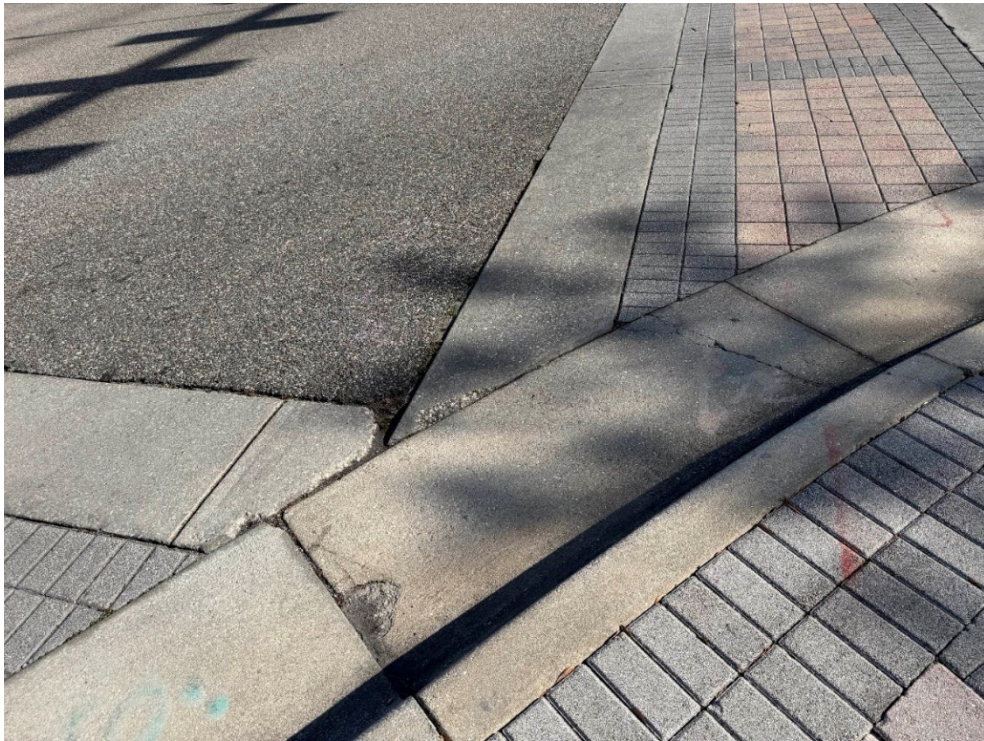
**Photo 75 – Cracked Pavers (No Observed Changes)  
(Refer to Prior Photo 97 - 2025 Assessment)**

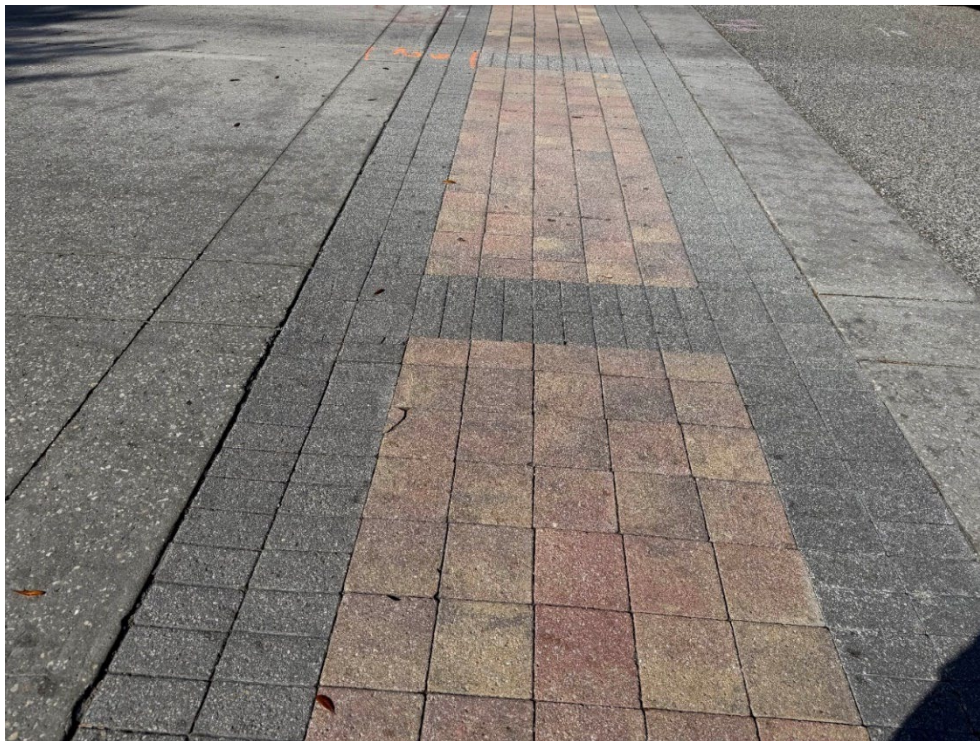
**Photo 76 – Cracked Pavers, Broken Concrete (No Observed Changes)  
(Refer to Prior Photo 98 - 2025 Assessment)**

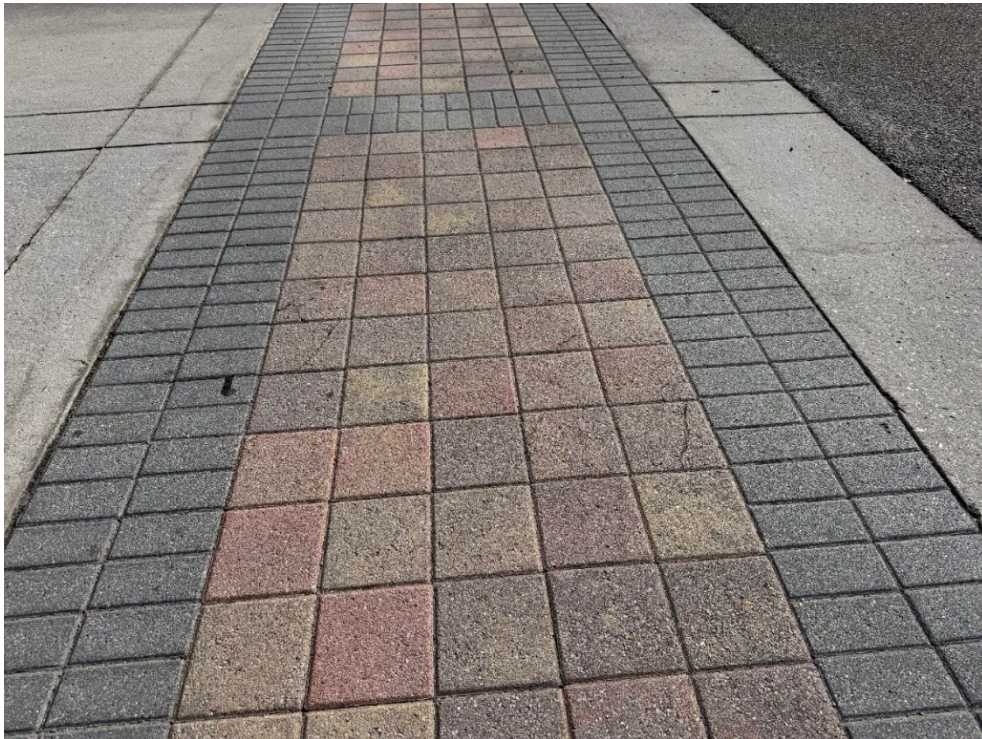
**Photo 77 – Cracked Pavers, Minor Settling (No Observed Changes)  
(Refer to Prior Photo 101 - 2025 Assessment)**

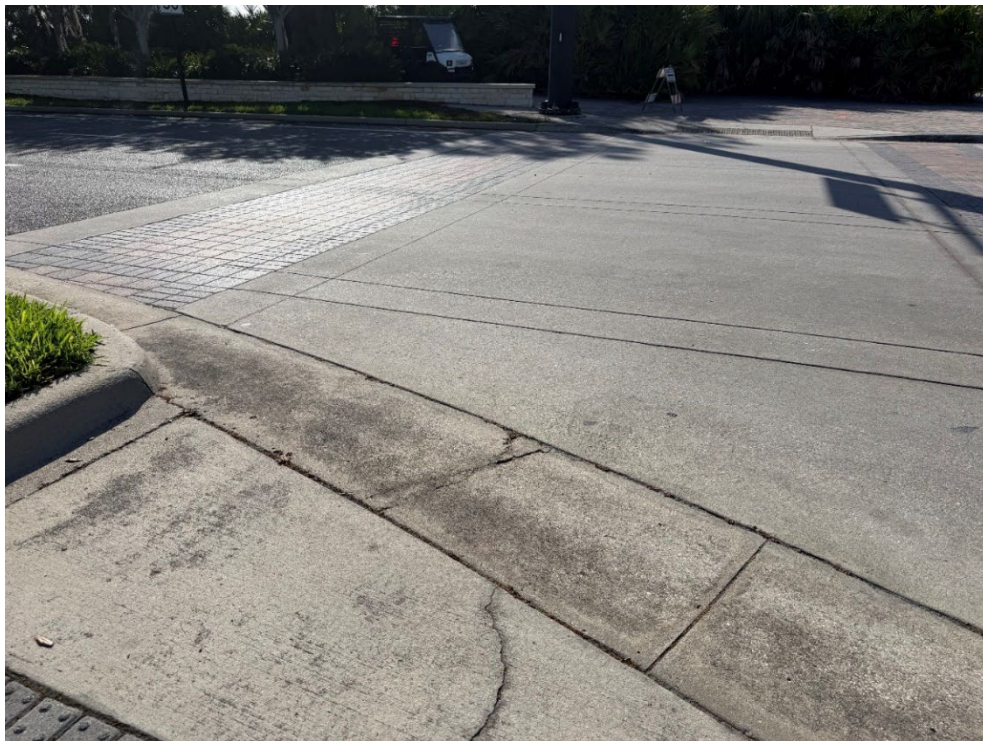
**Photo 78.1 – Surficial Concrete Cracks in East Median  
(New Photo – 2026 Assessment)**

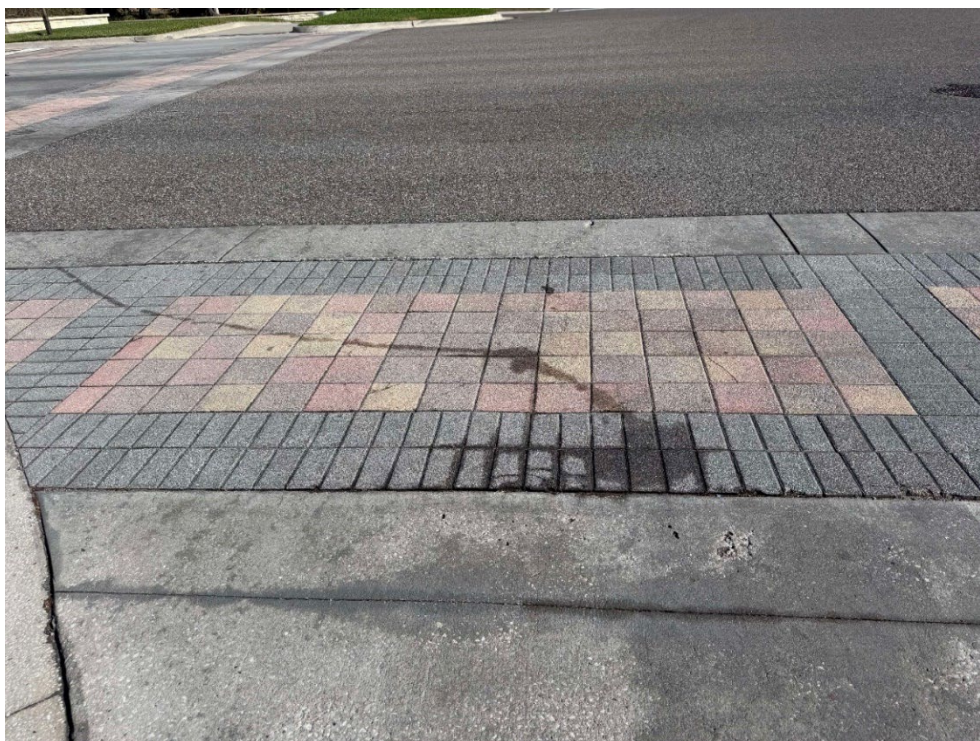
**Photo 78.3 – Cracked Concrete in Sidewalk  
(New Photo – 2026 Assessment)**

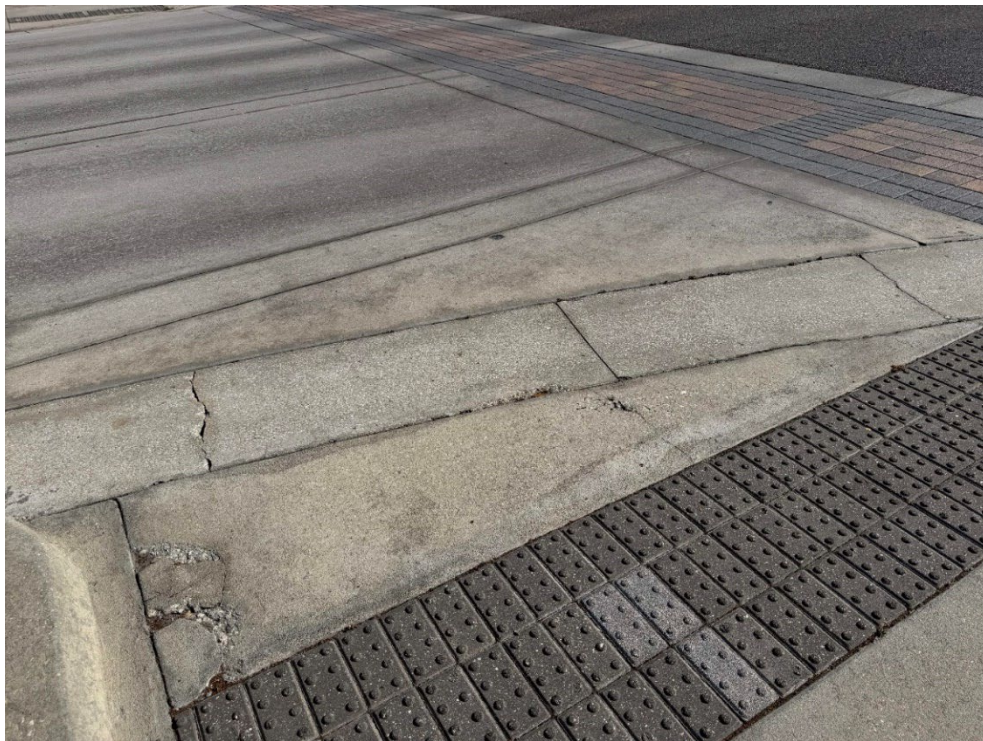
**Photo 79.1 – Broken Curb, Cracked Pavers and Surficial Concrete Cracks  
(New Photo – 2026 Assessment)**

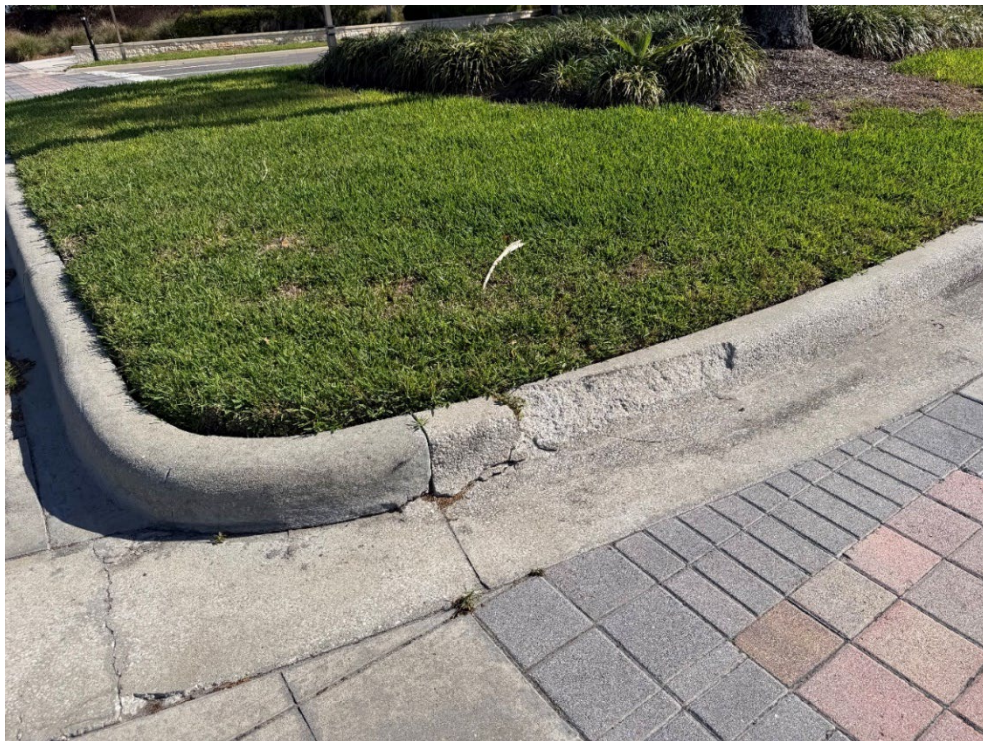
**Photo 79.3 – Broken Curb  
(New Photo – 2026 Assessment)**

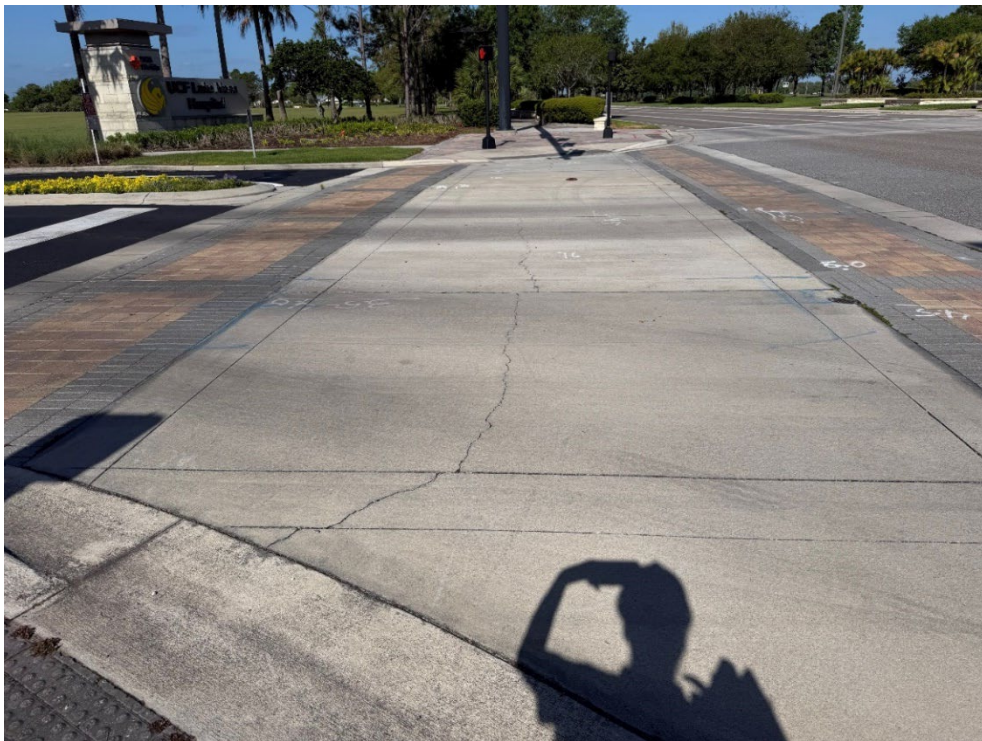
**Photo 81 – Cracked and Broken Pavers, Some Settling (No Observed Changes)  
(Refer to Prior Photo 108 - 2025 Assessment)**

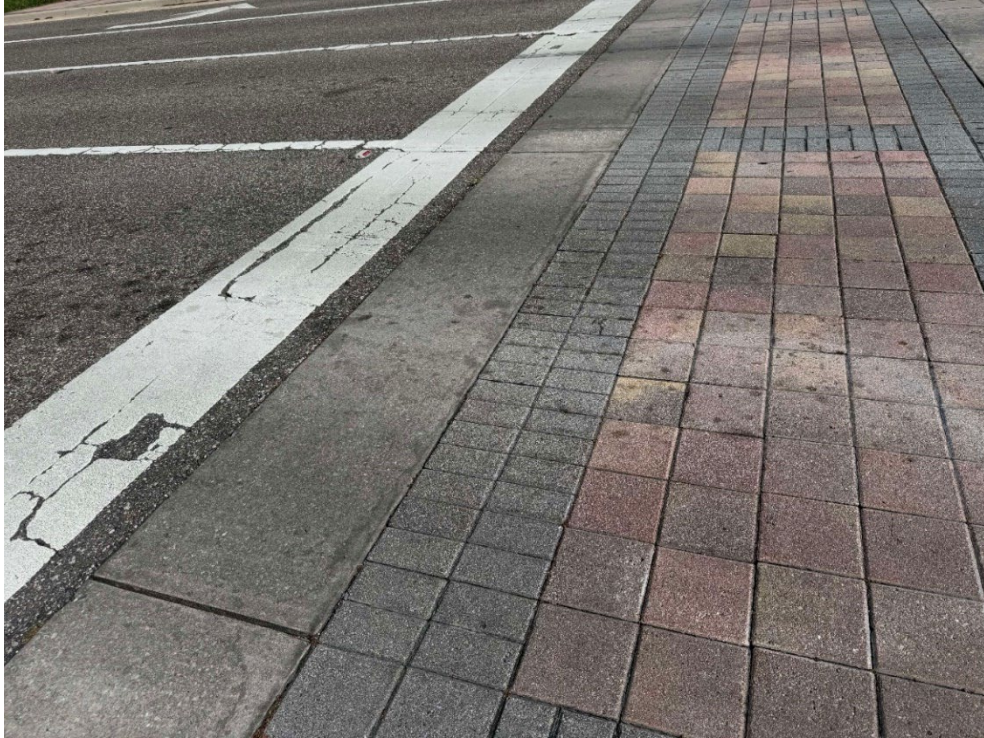
**Photo 82 – Surficial Concrete Cracks, Multiple Cracked Pavers, Some Settling  
(No Observed Changes) (Refer to Prior Photo 109 - 2025 Assessment)**

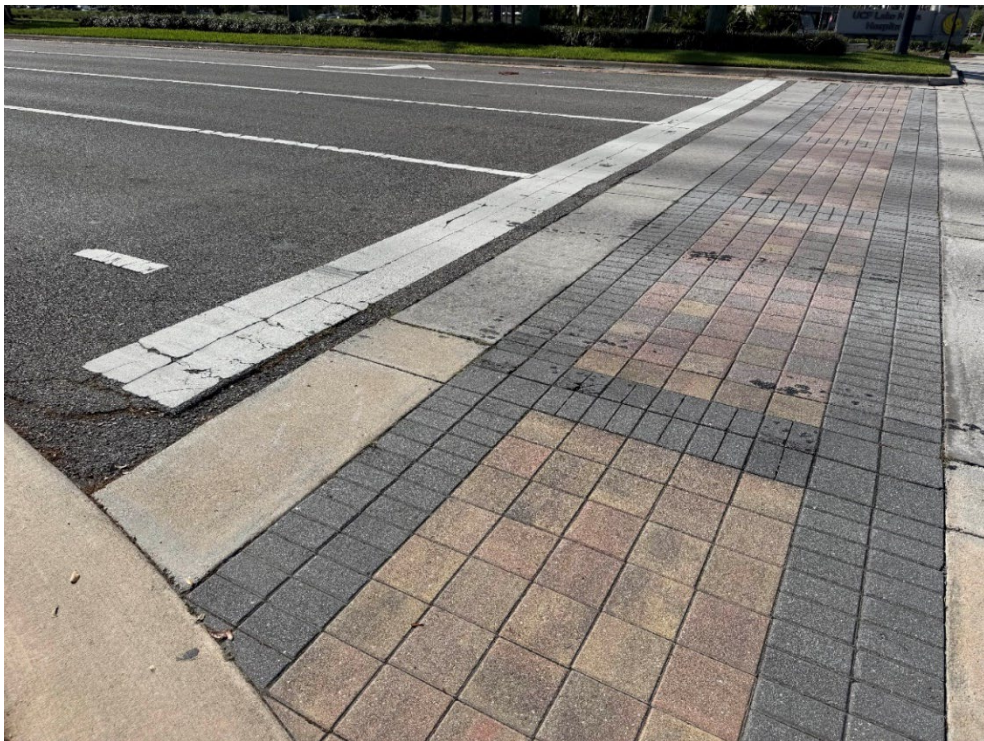
**Photo 83 – Cracked Pavers, Some Settling (No Observed Changes)  
(Refer to Prior Photo 110 - 2025 Assessment)**

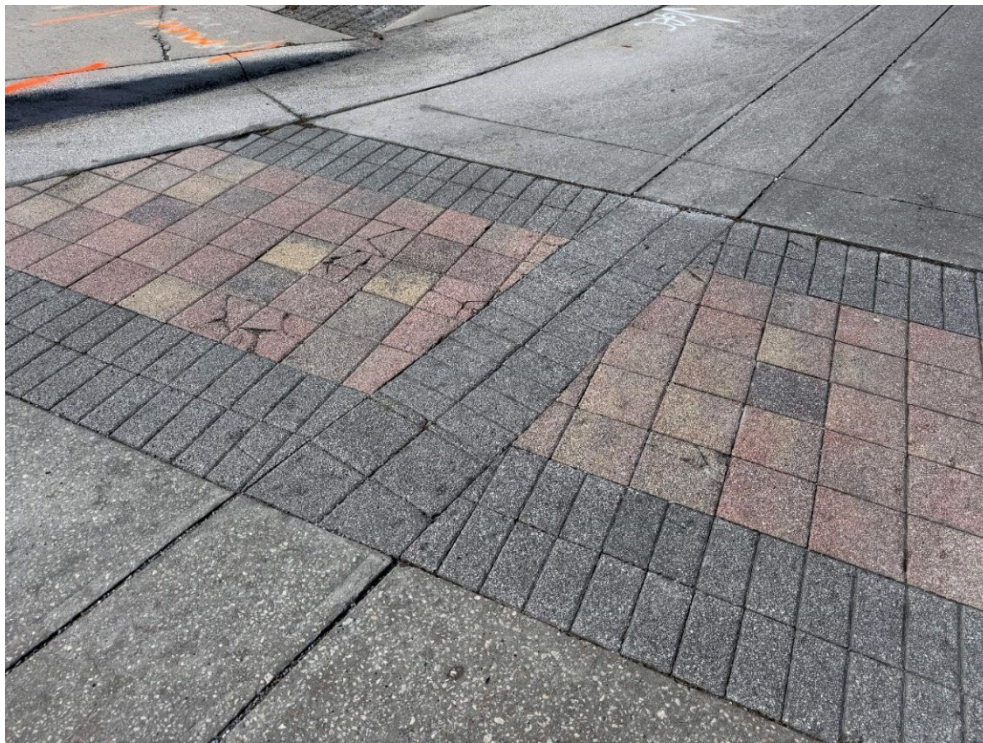
**Photo 84.1 – Surficial Cracks in Concrete  
(New Photo – 2026 Assessment)**

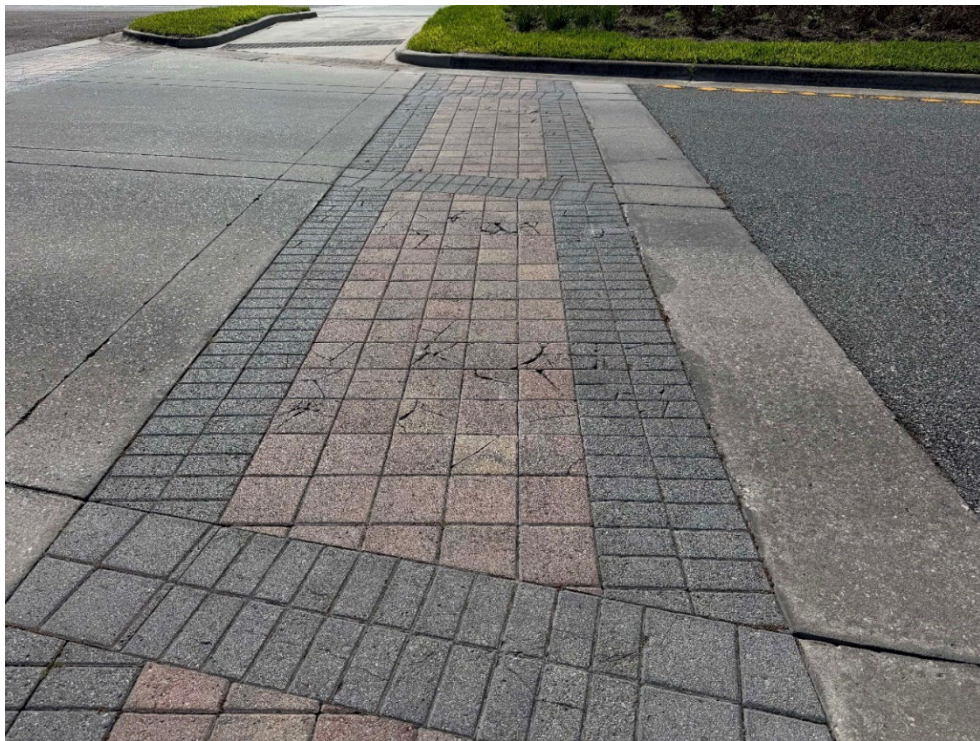
**Photo 84.3 – Multiple Cracked Concrete, Pavers Settling, Broken Flush Curb  
(New Photo – 2026 Assessment)**

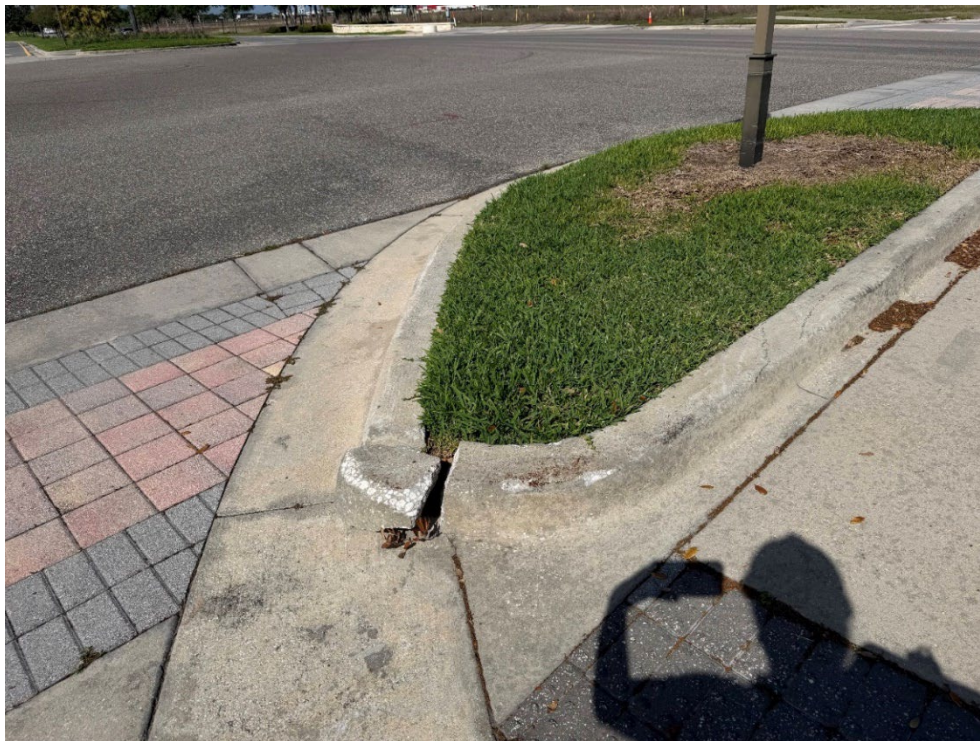
**Photo 85.1 – Multiple Cracked Concrete, Pavers Settling, Broken Flush Curb  
(New Photo – 2026 Assessment)**

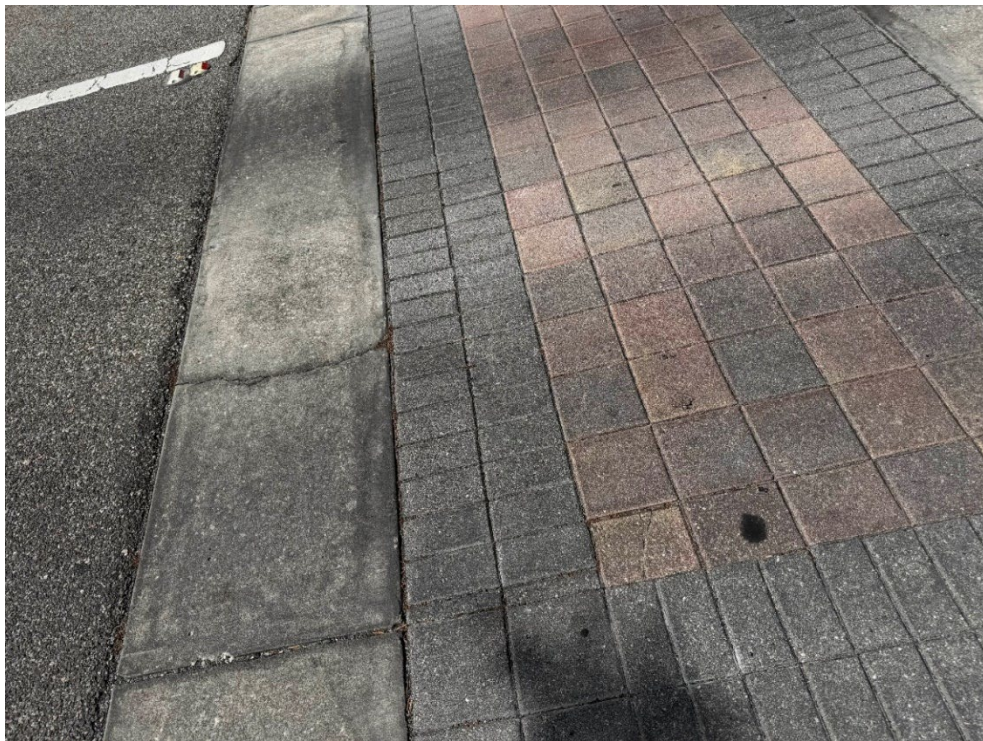
**Photo 87 – Entrance to Construction Storage Area (No Observed Changes)  
(Refer to Prior Photo 117 - 2025 Assessment)**

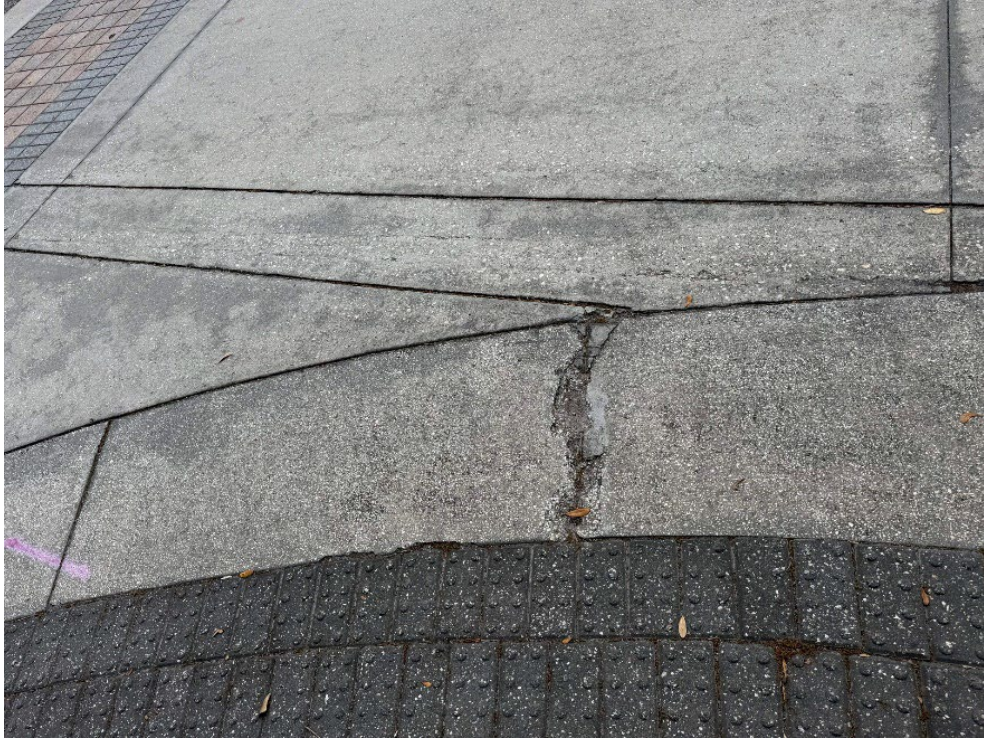
**Photo 88 – Construction Entrance – Broken Concrete in Flush Curb  
(No Observed Changes) (Refer to Prior Photo 119 - 2025 Assessment)**

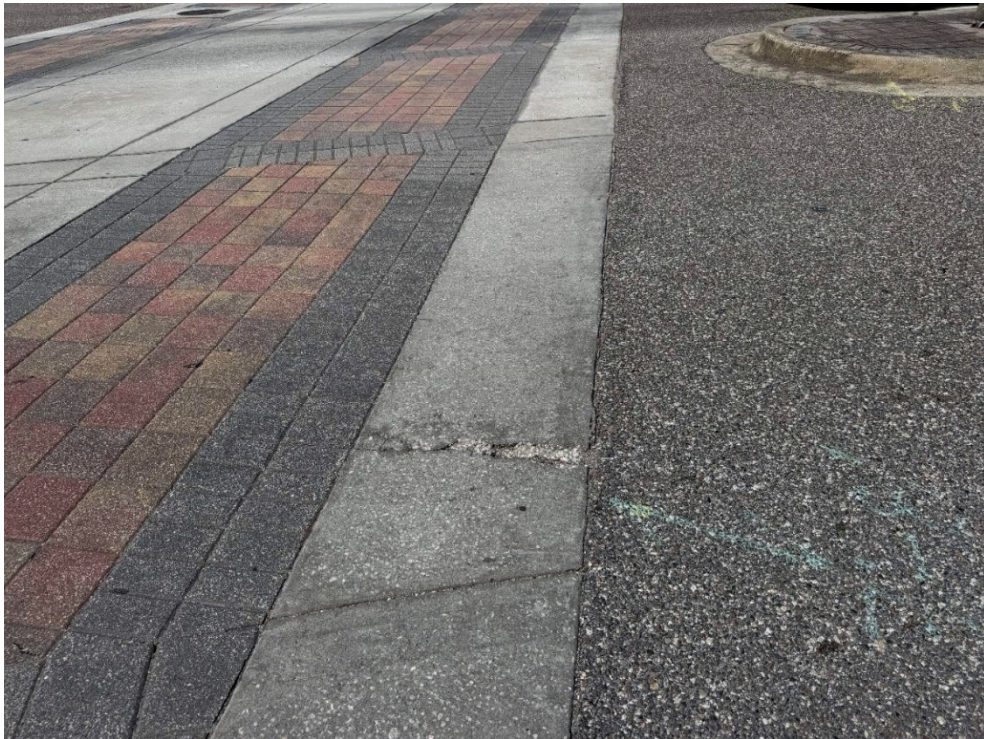
**Photo 89 – Construction Entrance – Broken Concrete in Flush Curb  
(No Observed Changes) (Refer to Prior Photo 120 - 2025 Assessment)**

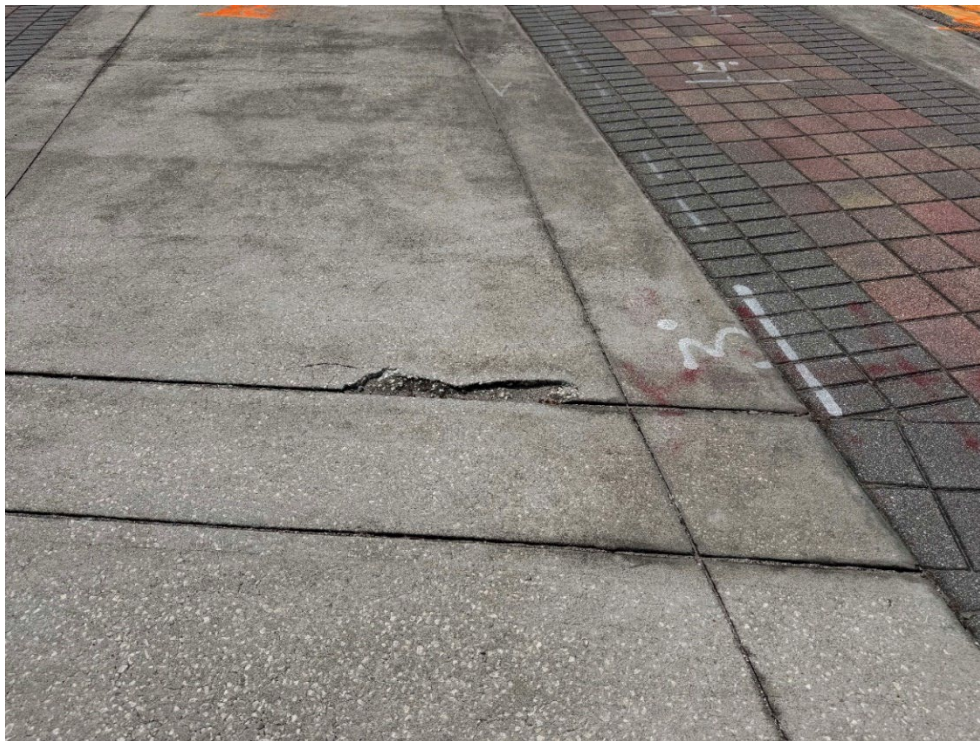
**Photo 90.1 – Cracked Pavers  
(New Photo – 2026 Assessment)**
