# **DISTRICT INFRASTRUCTURE ASSESSMENT REPORT**

## **BOGGY CREEK IMPROVEMENT DISTRICT**

**APRIL 30, 2026**

**BOGGY CREEK IMPROVEMENT DISTRICT  
ORLANDO, FLORIDA**

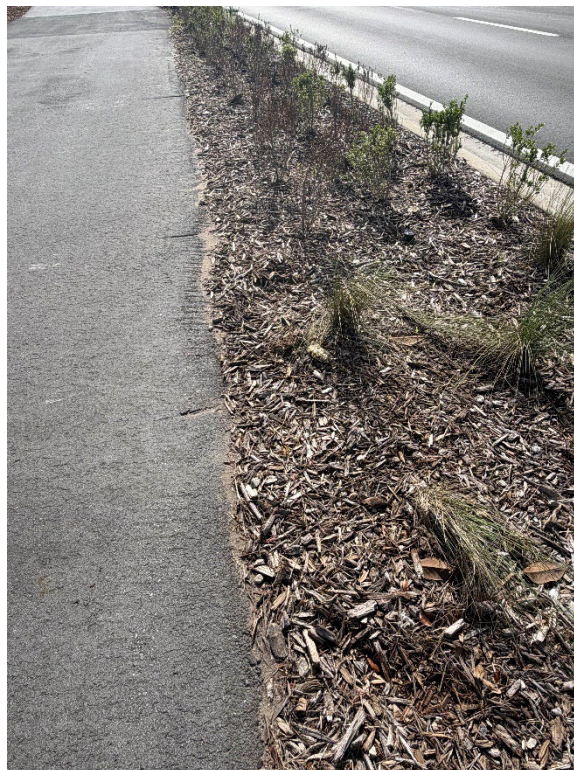
**Photo 5.1 – Damaged Asphalt  
(New Photo – 2026 Assessment)**

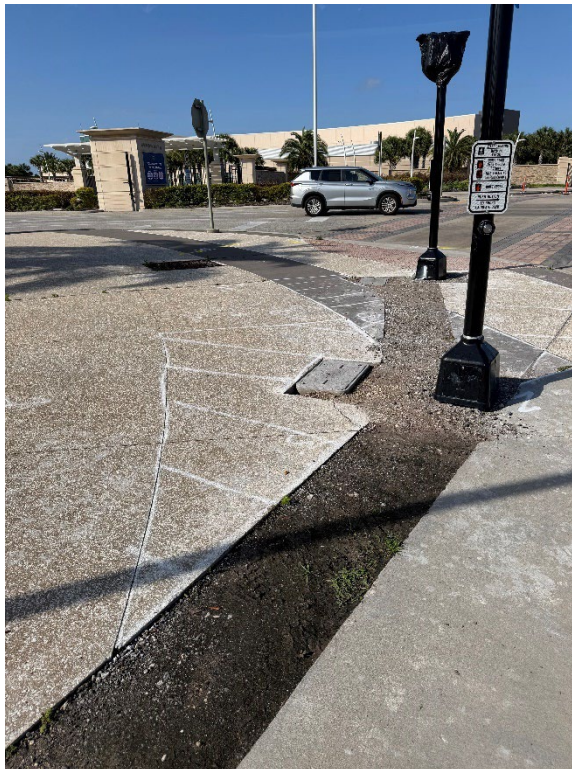
**Photo 52.2 – Concrete Work Unfinished  
(New Photo – 2026 Assessment)**

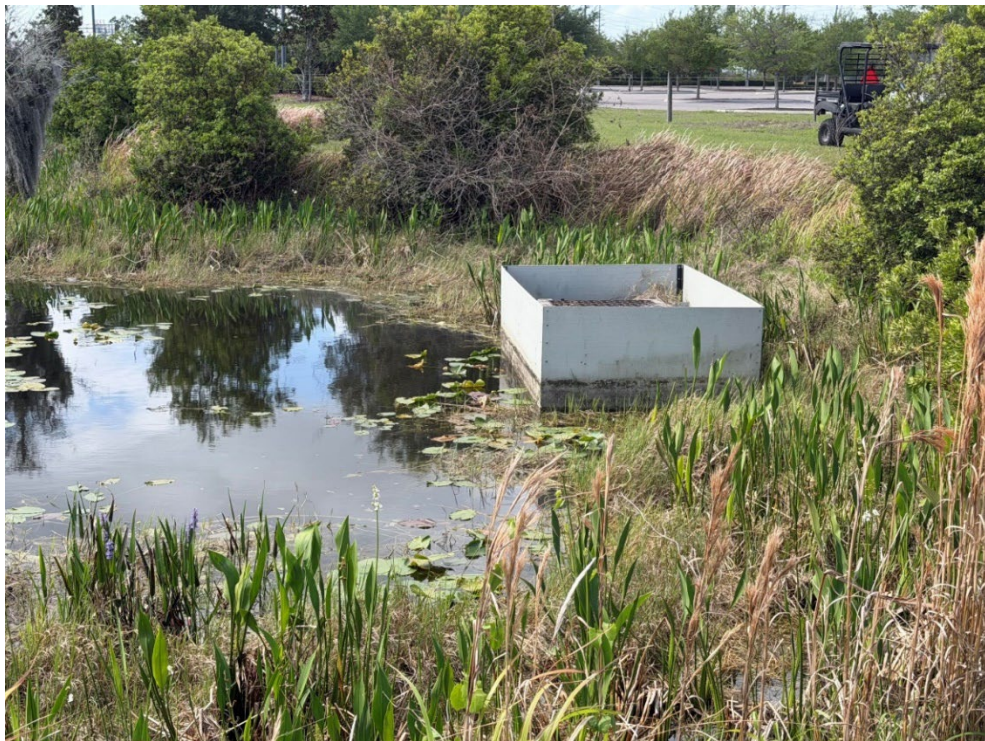
**Photo 61.3 – Outfall Structure Containing Vegetation  
(New Photo – 2026 Assessment)**

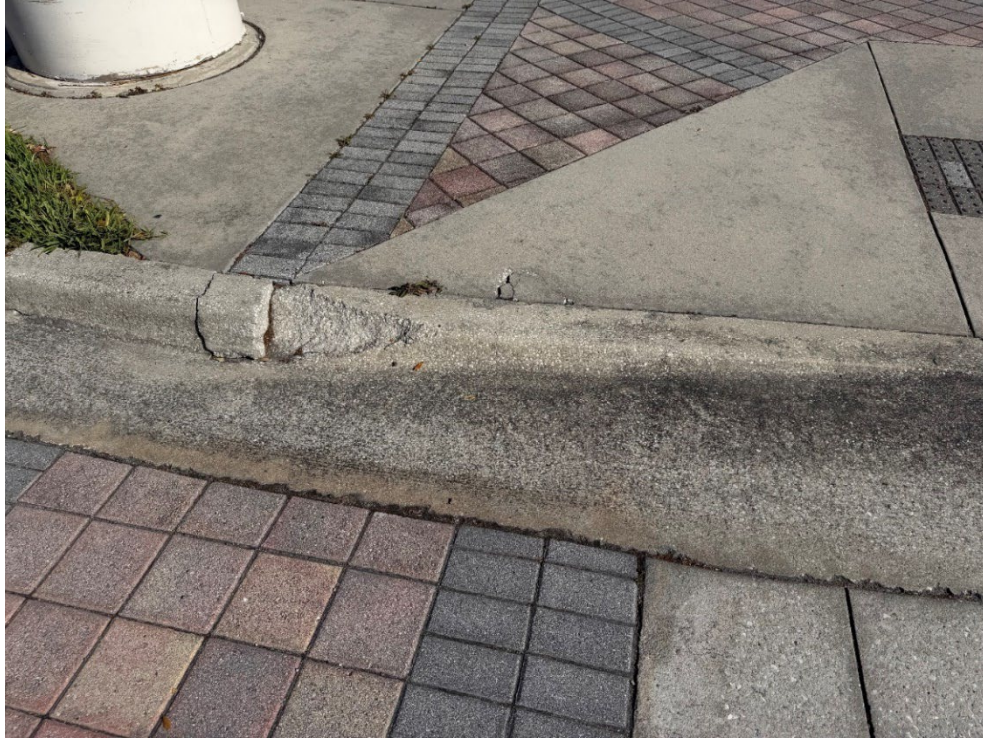
**Photo 79.2 – Broken and Spalling Concrete  
(New Photo – 2026 Assessment)**

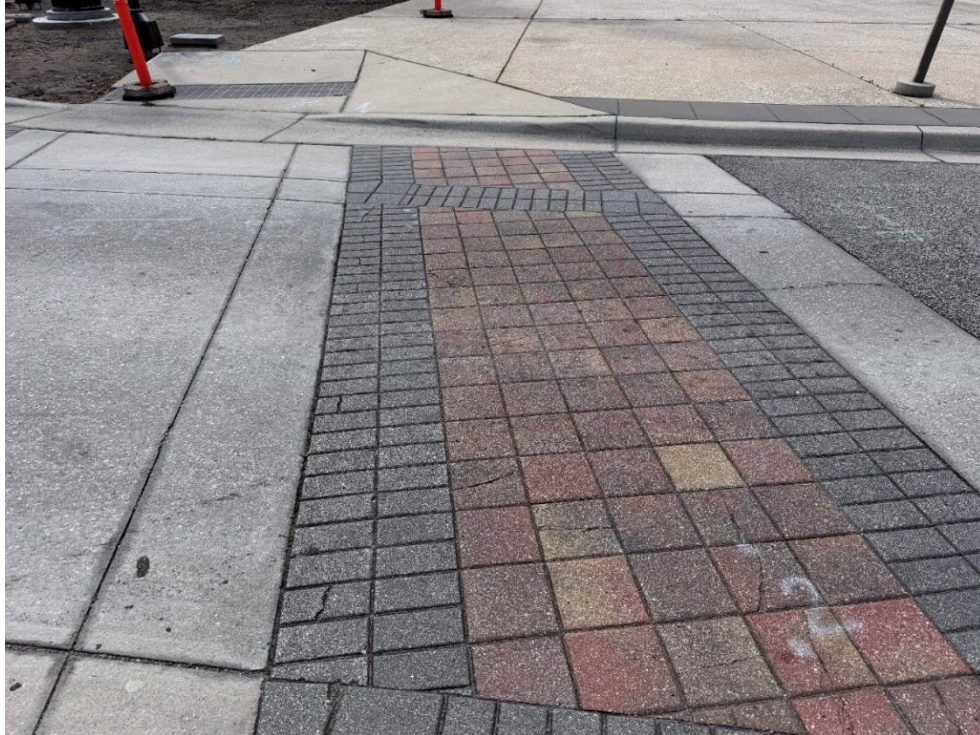
**Photo 90 – Broken Concrete (No Observed Changes)  
(Refer to Prior Photo 122 - 2025 Assessment)**
