# **DISTRICT INFRASTRUCTURE ASSESSMENT REPORT**

## **BOGGY CREEK IMPROVEMENT DISTRICT**

**APRIL 30, 2026**

**BOGGY CREEK IMPROVEMENT DISTRICT  
ORLANDO, FLORIDA**

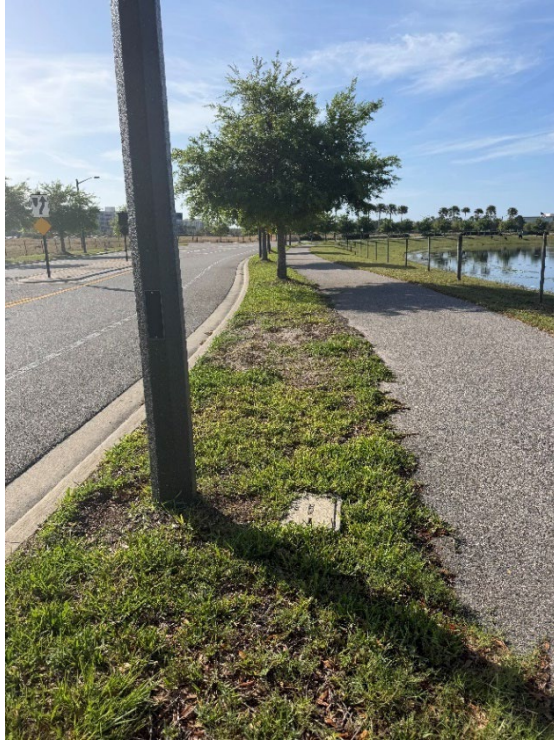
**Photo 1 – Sod Damage (Sod Damage Has Been Corrected)  
(Refer to Prior Photo 2 - 2025 Assessment)**

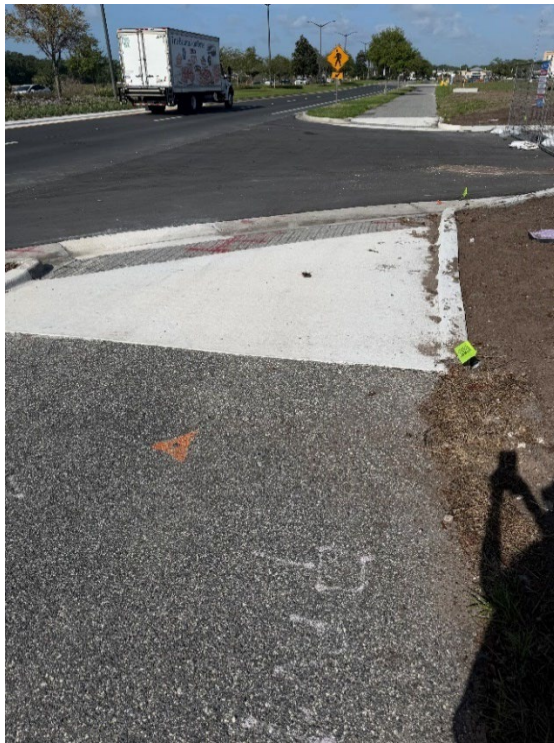
**Photo 2 – Surficial Concrete Cracks in Curb Ramp -Construction Ongoing  
(Concrete Cracked in Curb Ramp Has Been Corrected)  
(Refer to Prior Photo 3- 2025 Assessment)**

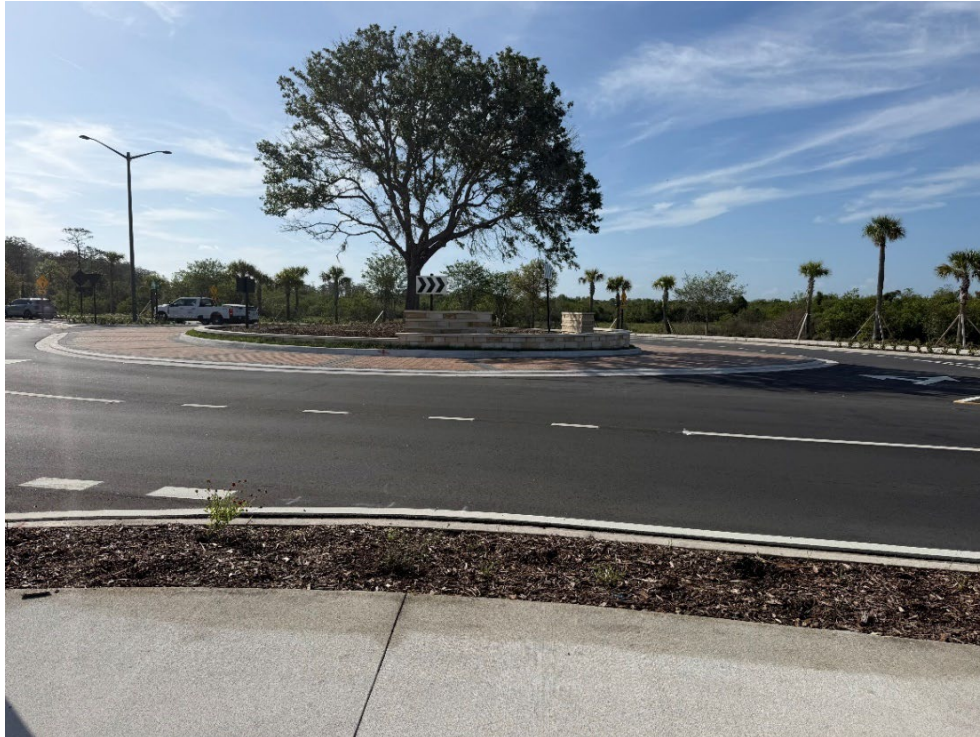
**Photo 3 – Roundabout Under Construction (Roundabout Constructed)  
(Refer to Prior Photo 4- 2025 Assessment)**

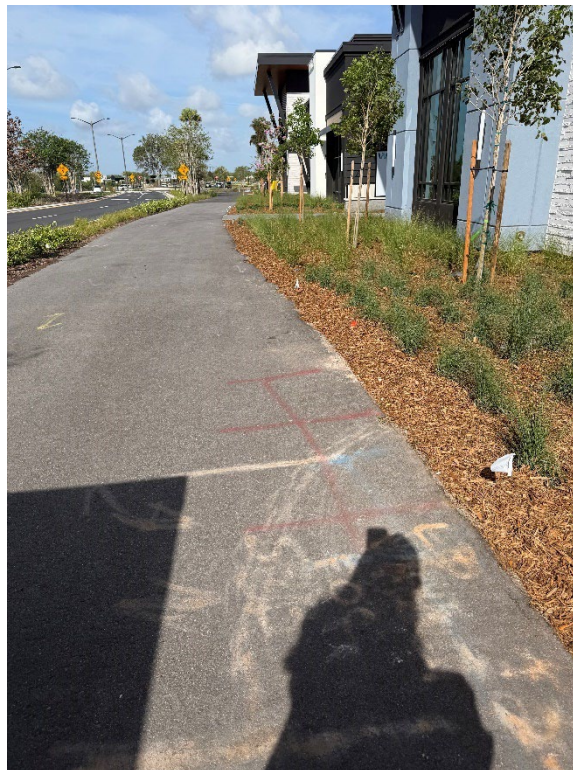
**Photo 4 – Asphalt Damage - Construction Ongoing  
(Asphalt Damage Has Been Corrected)  
(Refer to Prior Photo 5- 2025 Assessment)**

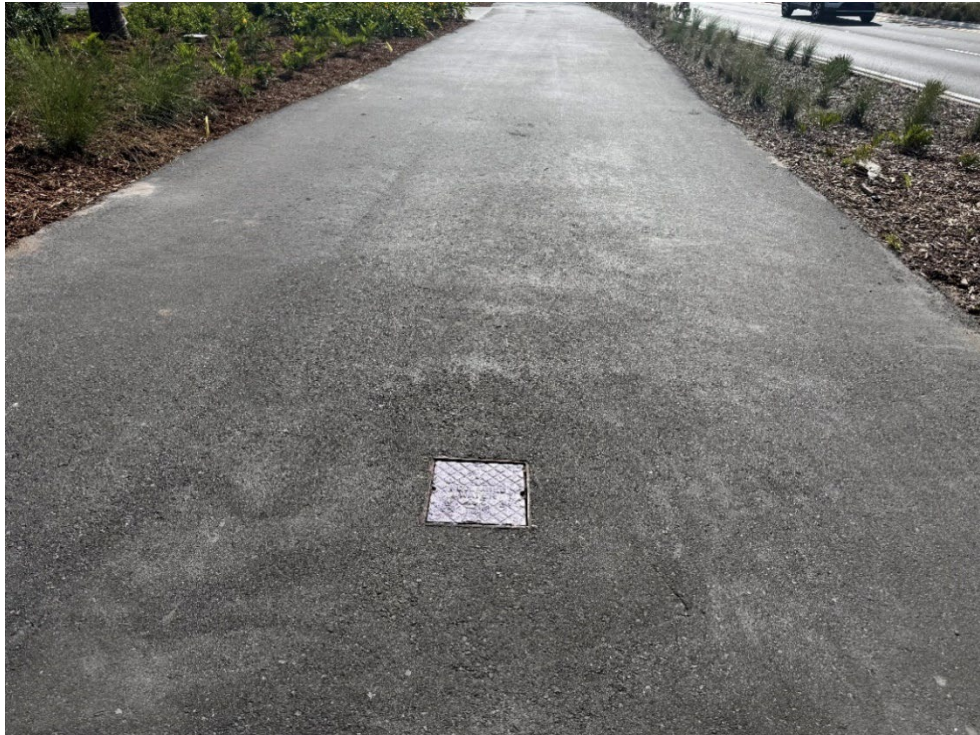
**Photo 5 – Sunken Reclaim Water Meter (No Observed Changes)  
(Refer to Prior Photo 6- 2025 Assessment)**

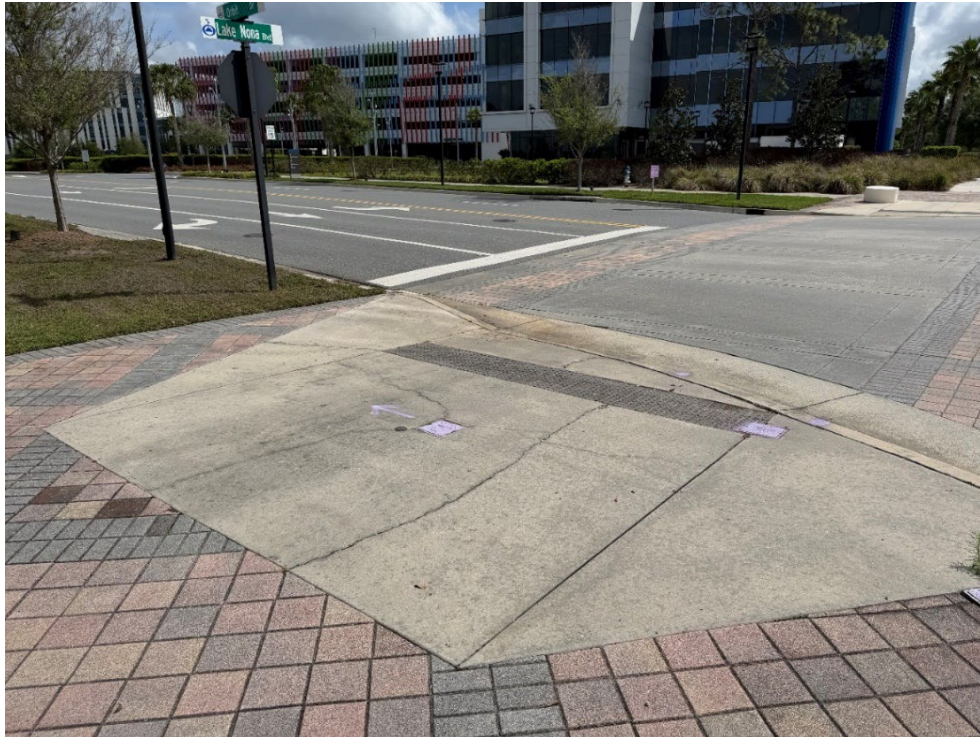
**Photo 16 – Surficial Concrete Cracks in Handicap Ramp (No Observed Changes)  
(Refer to Prior Photo 20- 2025 Assessment)**

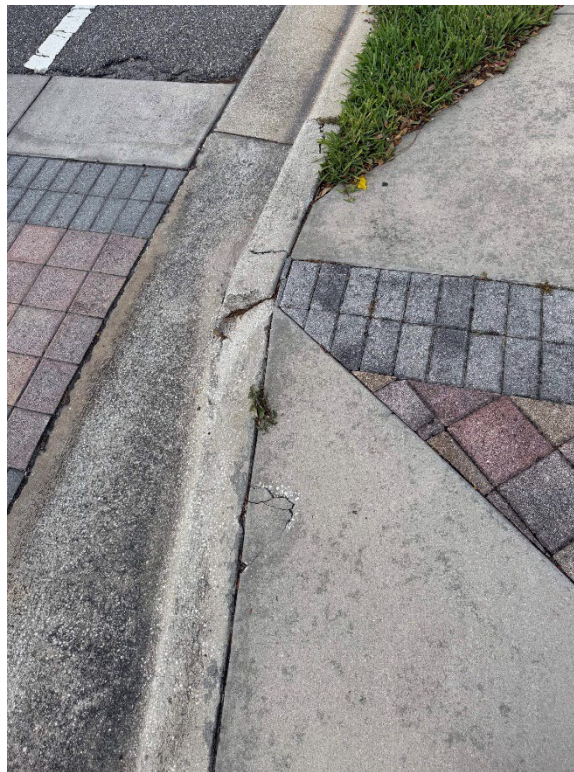
**Photo 19 – Cracked and Spalling Concrete in Handicap Ramp (No Observed Changes)  
(Refer to Prior Photo 23- 2025 Assessment)**

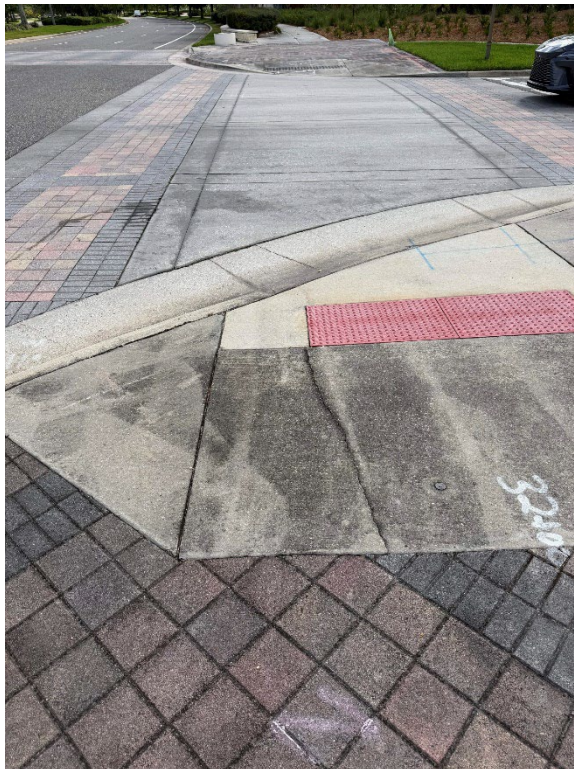
**Photo 21 – Surficial Concrete Cracks in Handicap Ramp (No Observed Changes)  
(Refer to Prior Photo 26- 2025 Assessment)**

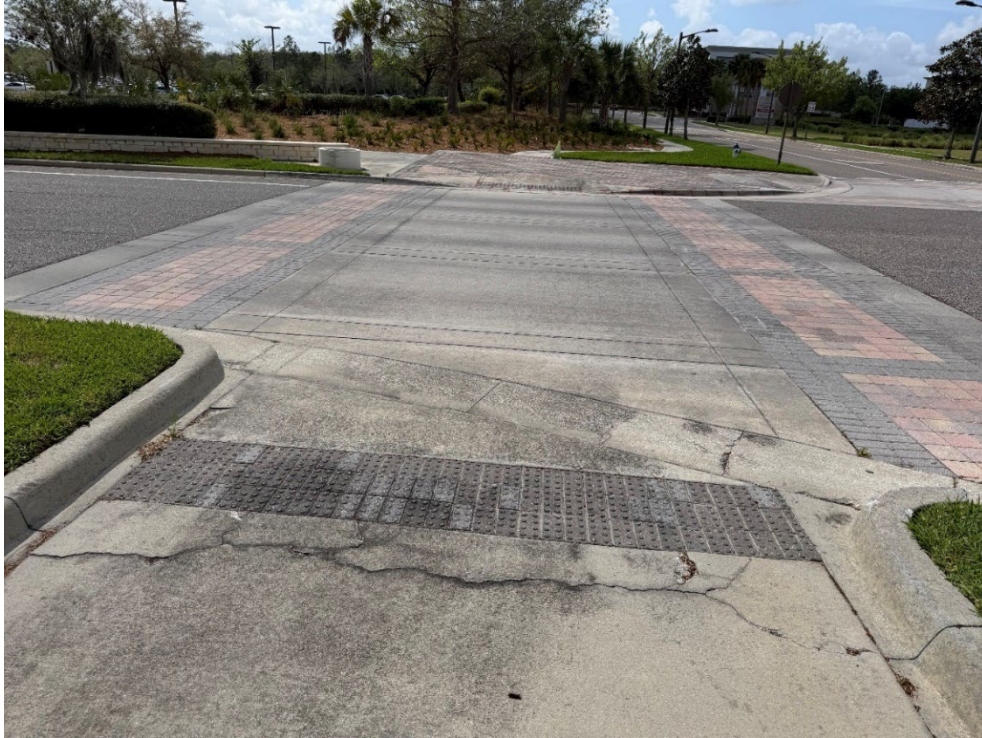
**Photo 22 – Surficial Concrete Cracks in Handicap Ramp (No Observed Changes)  
(Refer to Prior Photo 29- 2025 Assessment)**

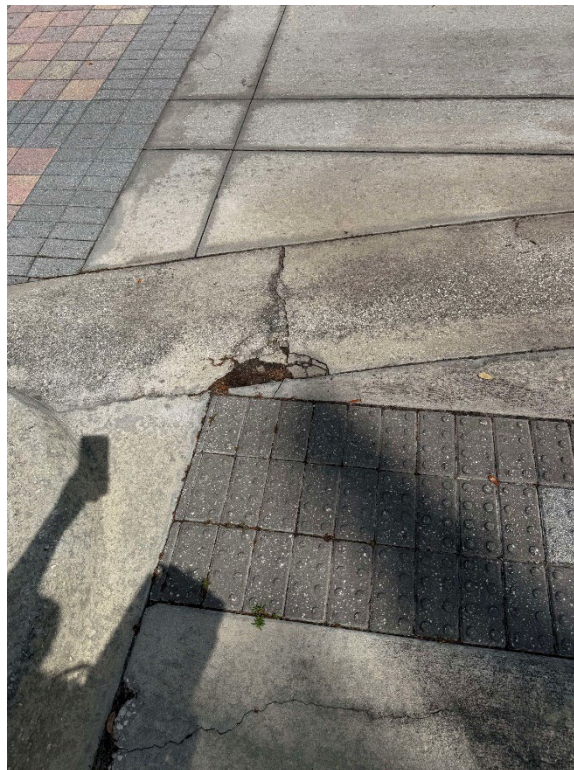
**Photo 23 – Cracked Concrete in East Median (No Observed Changes)  
(Refer to Prior Photo 30- 2025 Assessment)**

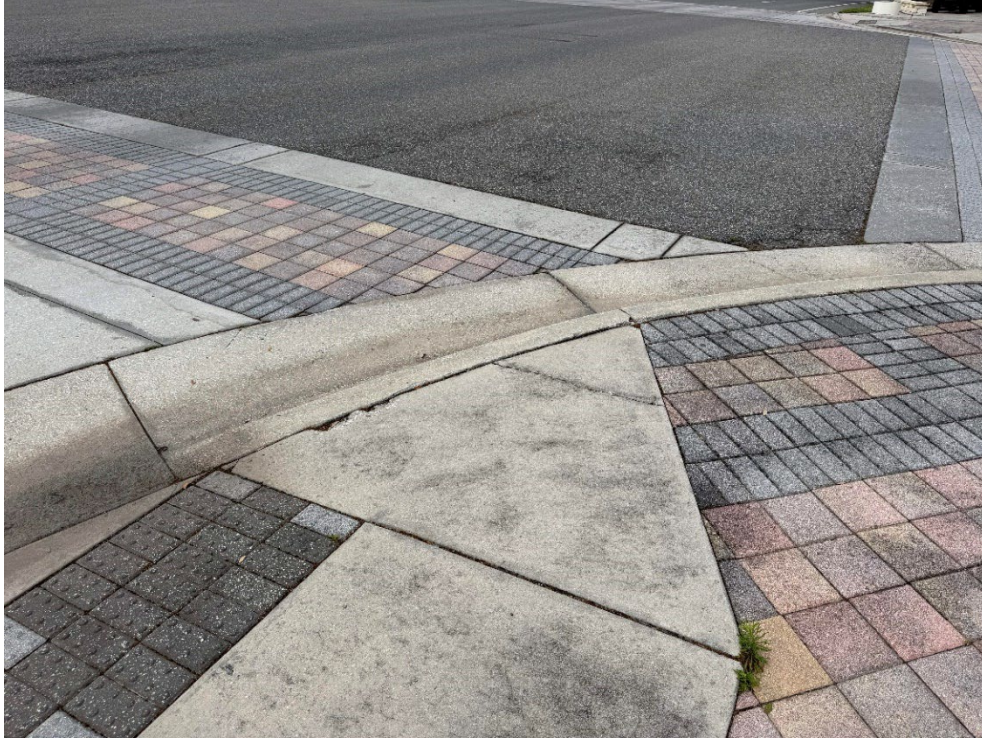
**Photo 24 – Surficial Concrete Cracks in Handicap Ramp (No Observed Changes)  
(Refer to Prior Photo 31- 2025 Assessment)**

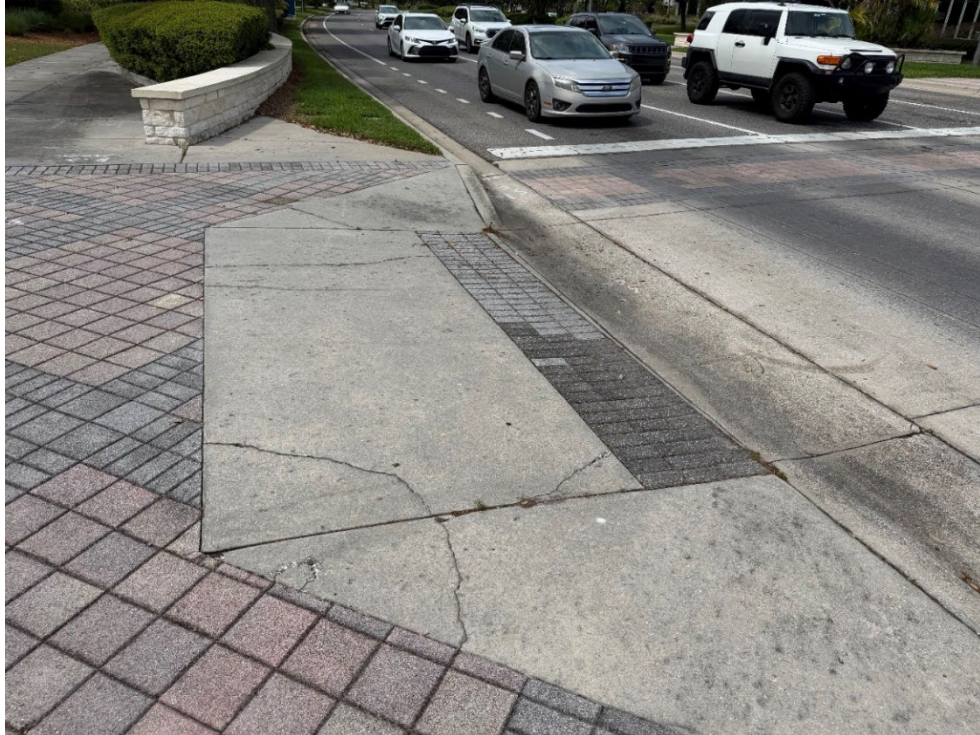
**Photo 26 – Surficial Concrete Cracks in Handicap Ramp (No Observed Changes)  
(Refer to Prior Photo 33- 2025 Assessment)**

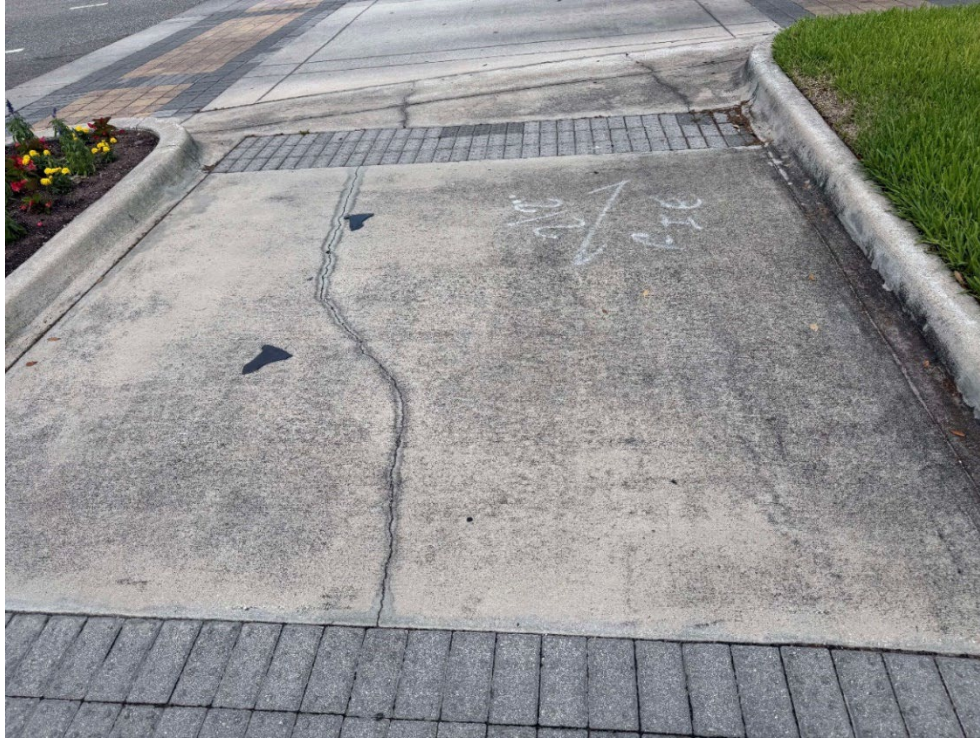
**Photo 32 – Surficial Concrete Cracks in Median Strip (No Observed Changes)  
(Refer to Prior Photo 39- 2025 Assessment)**

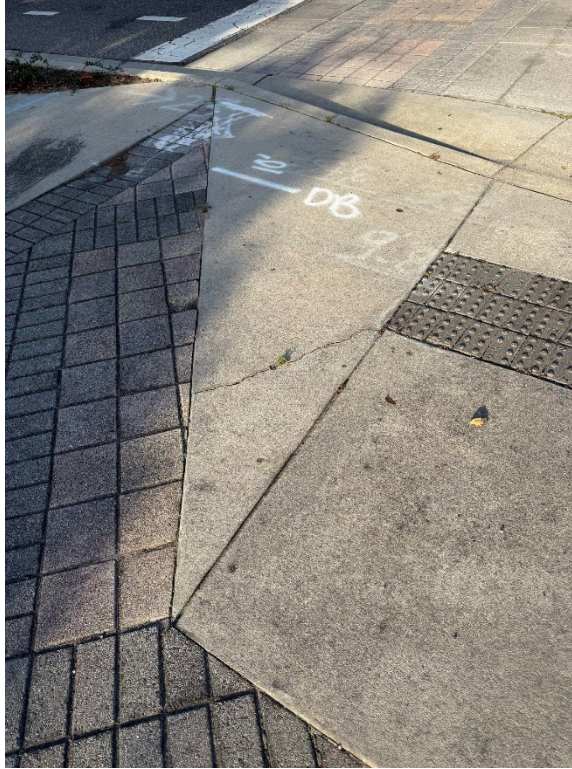
**Photo 41 – Surficial Concrete Cracks in Handicap Ramp (No Observed Changes)  
(Refer to Prior Photo 49- 2025 Assessment)**

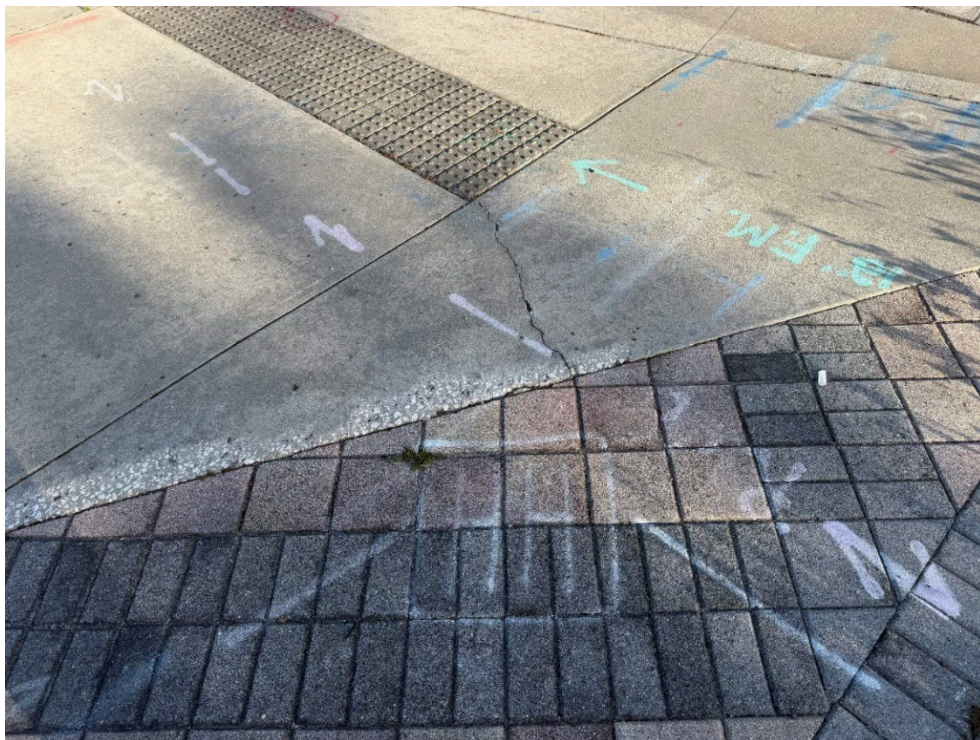
**Photo 42 – Surficial Concrete Cracks in Handicap Ramp (No Observed Changes)  
(Refer to Prior Photo 51- 2025 Assessment)**

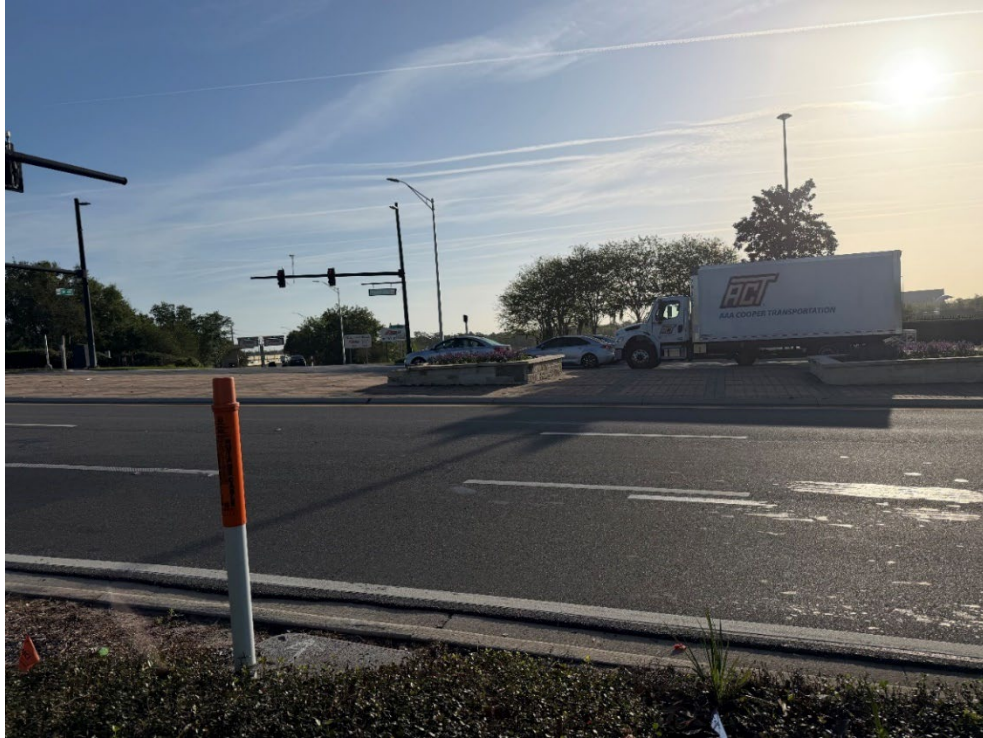
**Photo 43 – East Entrance on to SR 417 (No Observed Changes)  
(Refer to Prior Photo 53- 2025 Assessment)**

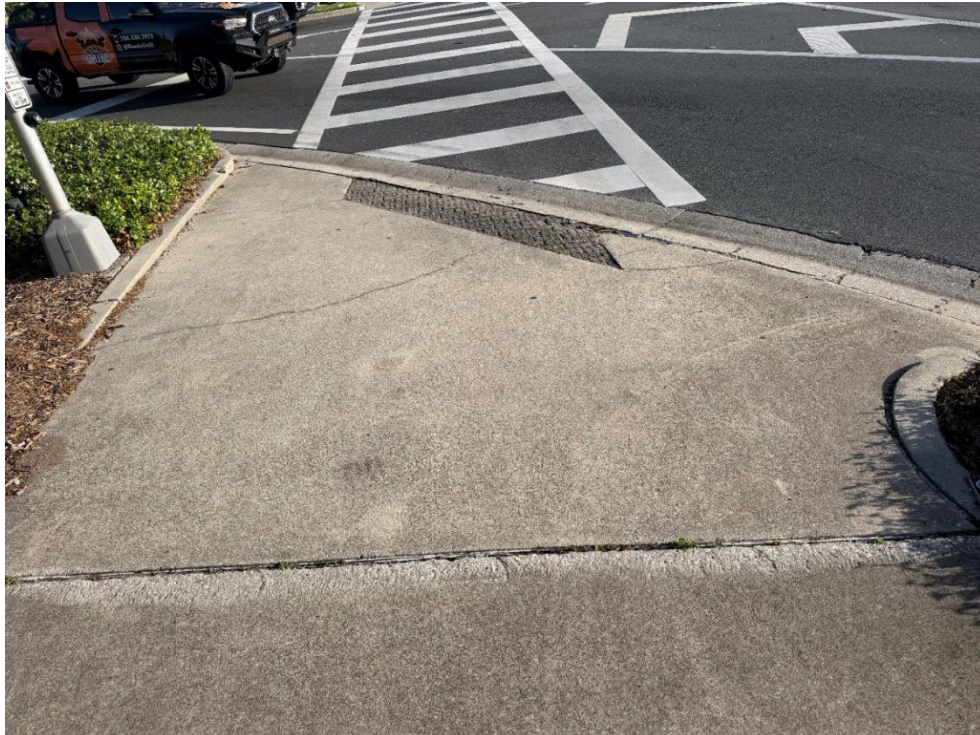
**Photo 45 – Surficial Concrete Cracks in Handicap Ramp in Median  
(No Observed Changes) (Refer to Prior Photo 55- 2025 Assessment)**

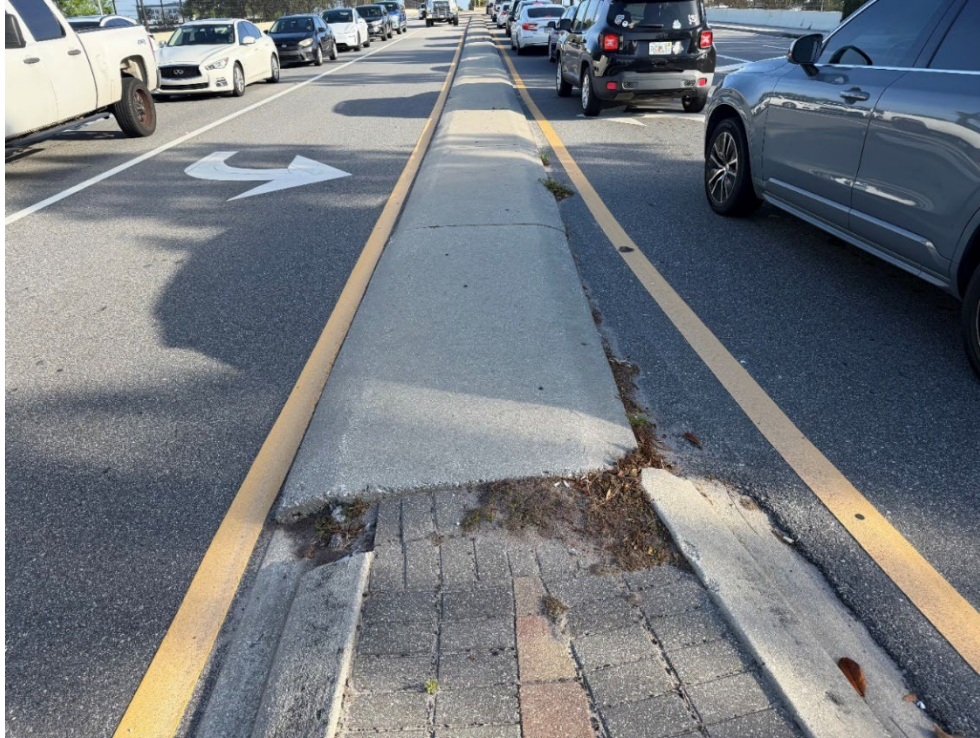
**Photo 47 – Paver Base Failure in North Median Looking North (No Observed Changes)  
(Refer to Prior Photo 57- 2025 Assessment)**

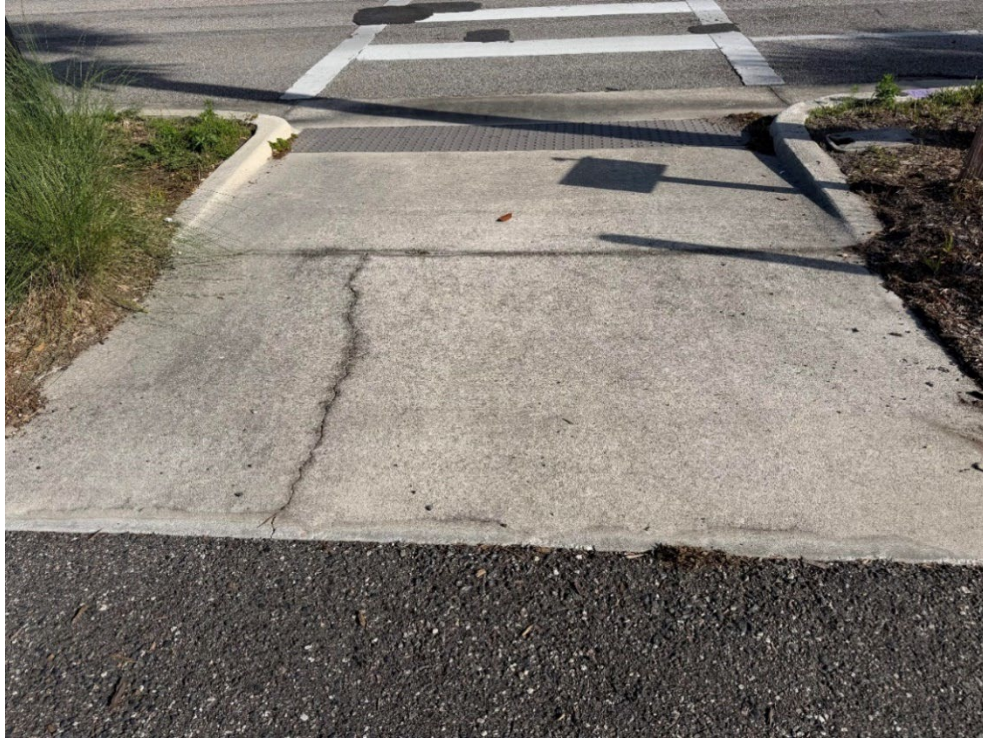
**Photo 51 – Surficial Concrete Cracks in Handicap Ramp (No Observed Changes)  
(Refer to Prior Photo 63 - 2025 Assessment)**

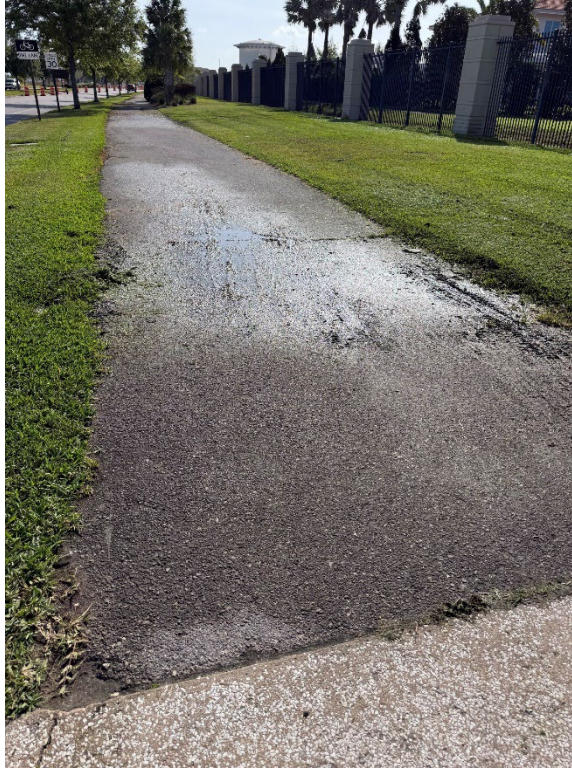
**Photo 52.1 – Poor Drainage on Sidewalk  
(New Photo – 2026 Assessment)**

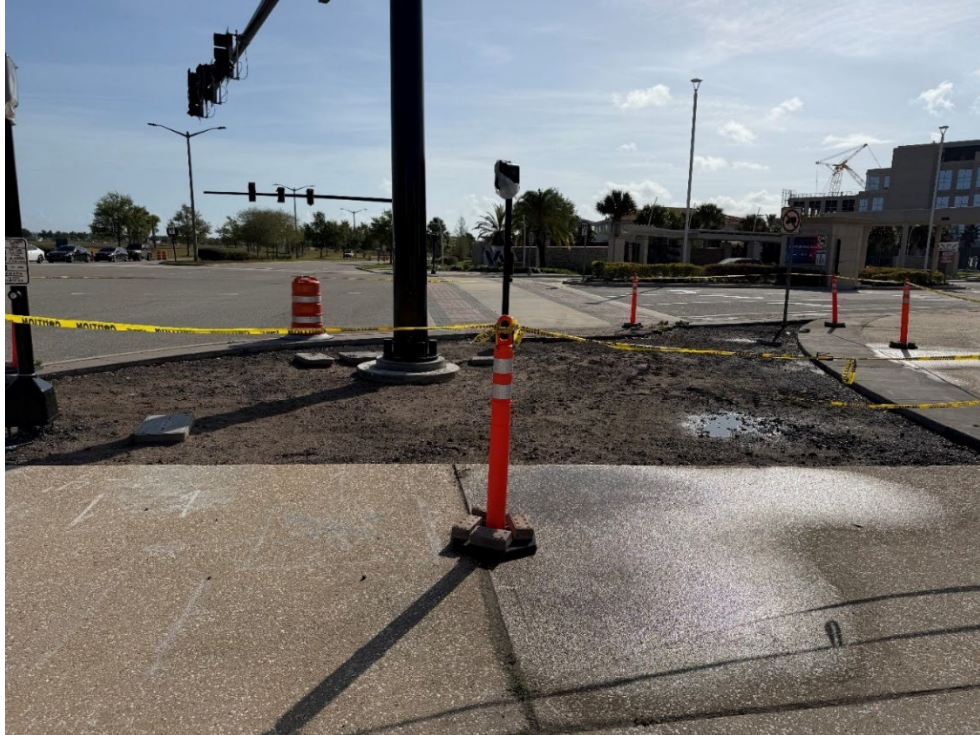
**Photo 53 – Construction in All Quads at VA Hospital Intersection  
(Construction Continues) (Refer to Prior Photo 68- 2025 Assessment)**

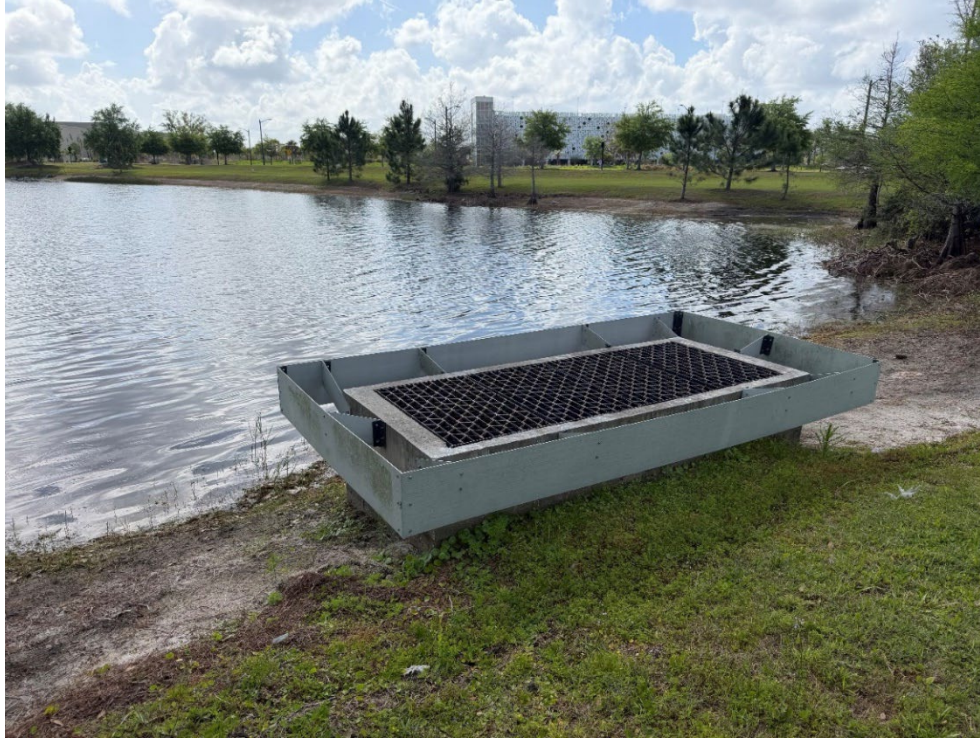
**Photo 56 – Pond Outfall Structure in Good Condition (No Observed Changes)  
(Refer to Prior Photo 74- 2025 Assessment)**

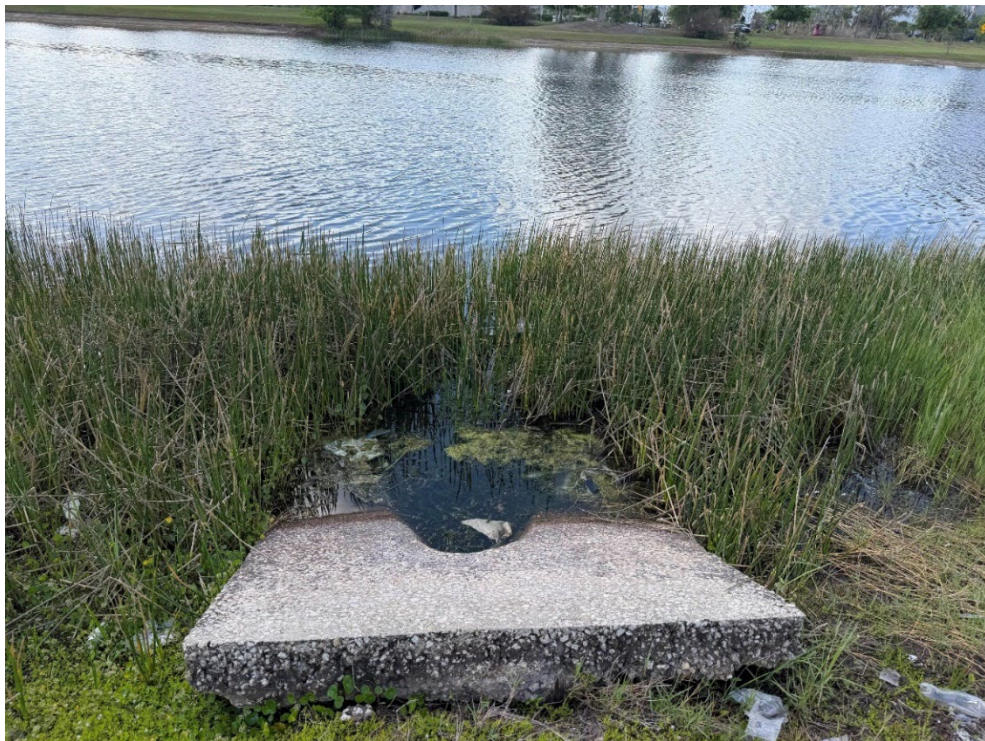
**Photo 57.2 – Discharge Into Pond  
(New Photo – 2026 Assessment)**

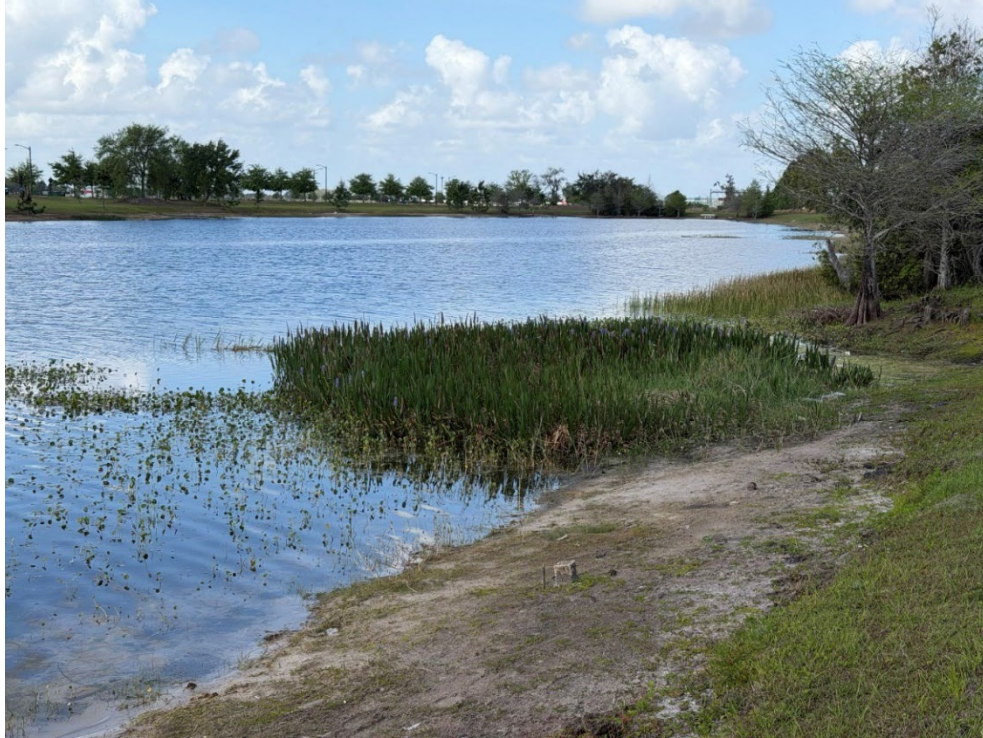
**Photo 58 – Vegetation in Pond (No Observed Changes)  
(Refer to Prior Photo 76- 2025 Assessment)**

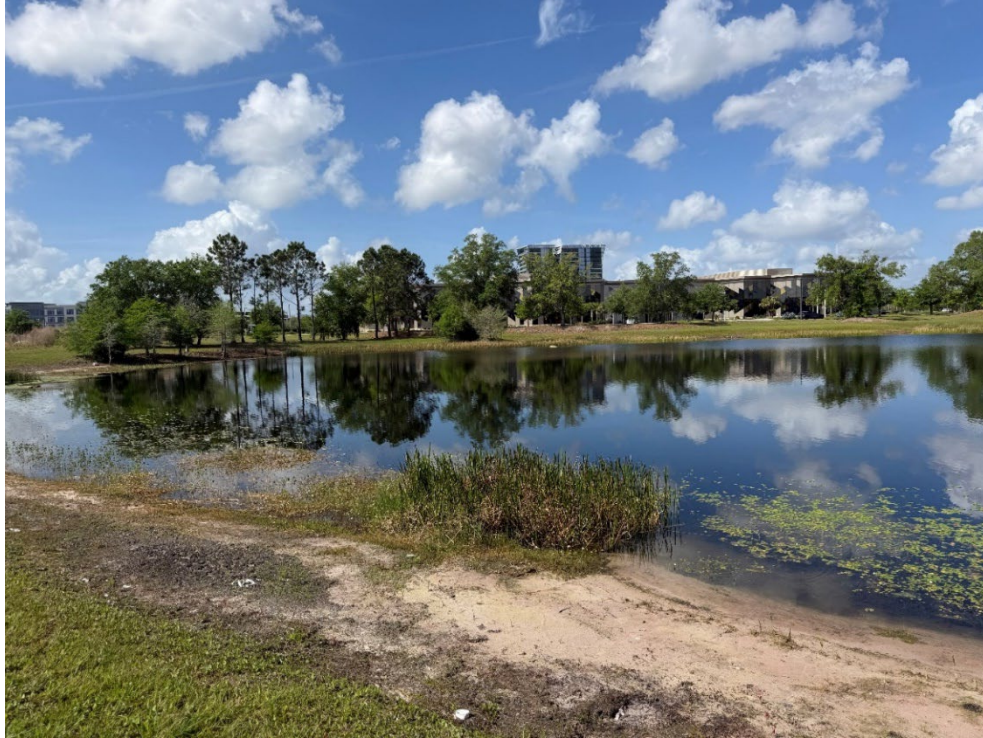
**Photo 59 – Vegetation in Pond – View from East End (No Observed Changes)  
(Refer to Prior Photo 78- 2025 Assessment)**

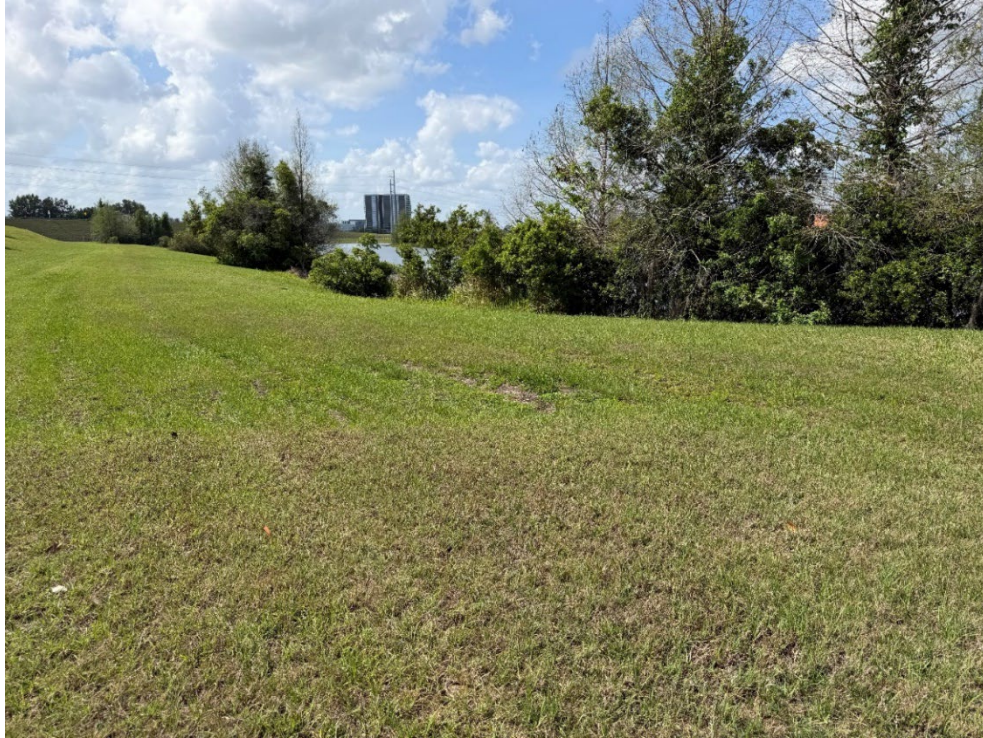
**Photo 61 –NE Corner Berm (No Observed Changes)  
(Refer to Prior Photo 81- 2025 Assessment)**

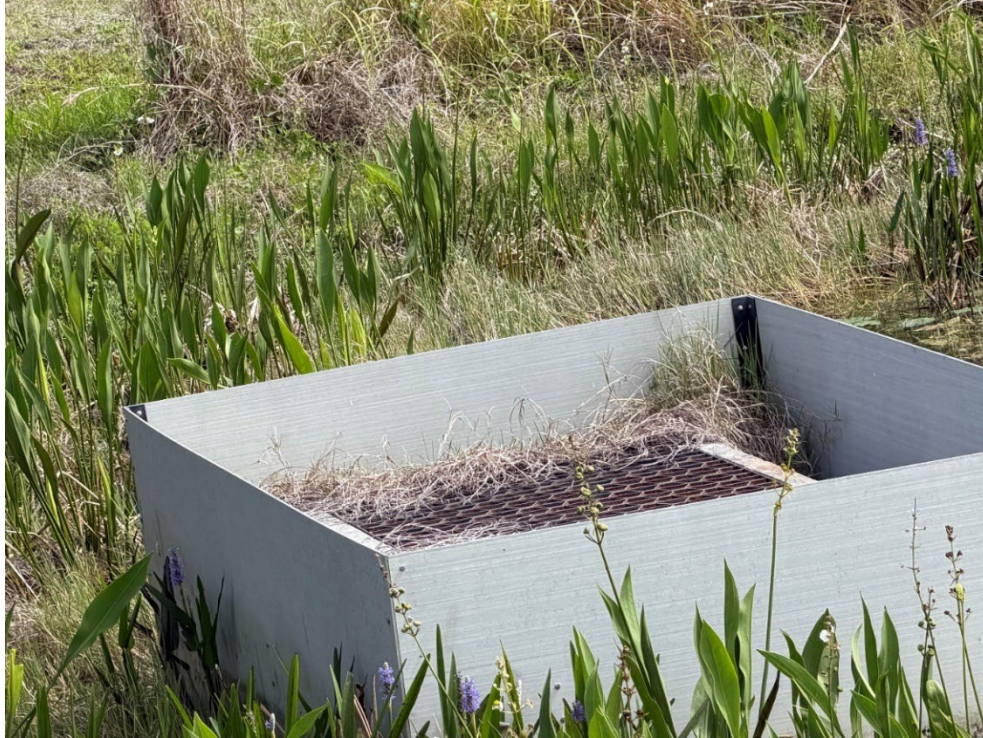
**Photo 61.4 – Outfall Structure Containing Vegetation  
(New Photo – 2026 Assessment)**

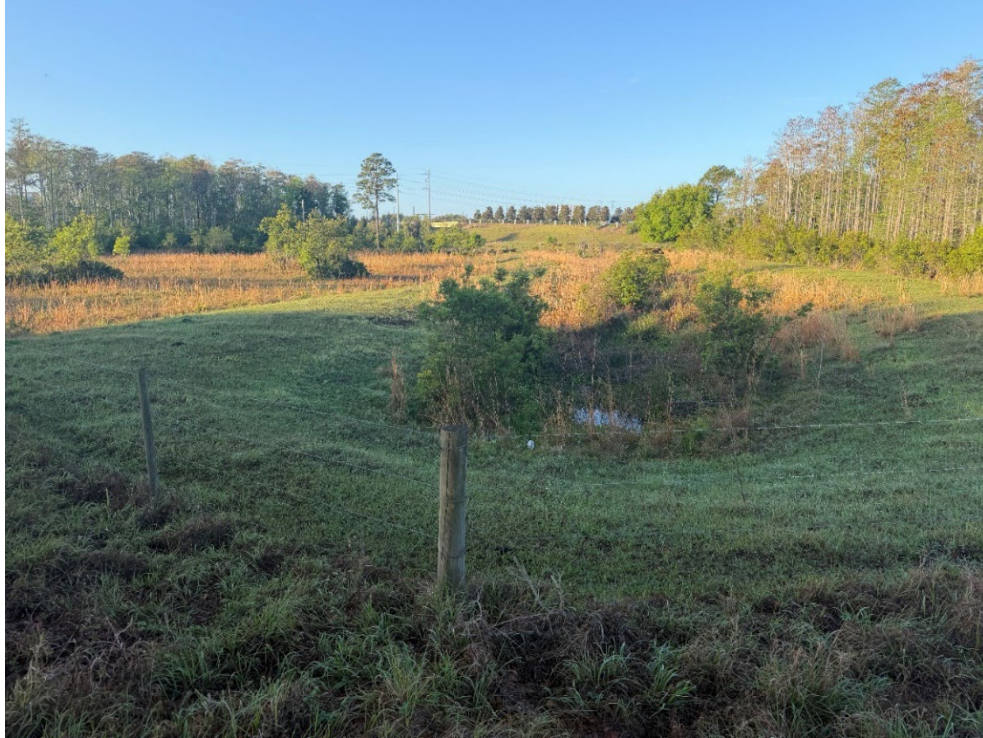
**Photo 63 – Overgrown Inflow Ditch from Apartment Access Road into Pond  
(No Observed Changes) (Refer to Prior Photo 83- 2025 Assessment)**

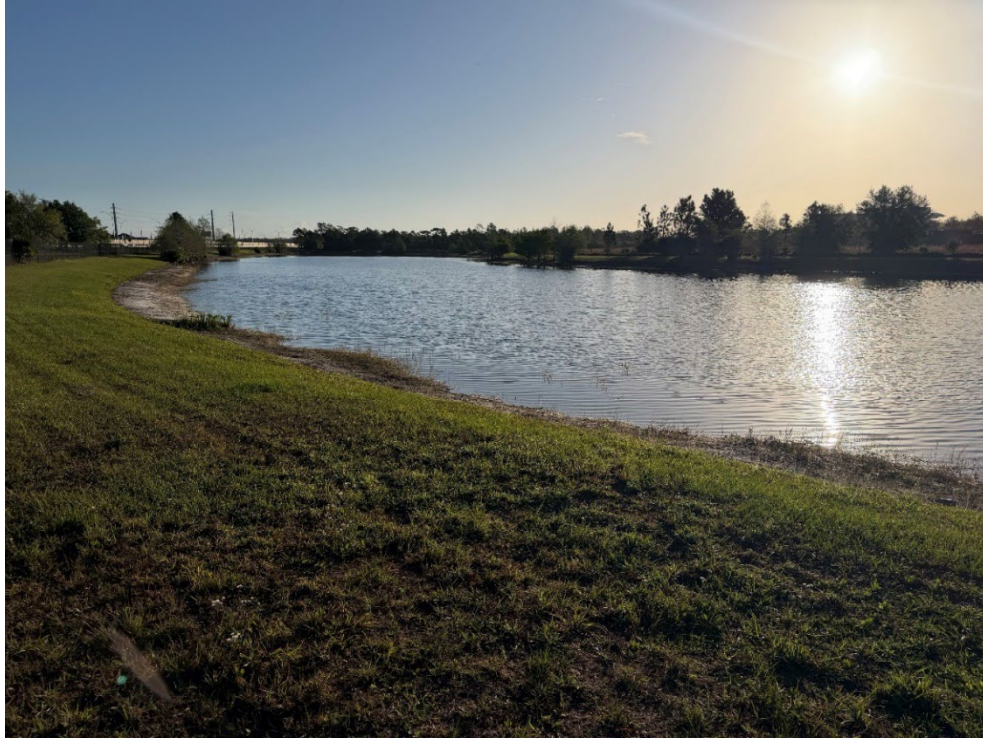
**Photo 65 – West Side of Pond in Good Condition (No Observed Changes)  
(Refer to Prior Photo 85 - 2025 Assessment)**

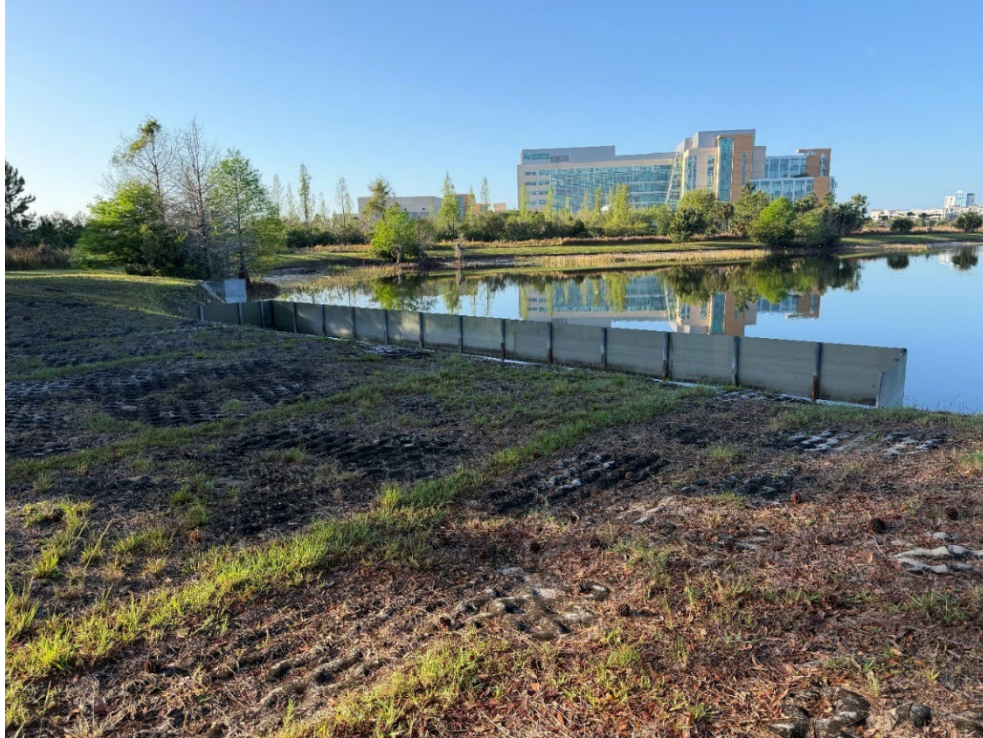
**Photo 67 – Weir on NE Corner in Good Condition  
(No Observed Changes) (Refer to Prior Photo 87 - 2025 Assessment)**

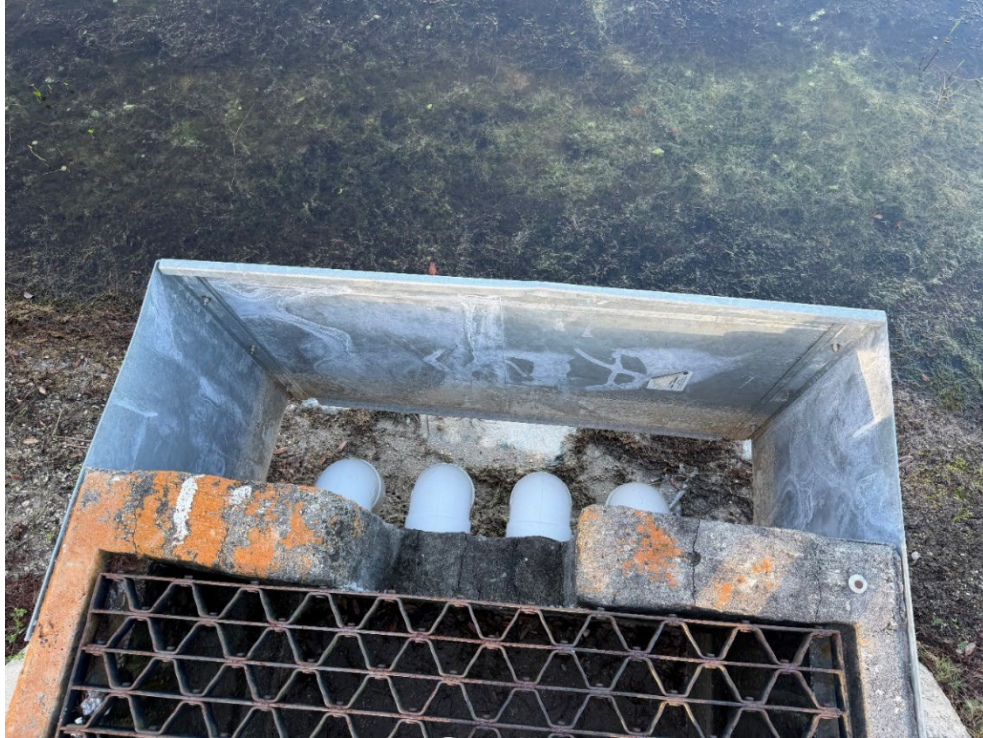
**Photo 69 – Drawdown Pipe Inside of Outfall Structure  
(No Observed Changes) (Refer to Prior Photo 89- 2025 Assessment)**

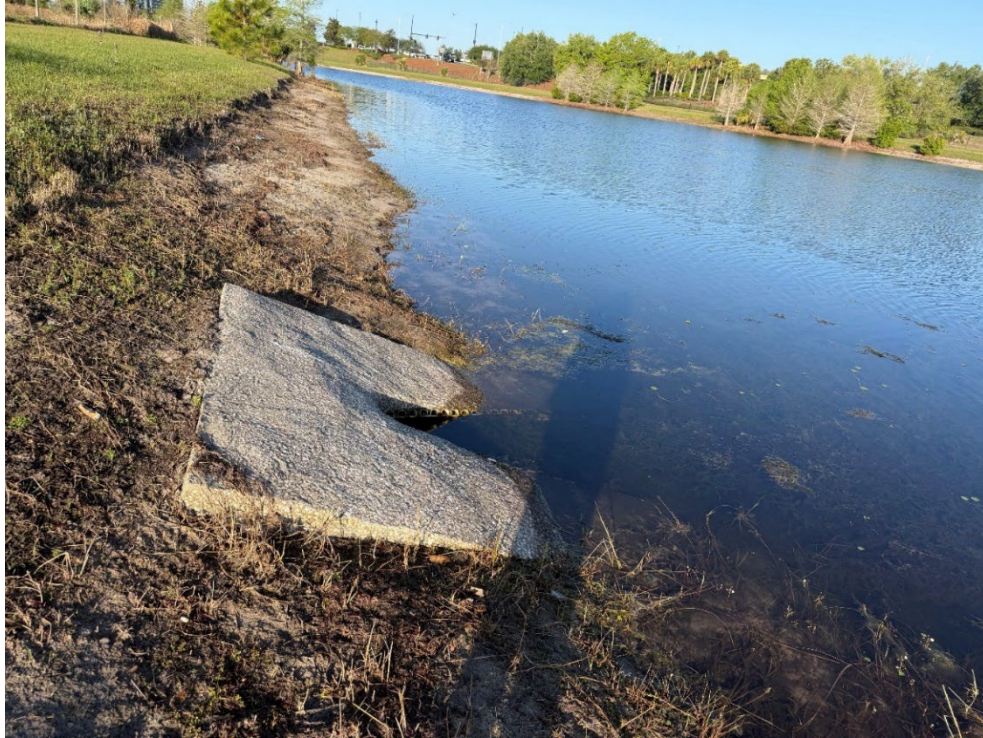
**Photo 70 – South Berm Facing West in Good Condition  
(No Observed Changes) (Refer to Prior Photo 90 - 2025 Assessment)**

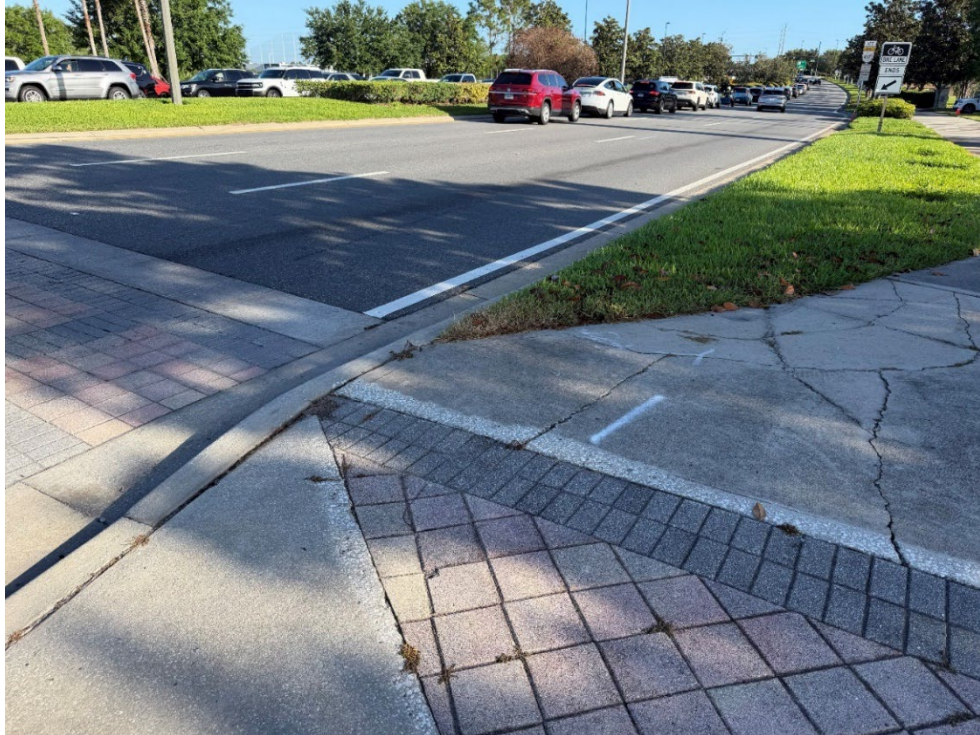
**Photo 72 – Surficial Paver Cracks, Minor Settling (No Observed Changes)  
(Refer to Prior Photo 92- 2025 Assessment)**
