# **DISTRICT INFRASTRUCTURE ASSESSMENT REPORT**

## **BOGGY CREEK IMPROVEMENT DISTRICT**

**APRIL 30, 2026**

**BOGGY CREEK IMPROVEMENT DISTRICT  
ORLANDO, FLORIDA**

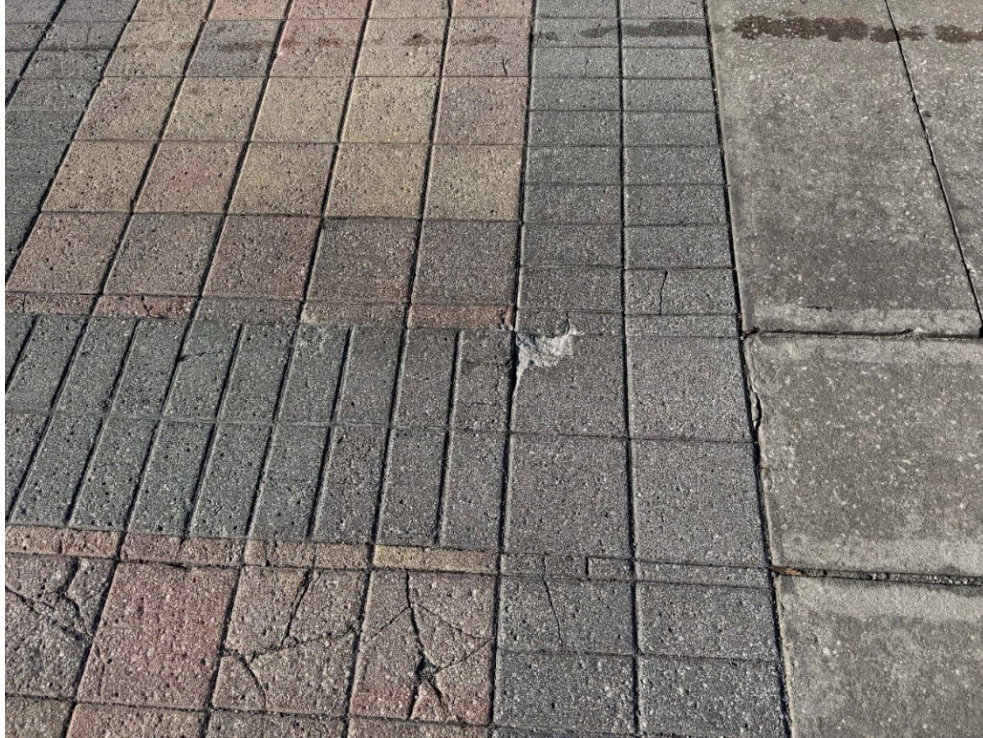
**Photo 72.2 – Spalling Concrete, Settling  
(New Photo – 2026 Assessment)**

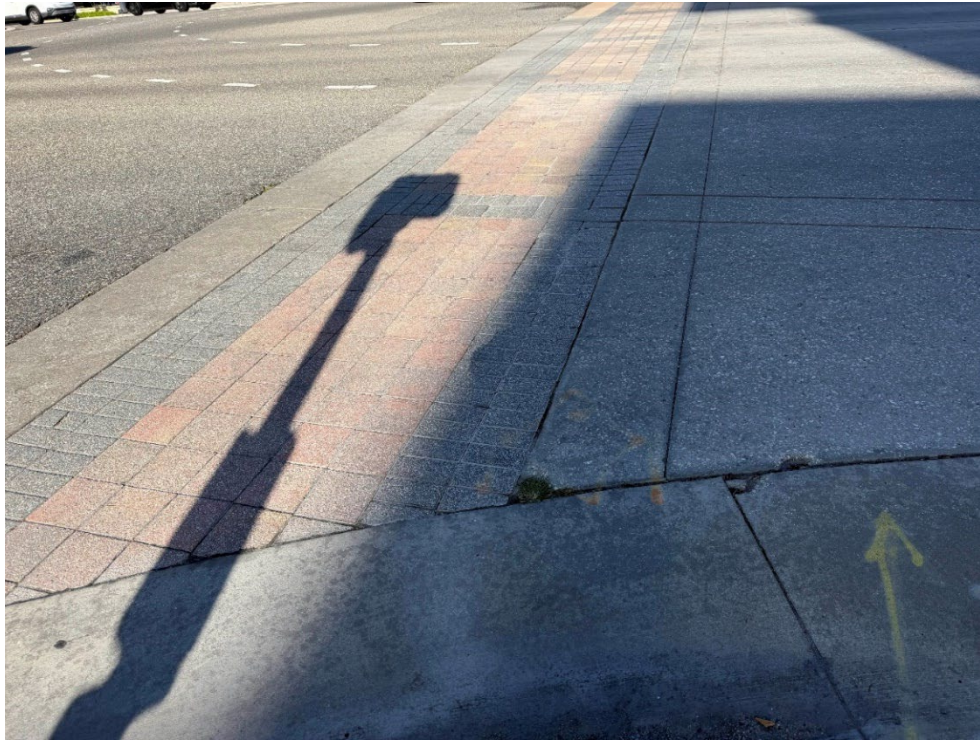
**Photo 75.1 – Broken Concrete Ribbon  
(New Photo – 2026 Assessment)**

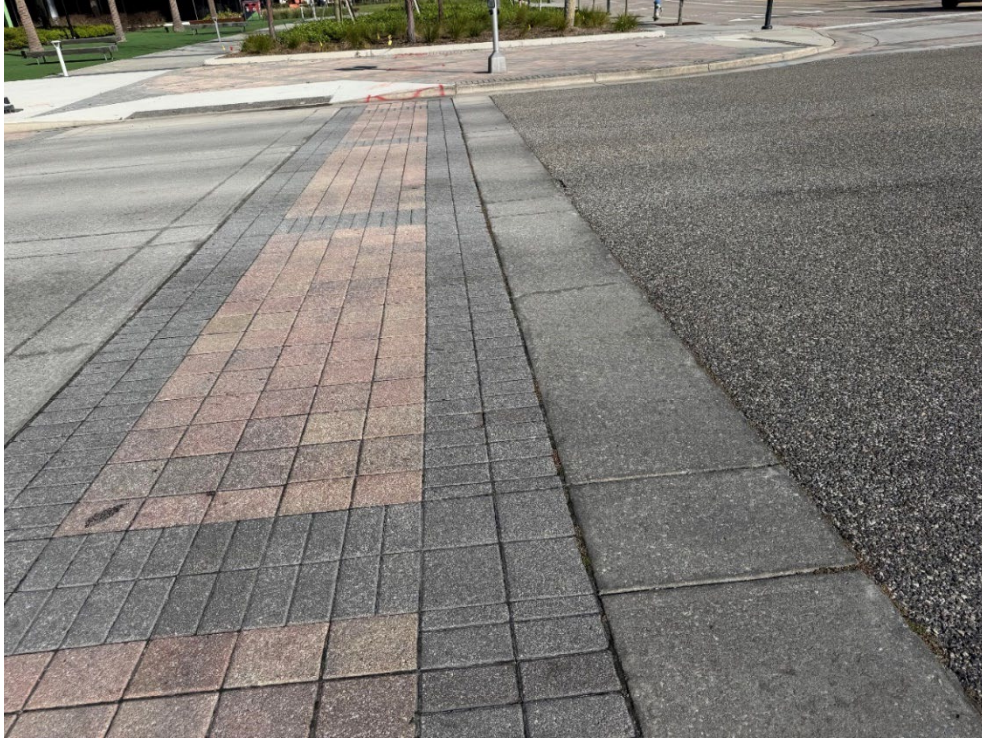
**Photo 76.1 – Cracked Pavers  
(New Photo – 2026 Assessment)**

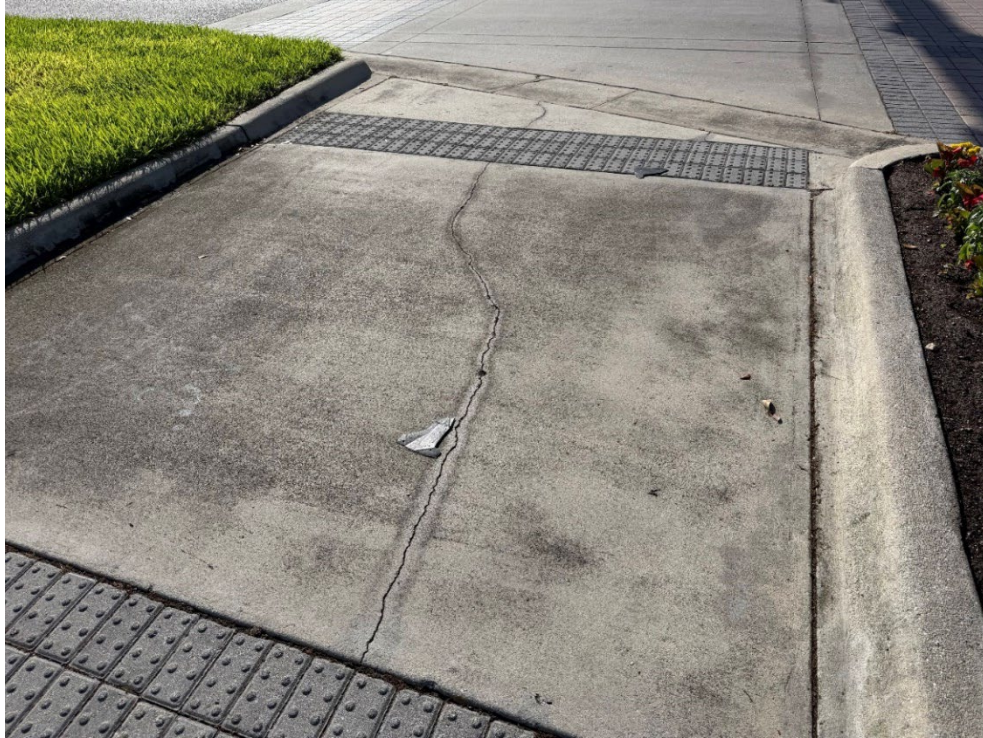
**Photo 78 – Cracked Pavers, Minor Settling (No Observed Changes)  
(Refer to Prior Photo 102 - 2025 Assessment)**

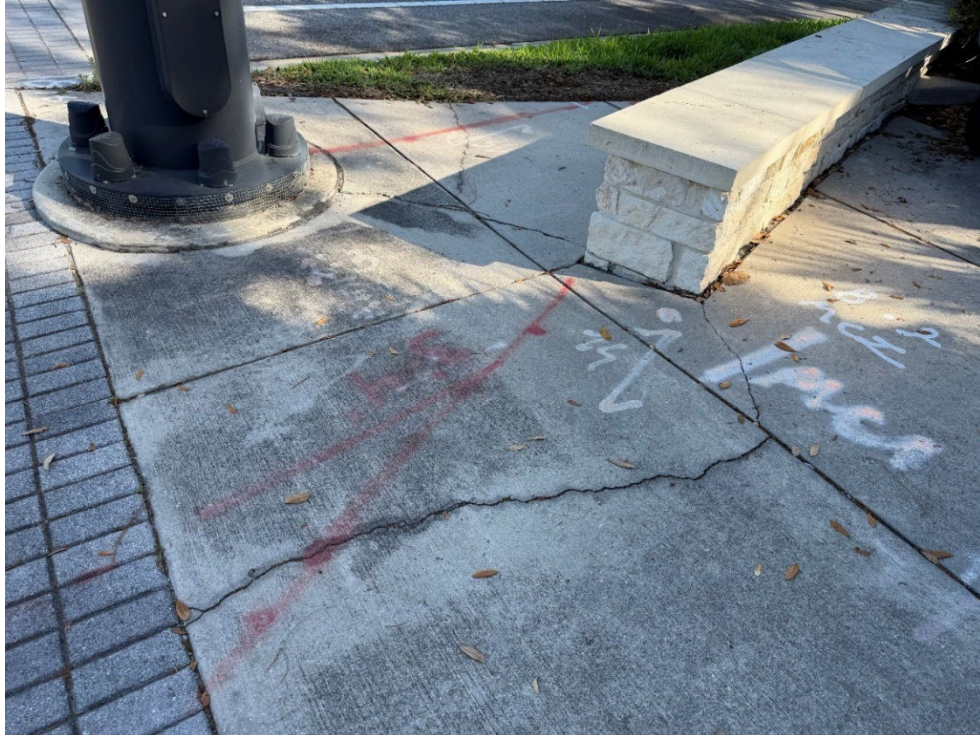
**Photo 78.2 – Cracked Concrete  
(New Photo – 2026 Assessment)**

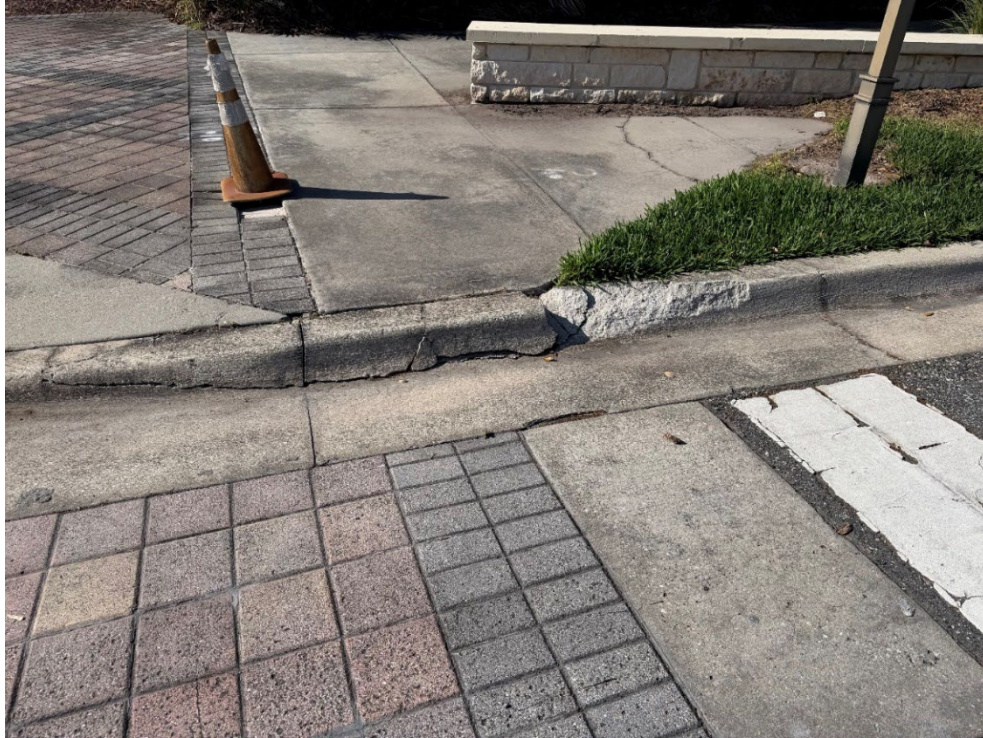
**Photo 79 – Cracked Pavers, Some Settling (No Observed Changes)  
(Refer to Prior Photo 105 - 2025 Assessment)**

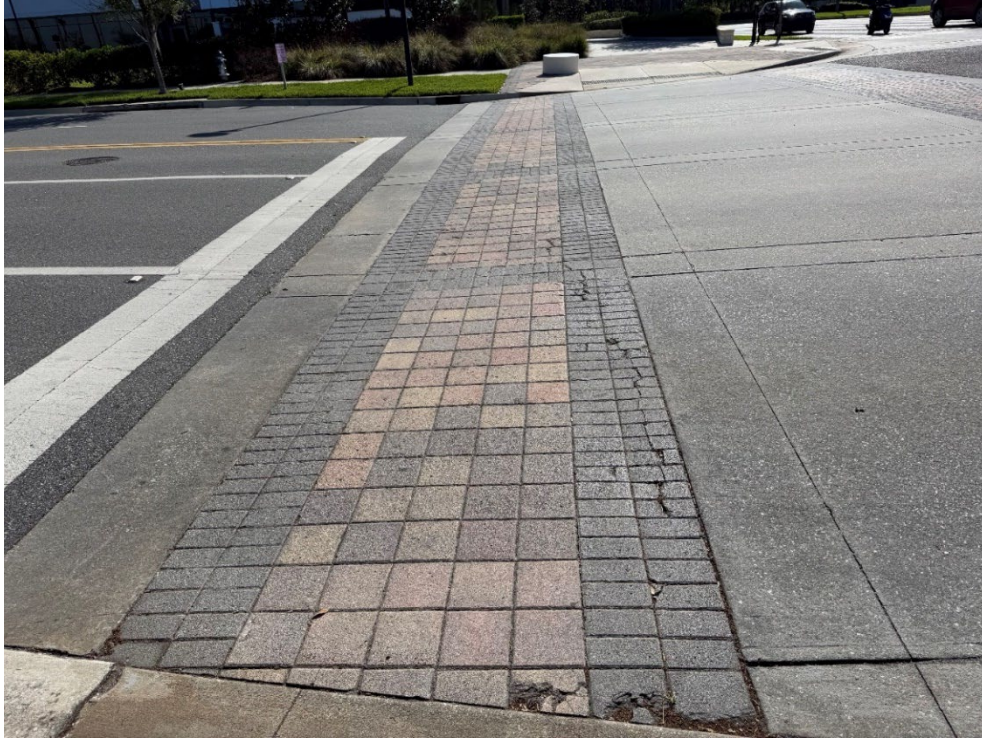
**Photo 80 – Broken Curb (No Observed Changes)  
(Refer to Prior Photo 107 - 2025 Assessment)**

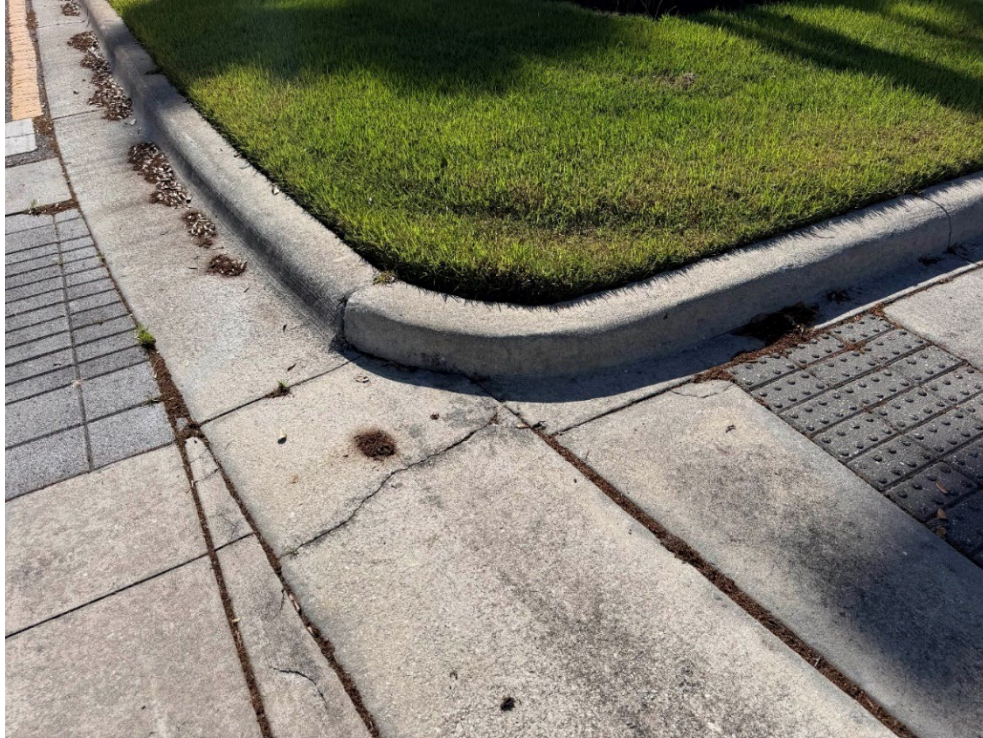
**Photo 84 – Broken Concrete Flush Curb (No Observed Changes)  
(Refer to Prior Photo 111 - 2025 Assessment)**

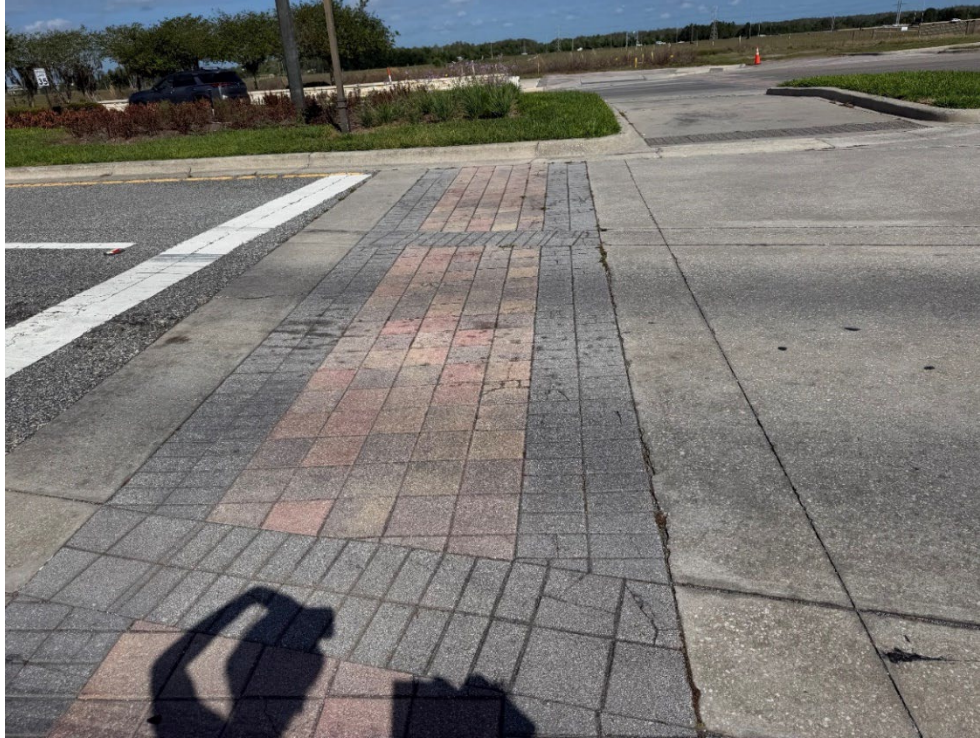
**Photo 84.2 – Cracked Concrete, Multiple Cracked Pavers, Some Settling  
(New Photo – 2026 Assessment)**

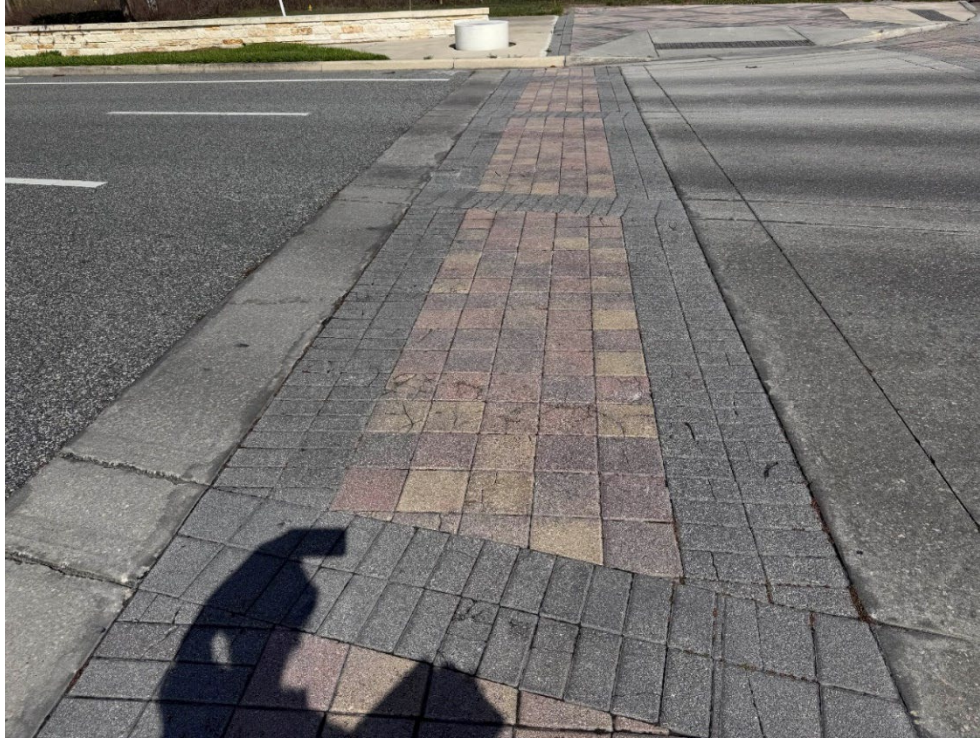
**Photo 85 – Multiple Cracked Concrete, Pavers Settling, Broken Flush Curb  
(No Observed Changes) (Refer to Prior Photo 113 - 2025 Assessment)**

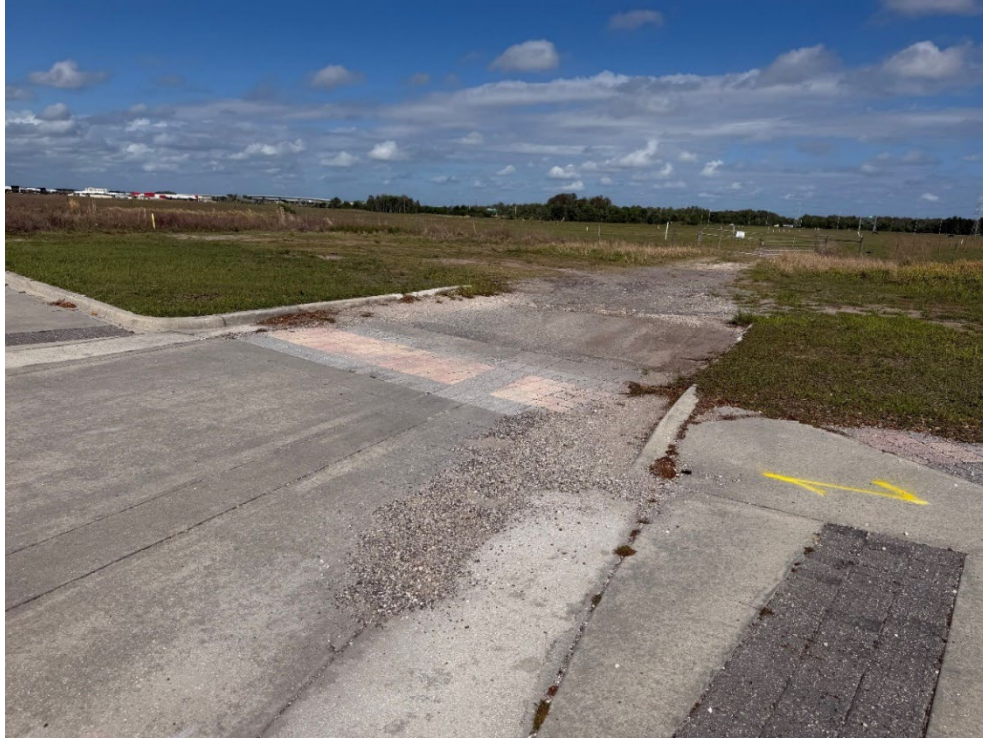
**Photo 86 – Broken Curb (No Observed Changes)  
(Refer to Prior Photo 116 - 2025 Assessment)**

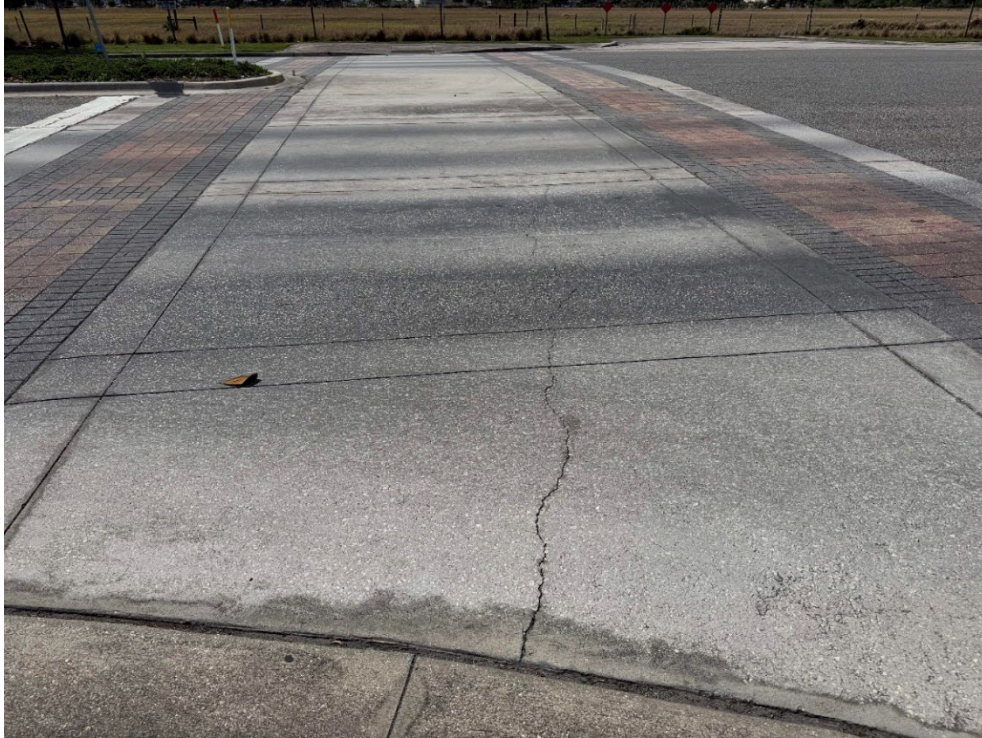
**Photo 91 – Broken Concrete (No Observed Changes)  
(Refer to Prior Photo 124 - 2025 Assessment)**
